DIAGNOSTICS OF STEEL ROOF STRUCTURES OF SPORT STADIUMS

2. DIAGNOSTICS OF STEEL ROOF STRUCTURE OF WINTER SPORT STADIUM IN OLOMOUC CITY – SPATIAL TRUSS GRID

3. DIAGNOSTICS OF STEEL ROOF STRUCTURE OF WINTER SPORT STADIUM IN JIHLAVA CITY – MAIN GIRDERS, PURLINS AND BRACINGS

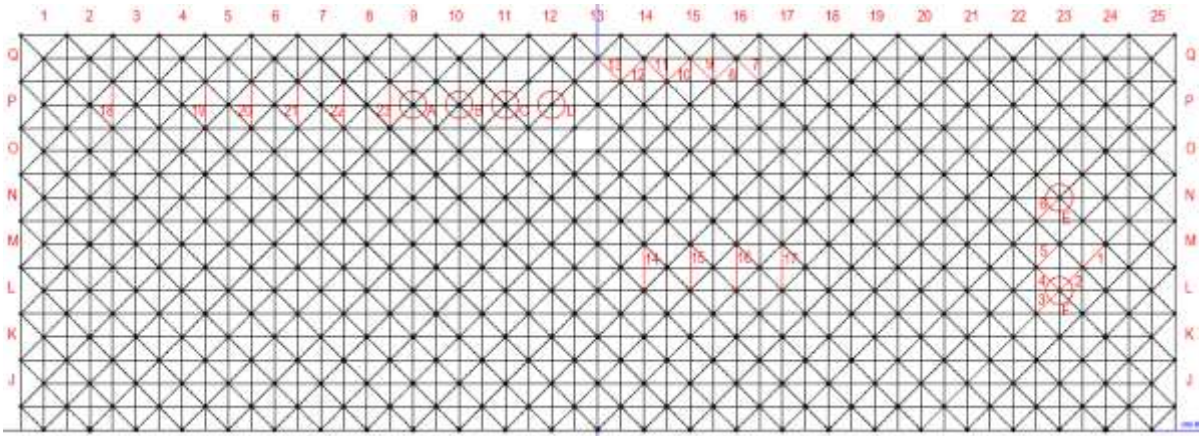
Figure 3: Localization of positions of verified tube members and spherical joints.

Based on the client requirements, the non-destructive verification of the thicknesses of selected members of steel load-carrying roof structure has been performed at first (Láník 2012). Within this control the thickness of 29 statically significant steel members of load-carrying structure has been measured using ultrasound method. The localization of the position of verified members is specified in Fig. 3 (marked by digits from "1" to "23" and letters from "A" to "F"). Based on the preliminary static assessment, the following members have been verified: 13 tube diagonals ("1–13" in Fig. 3) with cross-sections of TR Ø 102 / 4 (7 pc.), TR Ø 127 / 6 (4 pc.), TR Ø 168 / 8 (2 pc.); 4 tube members of lower chord ("14–17") with cross-sections of TR Ø 219 / 10 (2 pc.), TR Ø 219 / 14 (2 pc.), 6 tube members of upper chord ("18–23") with cross-sections of TR Ø 127 / 6 (2 pc.), TR Ø 168 / 6 (2 pc.), TR Ø 219 / 10 (2 pc.) and 6 lower chord spherical joints ("A–F").

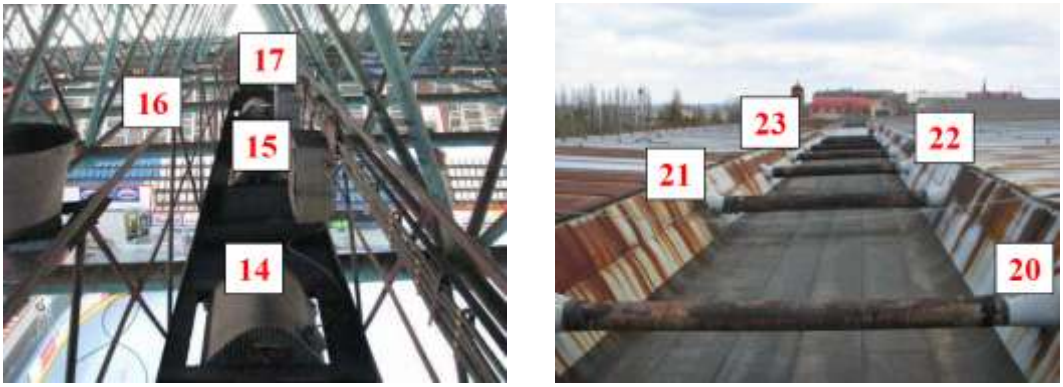
Figure 6: Examples of verified members of tube lower chords and upper chords.

Illustrations of examples of verified members including measuring places are depicted in Figs. 5 and 6; the overview of the thicknesses measured is listed in Table 1; for more see (Láník 2012).

Using ultrasound device "SONIC 1 200 HR", the thicknesses of the walls of selected statically important structural members of roof structure of the winter sport stadium in Olomouc city have been verified. Applying 10 MHz ultrasound probe and precise preparation of the verified members surface the measuring accuracy of ± 0.4 mm has been achieved. Based on the results of ultrasound measurement and available documentation of the roof structural system, it can be deducted, that the

actual thicknesses of particular selected members, which have been measured, correspond with the thicknesses mentioned in drawing documentation.
