DYNAMIC LOADING TESTS CARRIED OUT AFTER REPAIR WORKS OF THE YODOGAWA BRIDGE

Yodogawa Bridge having a total length of 723.3m is composed by 30 spans, 6 of which are simply supported truss bridges with span length of 32.918m. Completed in 1926, the bridge is located on a heavy traffic route and underwent repair works after being severely damaged during the World War II.

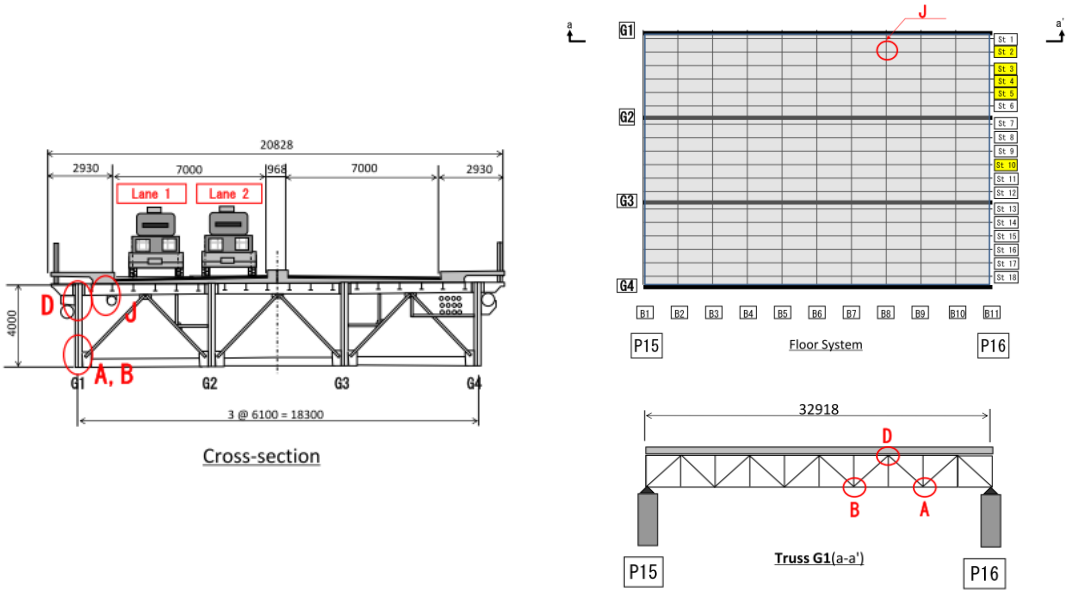
Figure 2: Measurement points

Based on the deterioration scenario obtained from the series of investigations carried out in 2011 (Natsuaki et al., Kohno et al., Ichinose et al., 2011), critical members were selected for repair and, after the execution of repair works, stress measurements were carried. Stress measurements were carried out through strain gages installed at the measurement points shown in Figures 2 and 3.

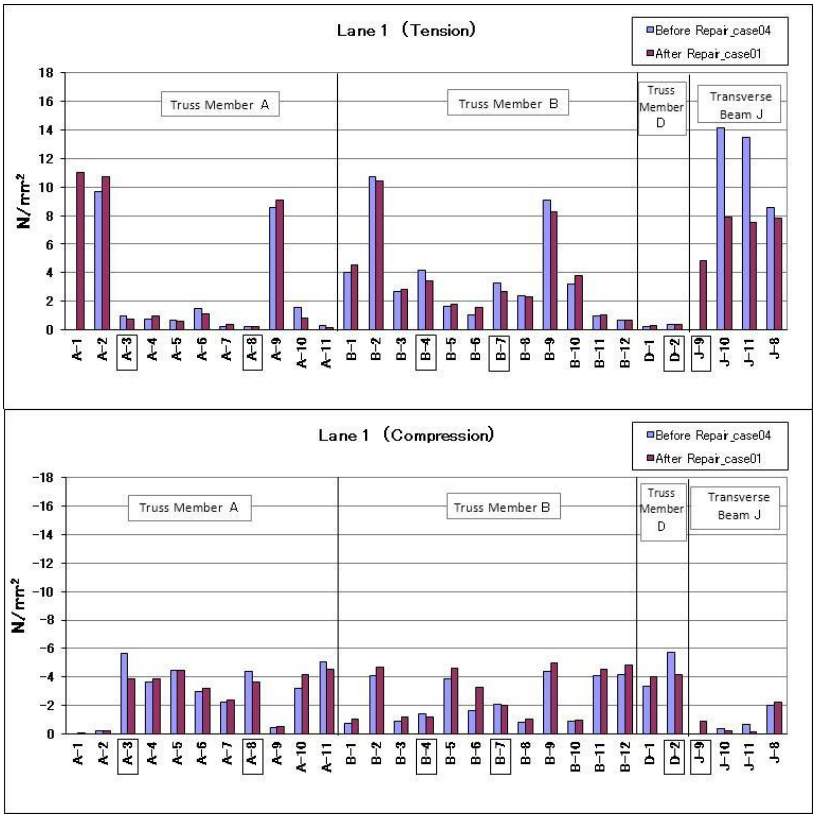
Figure 5: Stresses before and after repair works (Dynamic loading test)

The results of the dynamic loading test, compared to the results obtained in measurements carried out before the execution of repair works, showed relatively small differences for stresses measured in the truss members, whereas considerable improvements were observed in the transverse beam stresses. Measurements results for lane 1 are shown in Figure 5. The figure presents the measured stresses for the structure before and after the execution of repair works. In particular, it was observed that stresses at the lower flange of the repaired transverse beam presented a considerable reduction of stress (about 40%) after being retrofitted.

In the dynamic loading tests, stresses at the truss members did not present considerable differences compared to that measured before the execution of retrofitting works, whereas the stresses at the lower flange of the reinforced transverse beam presented considerable stress reduction (40%), proving the effectiveness of the retrofitting works.

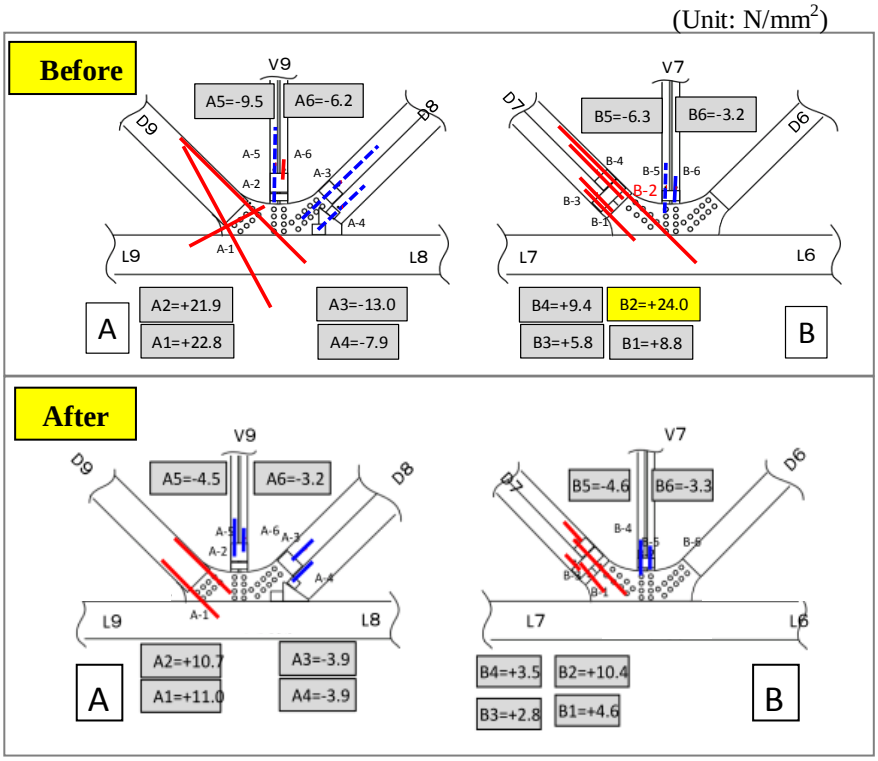
Figure 7: Stresses under traffic load before and after repair works (truss members)

The stresses measured during the 72 hours (3 consecutive week days) presented relatively small values, being most of them within the fatigue limit. Maximum stresses observed in truss members and transverse beam during the measurements are shown in Figure 7 and 8, respectively.

Under traffic load, stresses were considerably improved in both truss members and the transverse beam, what can be also seen in Figure 9 which shows a decrease in the stress range ($\Delta\sigma$) after the execution of repair works for almost all the measurement points. The transverse beam, in particular,

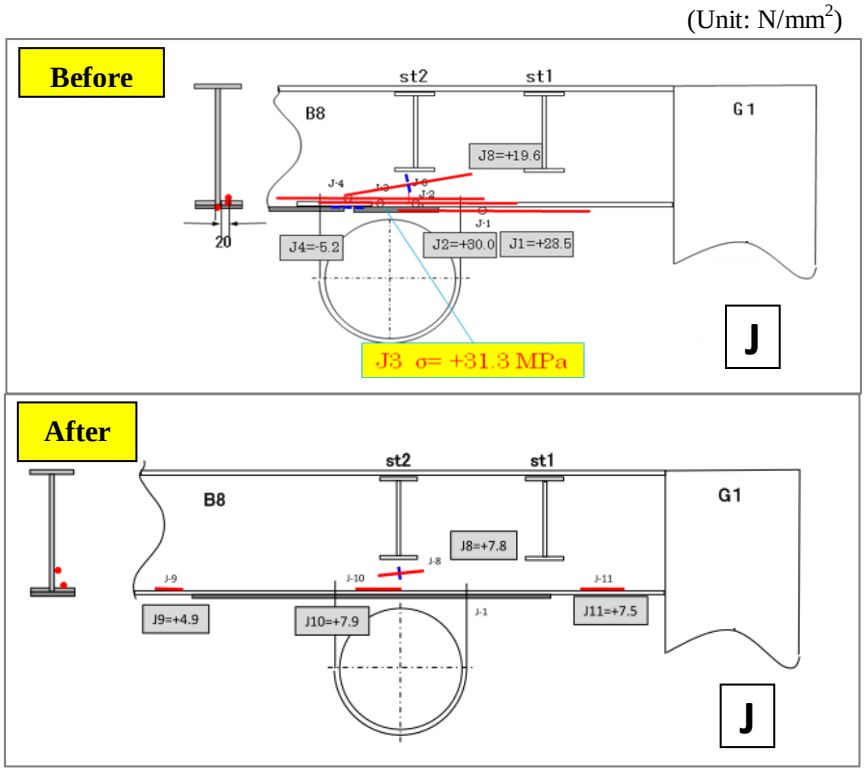
Figure 8: Stresses under traffic load before and after repair works (transverse beam)

had its predicted fatigue life extend to more than 10 times of that of before the execution of repair works.

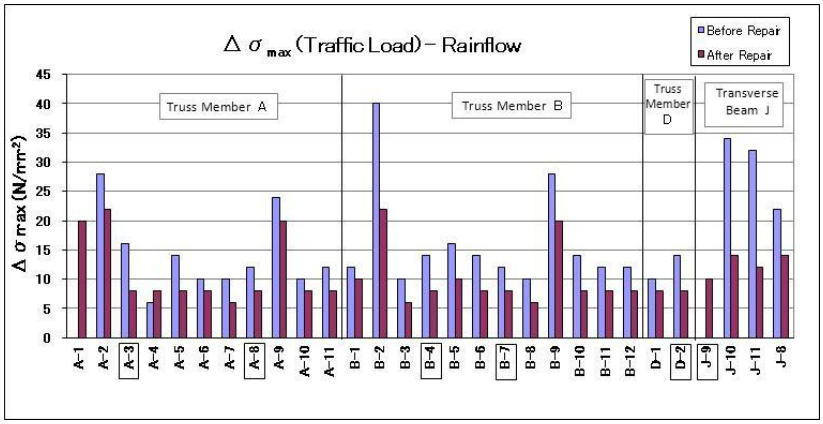
Figure 9: Maximum stress range before and after repair works (Traffic load)

Measurements carried out under traffic load showed improvements in the stress range for almost all the measurement points. However, the fatigue life obtained based on these measurement results did not show dramatic changes in the fatigue lives of most measured members, except for the lower flange of the retrofitted transverse beam, which presented a fatigue life improved to 10 times of that of before retrofitting .
