Title	MEASUREMENT AND ANALYSIS OF RC DECK DEFORMATION AFTER 27 YEARS OF SERVICE
Author(s)	SHIMADA, T.; MATSUMOTO, T.; HAYASHIKAWA, T. et al.
Description	The Thirteenth East Asia-Pacific Conference on Structural Engineering and Construction (EASEC-13), September 11-13, 2013, Sapporo, Japan.
Relation	Proceedings of the Thirteenth East Asia-Pacific Conference on Structural Engineering and Construction (EASEC-13), September 11-13, 2013, Sapporo, Japan, F-2-2.
Citation	Proceedings of the Thirteenth East Asia-Pacific Conference on Structural Engineering and Construction (EASEC-13), F-2-2
Issue Date	2013-09-12
Doc URL	https://hdl.handle.net/2115/54383
Type	conference paper
File Information	easec13-F-2-2.pdf

MEASUREMENT AND ANALYSIS OF RC DECK DEFORMATION AFTER 27 YEARS OF SERVICE

T. SHIMADA[1*], T. MATSUMOTO[2], T. HAYASHIKAWA[2], and X.HE[2]

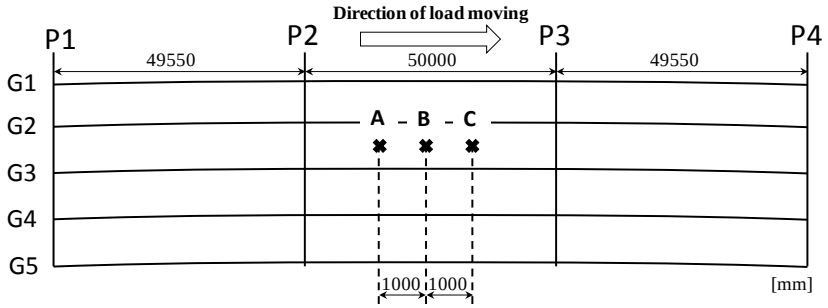
Figure 1: The viaduct ground span

The object of this study is a viaduct which was build in 1985, a three-spans continuous curved viaduct with RC deck slab supported by five steel girders. The viaduct ground span is shown in Figure 1. The cross section of the superstructure is shown in Figure 2. The measurement points were set up between P2, P3 and G2, G3. Remarkable crack and free lime was observed in this deck and already spread to the entire bridge deck. It seems that water has already permeated into the internal of the RC deck.

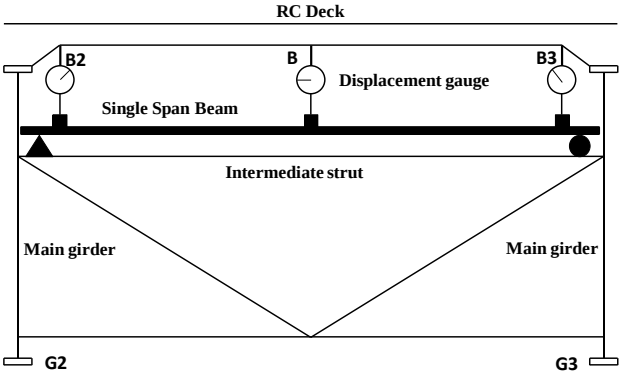
Figure 3: Measurement installation

The measurement of the deck deformation and crack width should avoid a concrete cast joint as far as possible. The measurement installation is shown Figure 3. A simply supported beam was placed on an intermediate strut, and three displacement gauges were set up on this beam. The measurement points were set up not only in the center of the deck span, but also in the end of the haunch for G2 and G3. The reason for setting up the simply supported beam on the intermediate strut is to reduce the measurement error as much as possible. When traveling load acts on the RC deck, not only the deck, but also the girder and the intermediate strut will be distorted, so that setting up the beam as such makes it possible to reduce the measurement error. Clip gauges were set up in order to

measure the crack width. Each one of the cracks happened around the center of the deck in longitudinal and transverse direction was chosen to study. Clip gauges were adopted to measure it.

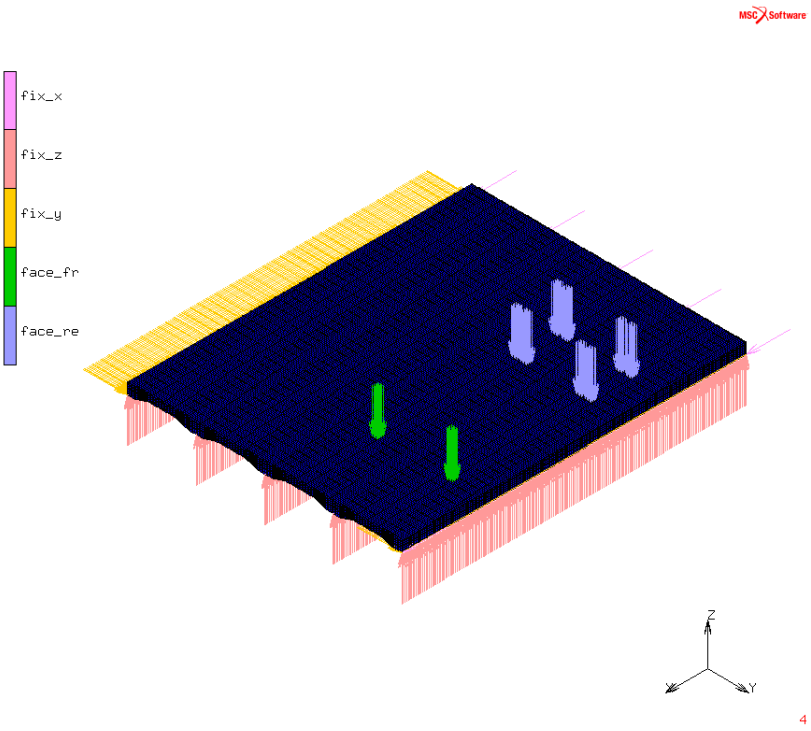
Figure 5: Finite element model

The finite element analysis was conducted with MSC.Marc, a non linear structural analysis software. The analytical model is shown in Fig 5. Only the RC deck was taken into consideration, while the

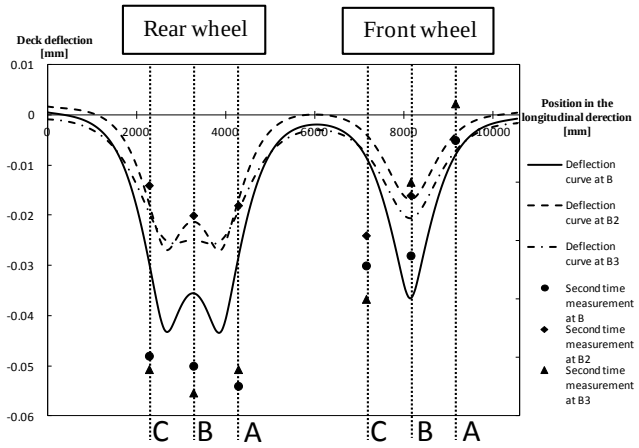
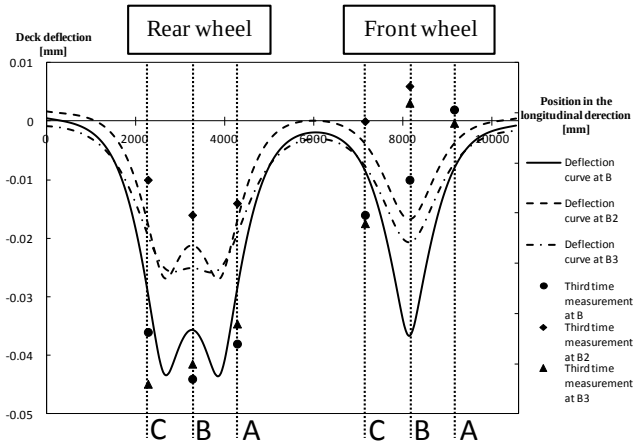
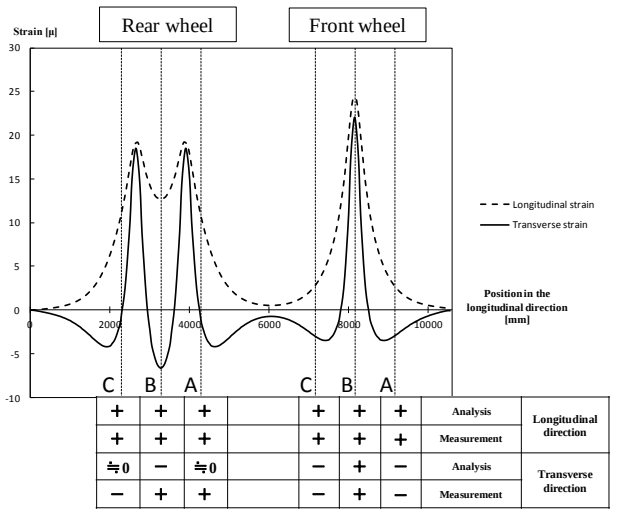
Figure 6: Deck deformation

Both the measurement and numerical result of deck deformation at the center of deck of between girders G2, G3 and at the end of the haunch for G2 and G3 were shown in Figure 6. To obtain accurate result, the measurement was conducted for three times and the measurement values were plotted in Figure 6 (a)-(c). There are some decrease tendencies of displacement due to the equipment error, while we can regard them as references. Moreover, no significant difference was

observed between the measurement value and the numerical result, meaning that no remarkable decrease of deck stiffness happens. On the other hand, a relatively large difference result was observed among each measuring process which probably due to the vehicle loading position error or the problem of the measuring equipments accuracy.

Although there is no safety problem was confirmed, but due to the obvious deterioration such as free lime and mesh crack were observed, there is necessity to set the waterproof layer for the deck and inspect regularly.
