NON-DESTRUCTIVE TESTS APPLIED DURING REPAIR WORKS OF THE YODOGAWA BRIDGE

Yodogawa Bridge having a total length of 723.3m is composed by 30 spans, 6 of which are simply supported truss bridges with spans of 32.918m. The bridge, completed in 1926, is located on a heavy traffic route and underwent repair works after being severely damaged during the World War II. Some of the repaired members had complex details whose structural components were not clear and, in some cases, their connections and welds to the original structural members were not visible.

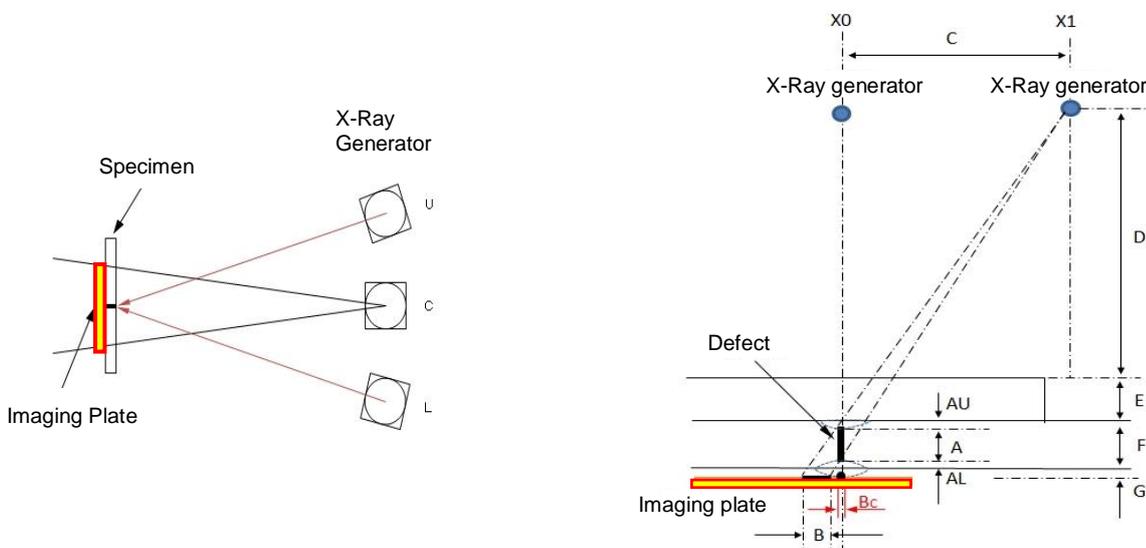
Figure 4: Scheme of the depth evaluation method

Based on Figure 4, the depth of the defect, A, can be calculated according to the following equations, assuming AU and AL to be 3mm.
