Damage to Steel Buildings Observed After the 2011 Tohoku Earthquake

Taichiro Okazaki,^{a)} Dimitrios G. Lignos,^{b)} M.EERI, Mitsumasa Midorikawa,^{c)} M.EERI, James M. Ricles,^{d)} M.EERI, and Jay Love,^{e)} M.EERI

A joint U.S.-Japan reconnaissance team examined the damage to steel building structures caused by the 2011 off the Pacific Coast of Tohoku Earthquake. In the city of Sendai, where the peak horizontal ground acceleration exceeded 1 g, the majority of steel buildings performed well. Buildings that used older cladding systems for external finish sustained damage to their claddings even if their structural performance was excellent. Damage to a few braced frames offer insight into the seismic design of bracing connections. In areas attacked by violent tsunami, many steel buildings stood upright after the tsunami subsided, although these buildings lost much of their external and internal finishes along with their contents. These steel buildings did not provide safe shelter for tsunami evacuation when the building submerged under the tsunami wave. A number of buildings suffered foundation failure, which was likely caused by scouring or liquefaction or the combination of mul

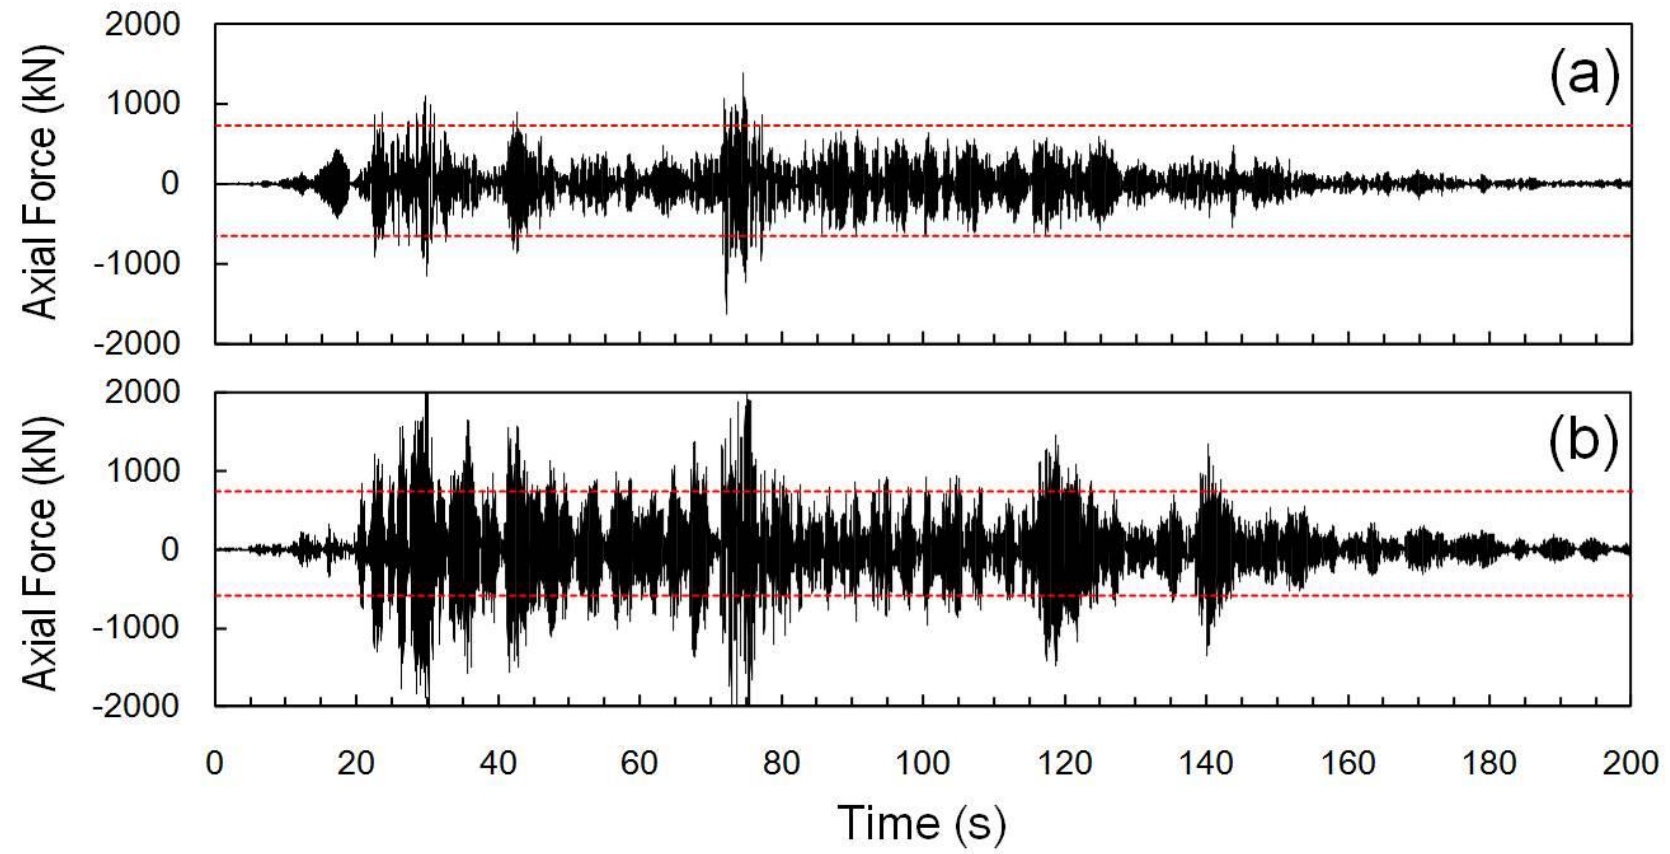
Fig. 11

- Figure 11.** Axial force history for (a) NS-brace; and (b) EW-brace.
- Figure 12.** SRC-Building A: (a) Overall view; and (b) repaired corner column.
- Figure 13.** SRC-Building B: (a) Overall view; and (b) cracking in nonstructural walls.

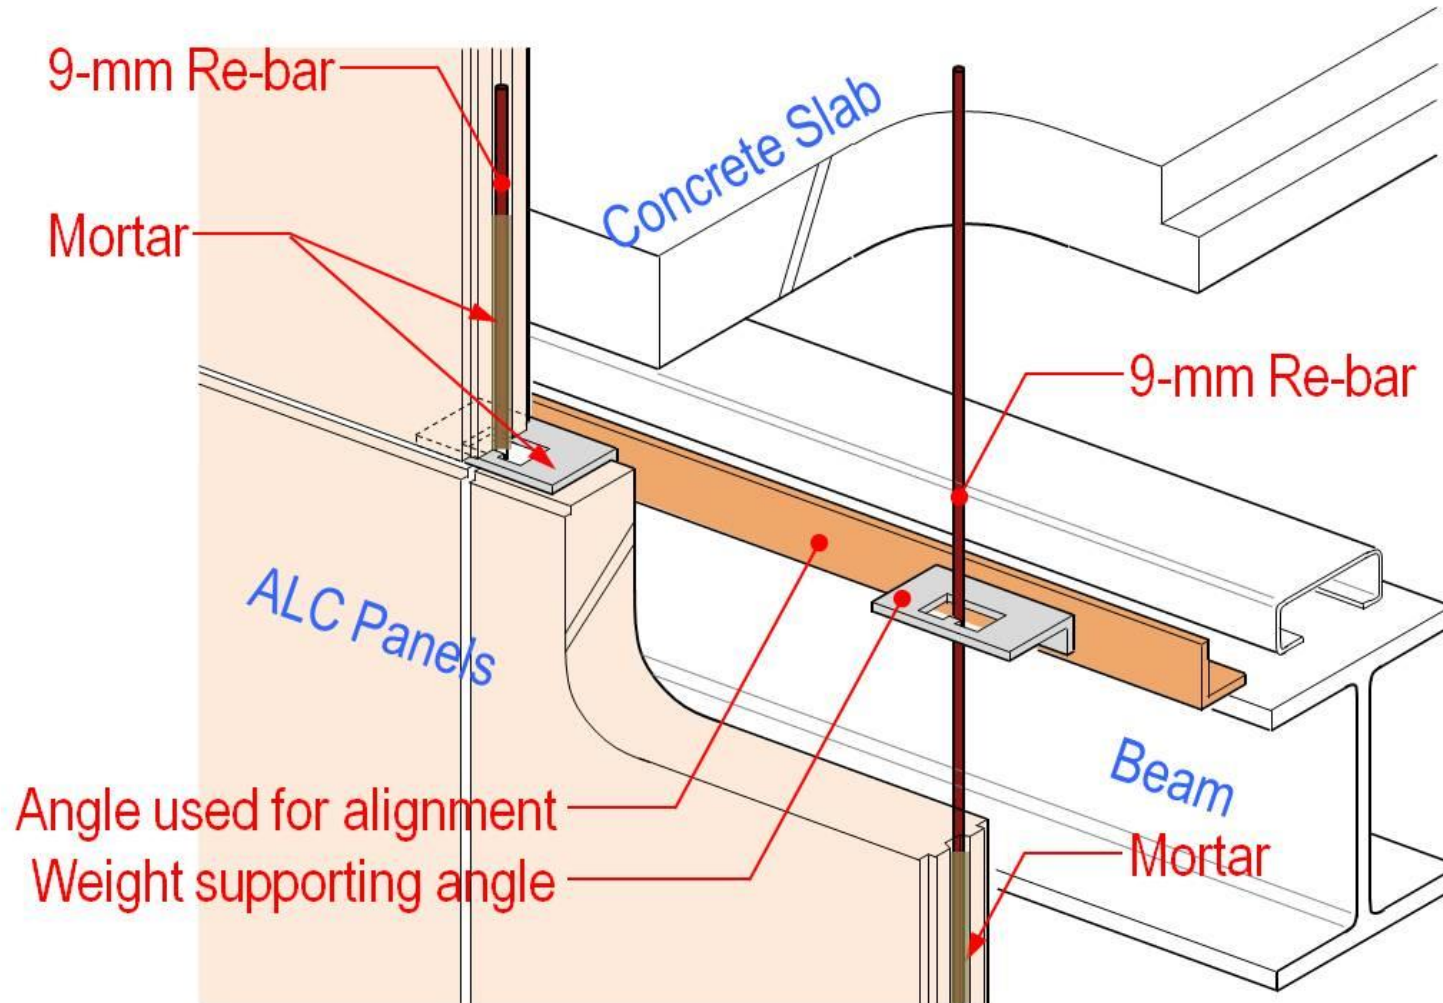
Fig. 16

Figure 16. Older installation method for ALC panel claddings

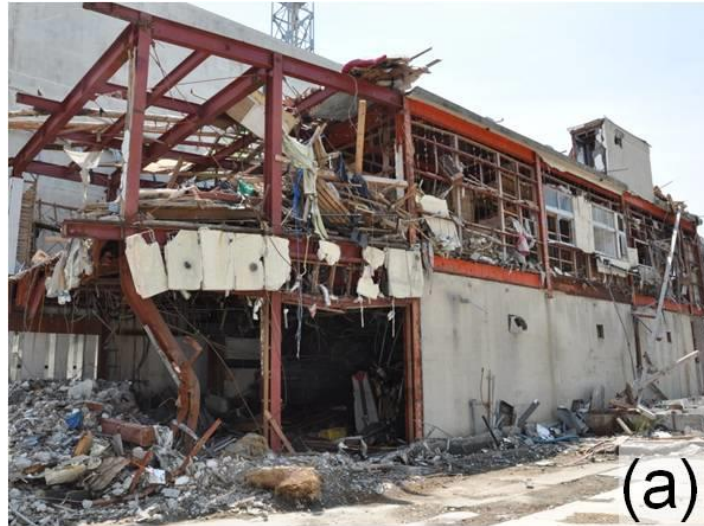
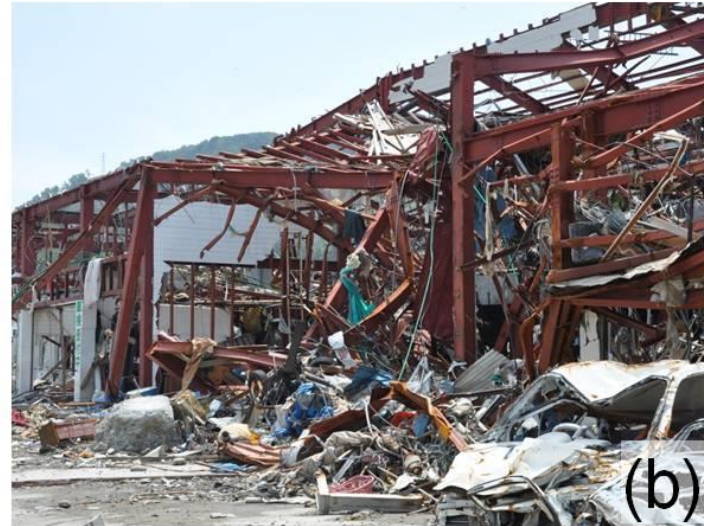
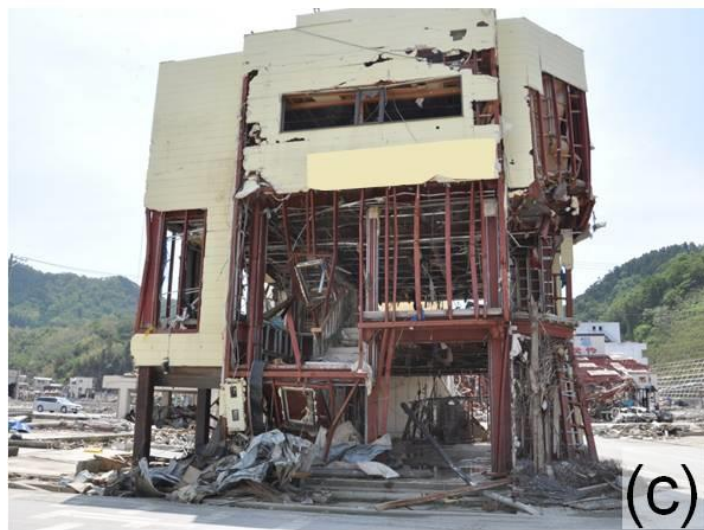
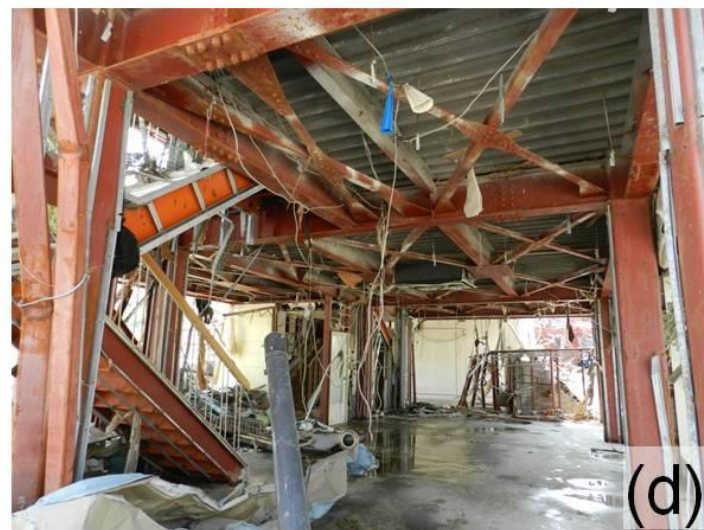
Fig. 18

Figure 18. Steel buildings in Onagawa: (a) a building (1 by 6-bay, 2-story MRF/MRF) with evidence of debris impact; (b) a building (details unknown) deformed beyond recognition; (c) a building (2 by 3-bay, 3-story MRF/MRF) standing upright; and (d) interior of building shown in c.
