Geo-Disaster Report

Reconnaissance report on geotechnical damage caused by 2018 Hokkaido Eastern Iburi earthquake with JMA seismic intensity 7

Tatsuya Ishikawa^{a,*}, Masayuki Yoshimi^b, Koichi Isobe^a, Shoji Yokohama^a

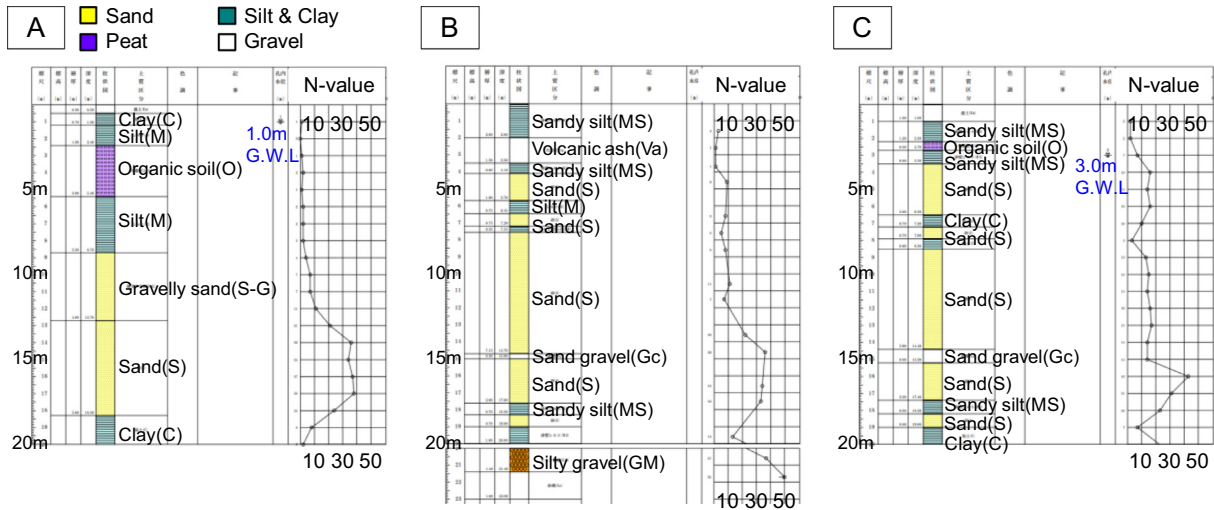
Fig. 16. Geological column diagram of the original ground around Kita 34 Station based on G-Space II.

Fig. 16 shows the geological columns around the affected area obtained from the Geological and Geotechnical Information Database G-Space II in Japan. From this figure, it can be seen that the original ground around Kita 34 Station is mainly composed of clay and silt with a very small N value and sand with an N value of 10 or less, partially containing organic soil. Moreover, the groundwater level at the time of the earthquake occurrence is unknown, but in the geological column map, the groundwater level is at a depth of 1.0–3.0 m from the ground surface.

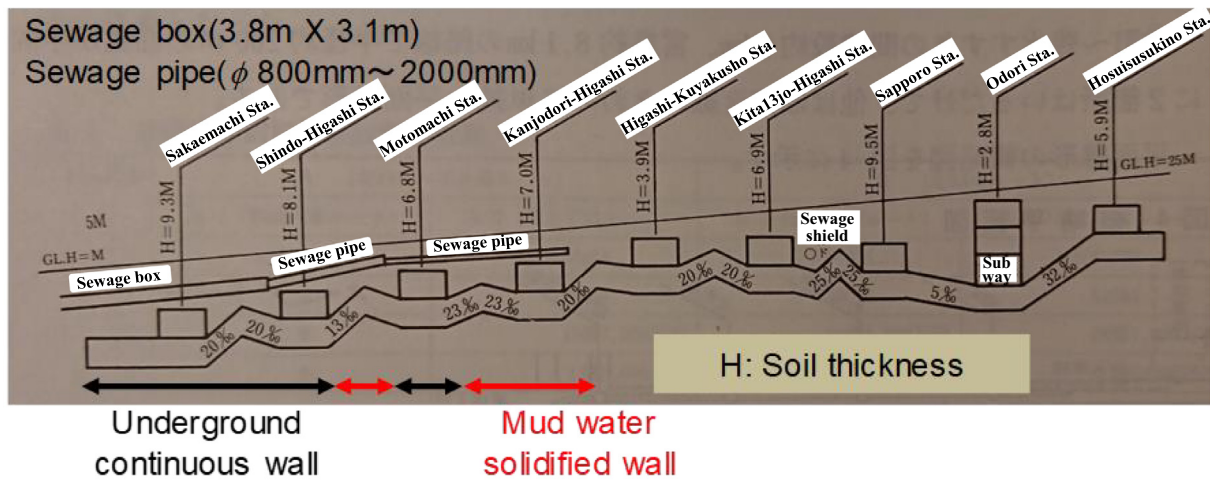
Fig. 19. A schematic longitudinal profiles along the Toho subway line drawn in the reference (Sapporo City Transportation Bureau Planning Department, 1989).

According to the Sapporo City High Speed Toho Subway Line construction history (between Sakaemachi and Hosui-Susukino) published by the Sapporo City Transportation Bureau Planning Department in 1989, in the 1970s to 1980s the Toho subway line was constructed by the open-cut method using underground continuous walls and muddy water solidified walls: these were the latest technique at that time. According to records, clean sand which was purchased for backfill soil was used. It can be inferred that the backfill soil was liquefied, and that the damage due to ground subsidence and road collapse was the result of this liquification. Figs. 19 and 20 show schematic longitudinal and geological profiles along the Toho subway line described in the same document. Here, H in Fig. 19 is the soil thickness at the center of the subway station, and the values on the subway line are the longitudinal grades. In the damaged area along Higashi 15-chome Tonden Street, peat and corroded soil layer with a layer thickness of 1–3 m exists near the ground surface, the cohesion soil

layer and the sandy soil layer alternate, and the gravel layer which is assumed to be bearing layer deposits below them. Along Kita 13 Kitago street, peat and corroded soil layer with a layer thickness of 1–3 m exists around 7–10 m from the ground surface below the alternative layers of cohesive soil and sandy soil. The gravel layer is deposited below it. In addition, the ground surface slopes gently toward the Sea of Japan, and the soil thickness of backfill soil reaches 9.3 m at Sakaemachi Station with the increase of the soft layer thickness. In addition, a sewage duct of 3.8 m × 3.1 m and a sewage pipe with a diameter of 800–2000 mm are buried along Higashi 15-chome Tonden street in the affected area. There is a construction record that an air mortar was filled between the subway structure and the retaining wall (25 cm) at the intersection with the main drive where only minor damage were observed. Based on the above, it is possible that the compaction of the backfill soil in the vicinity of the buried structure and between the subway structure and the retaining wall was insufficient.

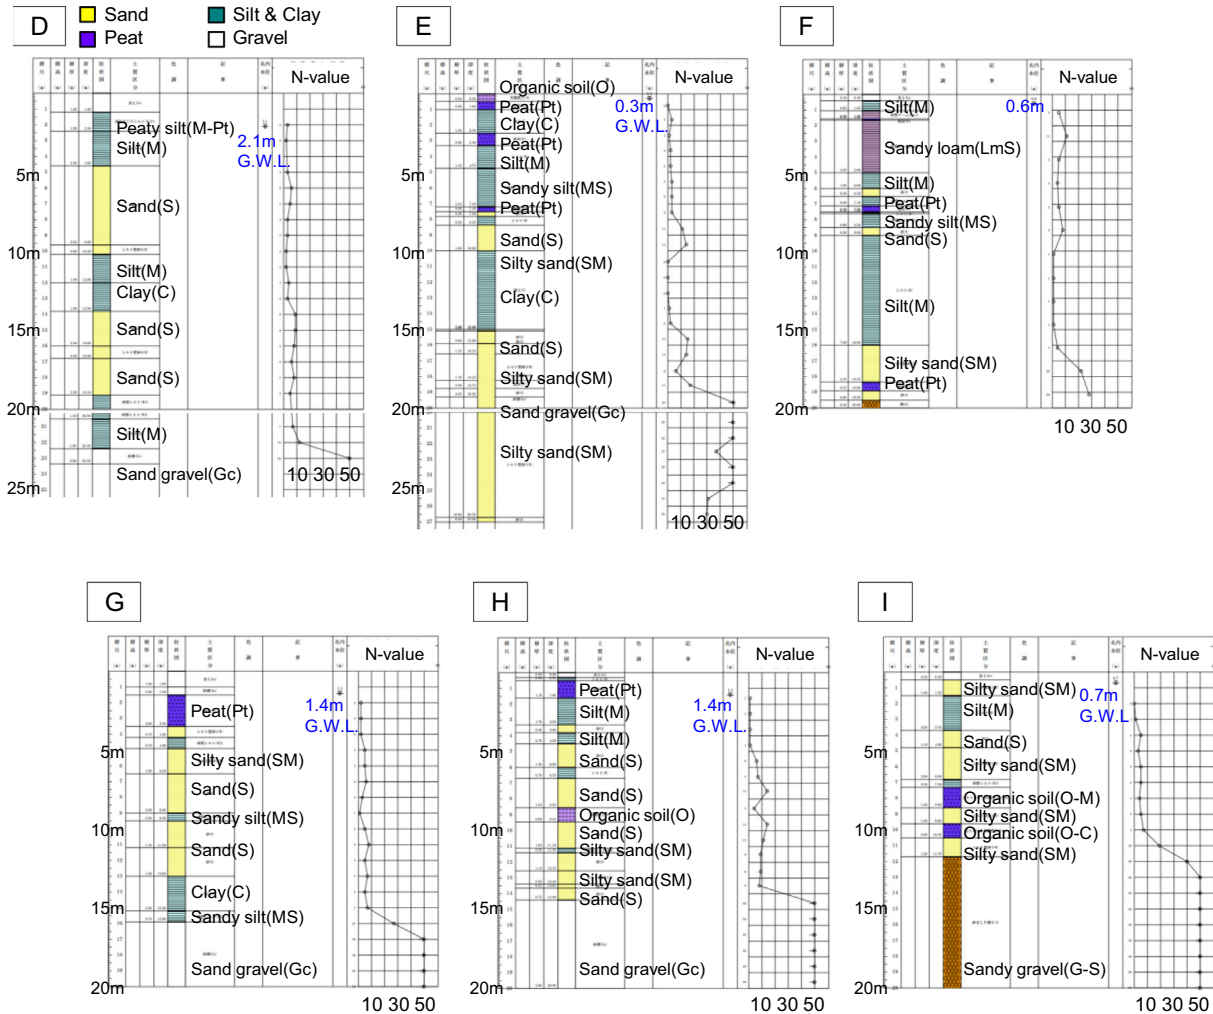
Fig. 21. Geological column diagram of the original ground along Higashi 15-chome Tonden street based on G-Space II.

Fig. 21 shows the geological columns around the affected area obtained from the Geological and Geotechnical Information Database G-Space II in Japan,

showing the location in Fig. 17. It was found that the original ground around this area partially contained organic soil, clay and silt with very a low N value and sand with an N value of 10 or less are deposited to a depth of 15–20 m as the same as the schematic longitudinal and geological profile. From Kita 34 (Shindo Higashi Station) to Kita 22, thick layers of peat and organic soil are deposited up to about 3 m near the ground surface. The original ground around Kita 16 to Kita 13 and along Kita 13 Kitago Street also partially contained organic soil, clay and silt with a very low N value and sand with an N value of 10 or less are deposited to a depth of 10 m. This is less than that at the northern part. In addition, the peat and organic soil layers are deposited about 2 m around 7–10 m from the ground surface, indicating that the deposition is shallower than in the northern area. Moreover, the groundwater level at the time of the earthquake occurrence is unknown, but in the geological column map, the average groundwater level is approximately 2.0 m from the ground surface. It tends to decrease toward the Sosei River, which flows north and south on the west side of this area.

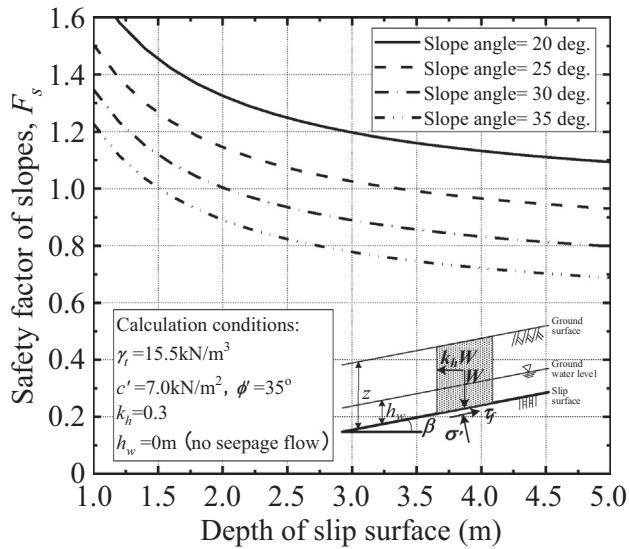
Fig. 26. Results of slope stability analysis: depth of slip surface for the collapsed slopes under various slope angles.

ness is thinner at the area where little slope failure was seen. From these facts, it is obvious that many slope failures occurred in the distribution area with thick pyroclastic deposits. When conducting the slope stability analysis under the assumed calculation conditions shown in Fig. 26 by referring to Amemiya (2019), the depth of the slip surface of the collapsed slope with a 25–35 deg range in the slope angle, which were frequently observed in Atsuma town, is between 1.5 m and 3.5 m. According to an estimation by the Ministry of Land, Infrastructure, Transport and Tourism (MLIT, 2018), the scale of slope collapses due to the 2018 Hokkaido Eastern Iburi earthquake was as follows: (a) the amount of collapsed sediment: 30.0 million m^3 ; (b) the collapsed area 13.4 km^2 . The average collapse depth estimated from the amount of collapsed sediment and the collapse area is about 2.2 m. In addition, according to the results of field investigation, though the slip surface position varied depending on the location, in most cases the collapse depth was approximately 2–3 m in places where Ta-d and En-a are deposited. From these results, it is recognized that the depths of all the slip surfaces was similar, indicating that the slope failures seen around Atsuma town were strongly influenced by the geological structures. Therefore, it is necessary to discuss and to propose prevention and mitigation measures

for earthquake-induced slope failures by considering both the amplification-attenuation characteristics of the local site and the geological structures.
