ON THE DAMAGE TO THE HAKODATE COLLEGE BY  
THE TOKACHIOKI EARTHQUAKE, 1968

Kazuo OHNO\*  
Takuji SHIBATA\*\*

2. Structure of the destroyed school-building of the Hakodate College

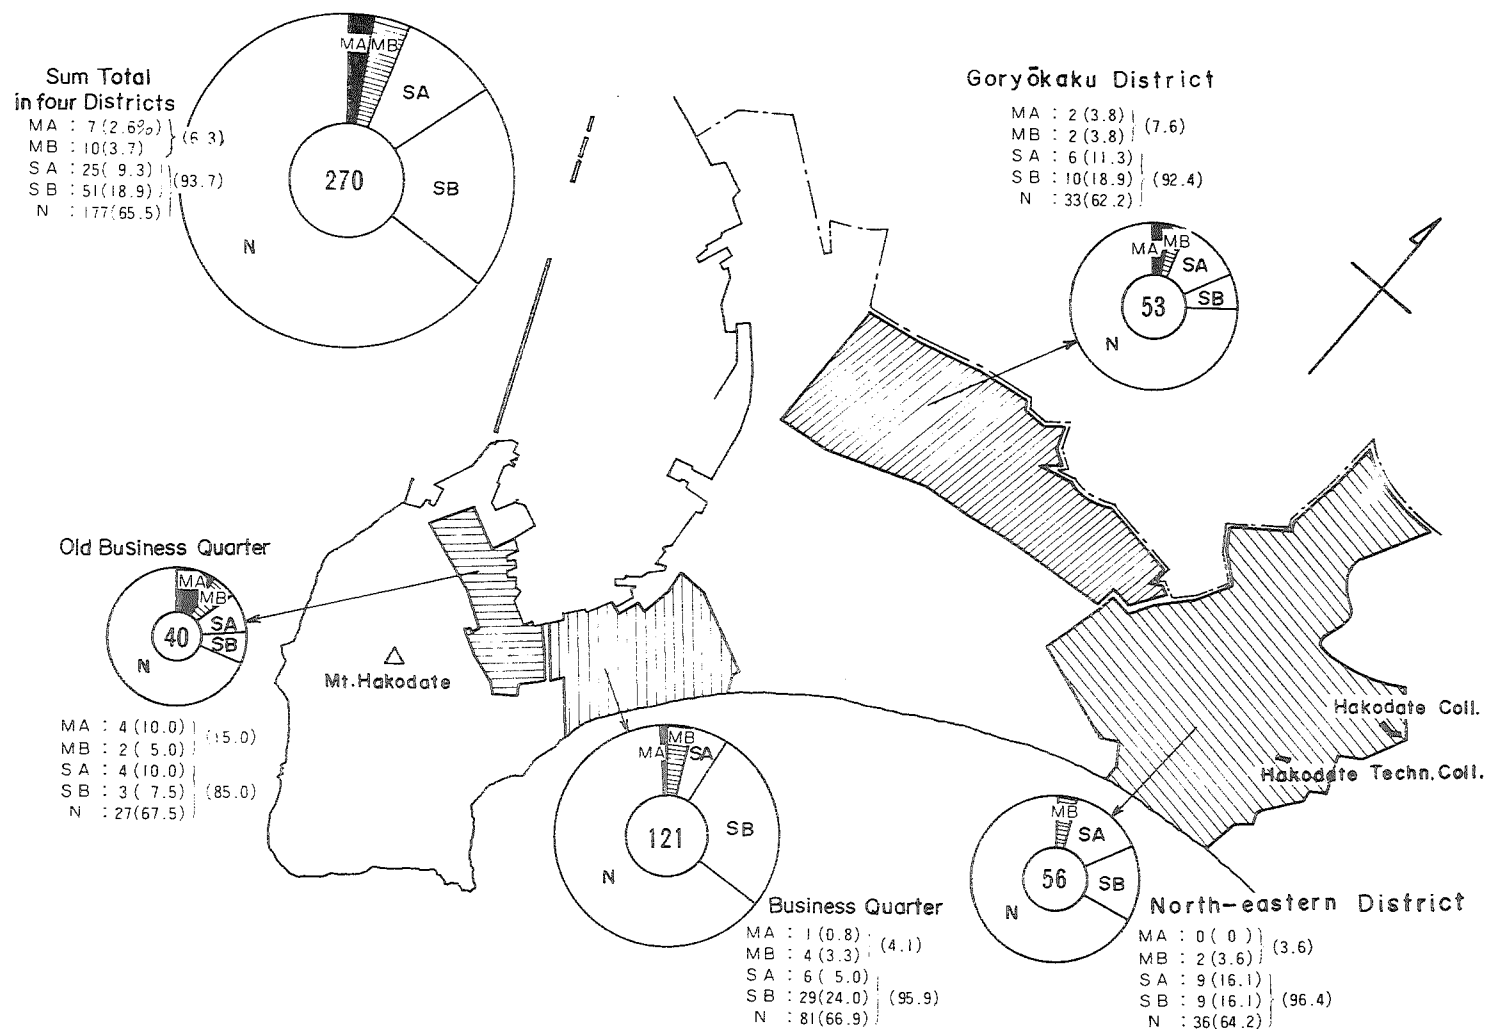
Fig. 1. Damages to reinforced concrete buildings in four specific regions in Hakodate City

Speaking of the damaged buildings in Hakodate City, details of damages in all the reinforced concrete buildings in four specific regions shown in Fig. 1 were investigated. The number of buildings of reinforced concrete in these regions was 270 at the time of the earthquake, but the number of damaged buildings was rather small. Fig. 1. shows the percentages of these damaged buildings, where symbol N means no damage and  $M_A$ ,  $M_B$ ,  $S_A$ ,  $S_B$  mean the following classifications of damages:

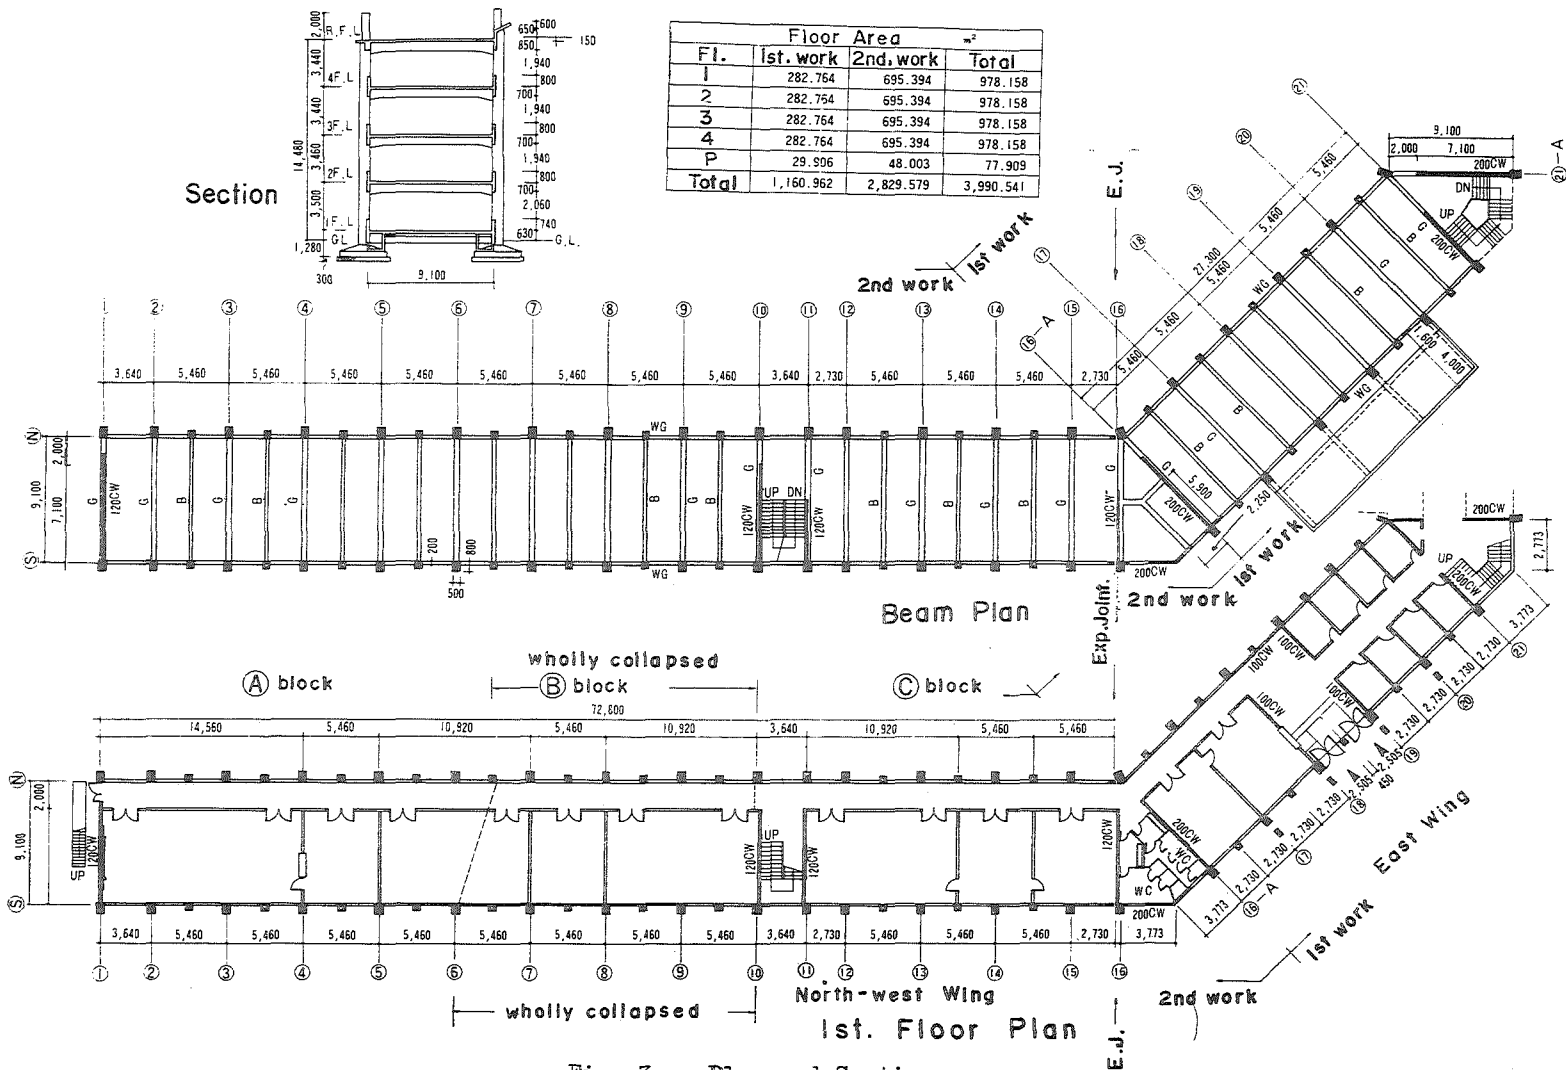
Fig. 3. Plan and Section

This four-storied school-building had a long and narrow plan of an open L-shape as is shown in Fig. 3. The east wing ( $9.1 \text{ m} \times 27.3 \text{ m}$ ) was finished in 1964 and the north-west wing ( $9.1 \text{ m} \times 72.8 \text{ m}$ ) was constructed in 1966. There was an expansion joint near the bent corner of the building which was included in the second work of construction. The structure of this expansion joint was somewhat incomplete, because the floor slab of each story was constructed continuously over the joint, although the external girders and walls were separated from the columns at the joint (see Fig. 3).

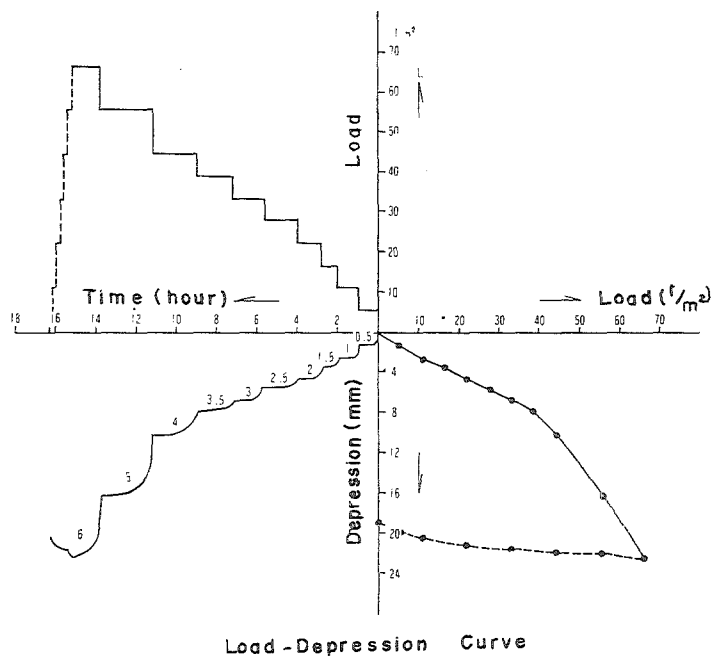
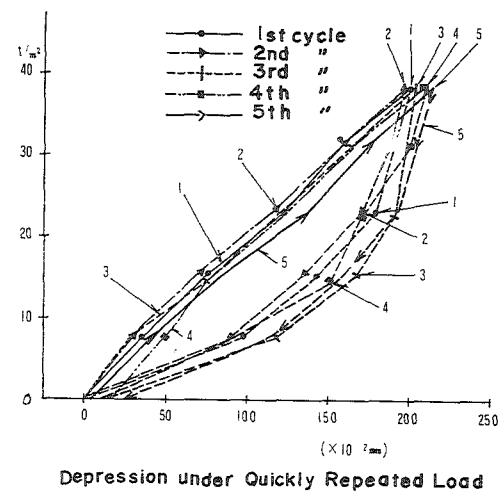
Fig. 17. Load — Depression Curves of Soil

The authors made a load test on the ground near the building to obtain the load-depression curves shown in Fig. 17. As the estimated

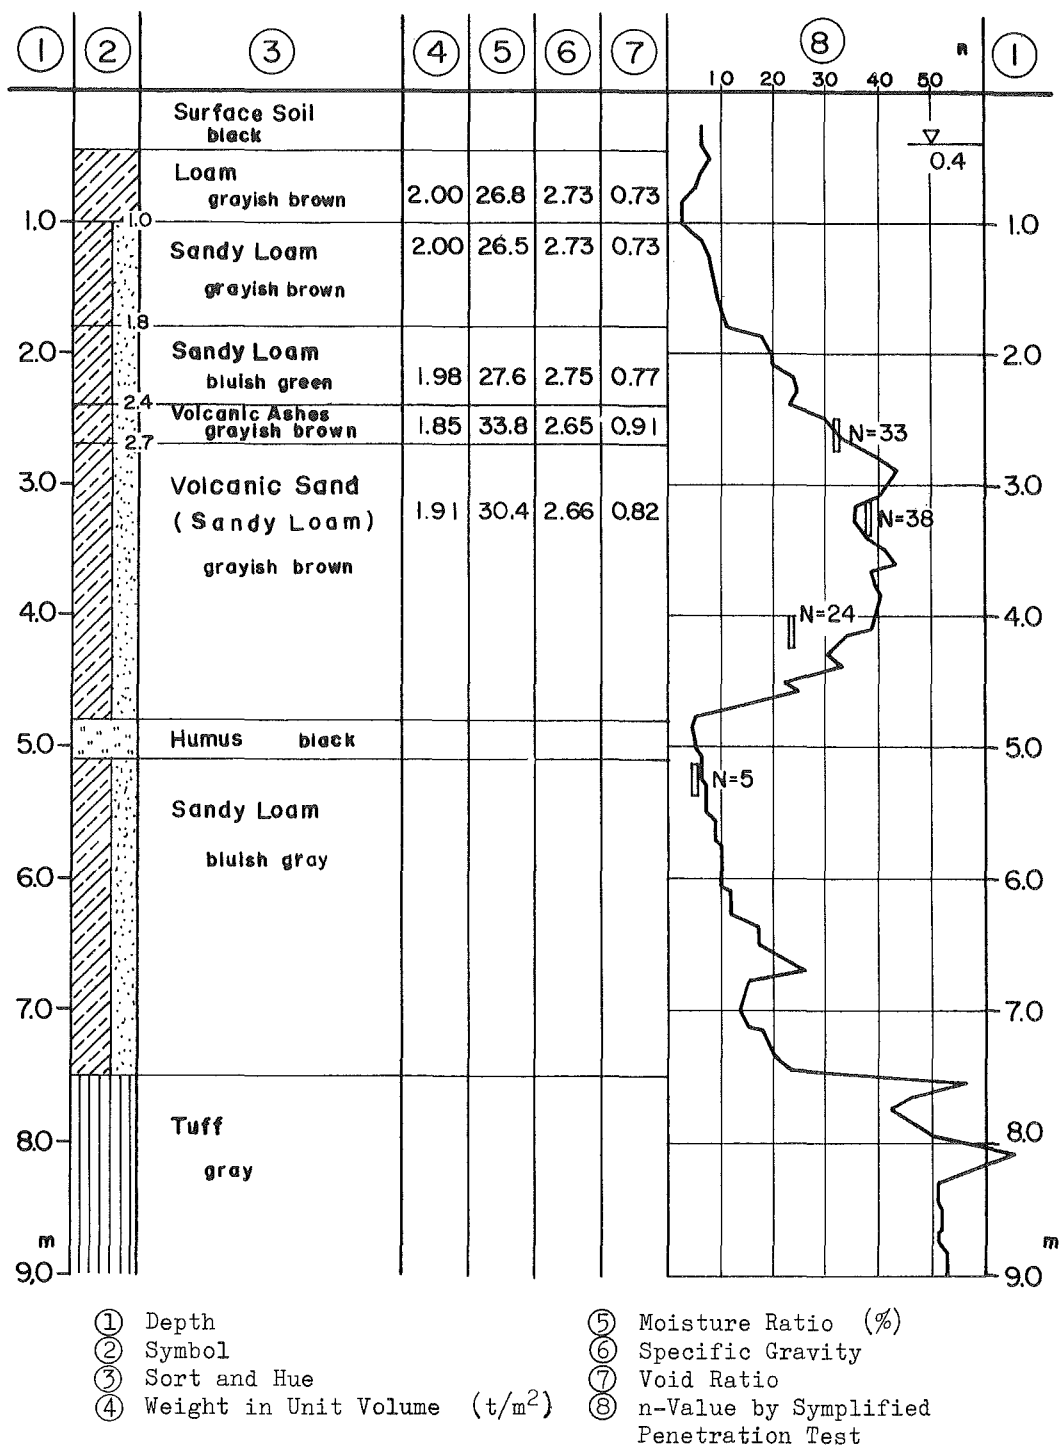
Fig. 18. Soil Profile (by Mr. S. Takamiya)

Mr. S. Takamiya made a number of core-boring tests of the underground near the damaged building as is shown in Fig. 18.

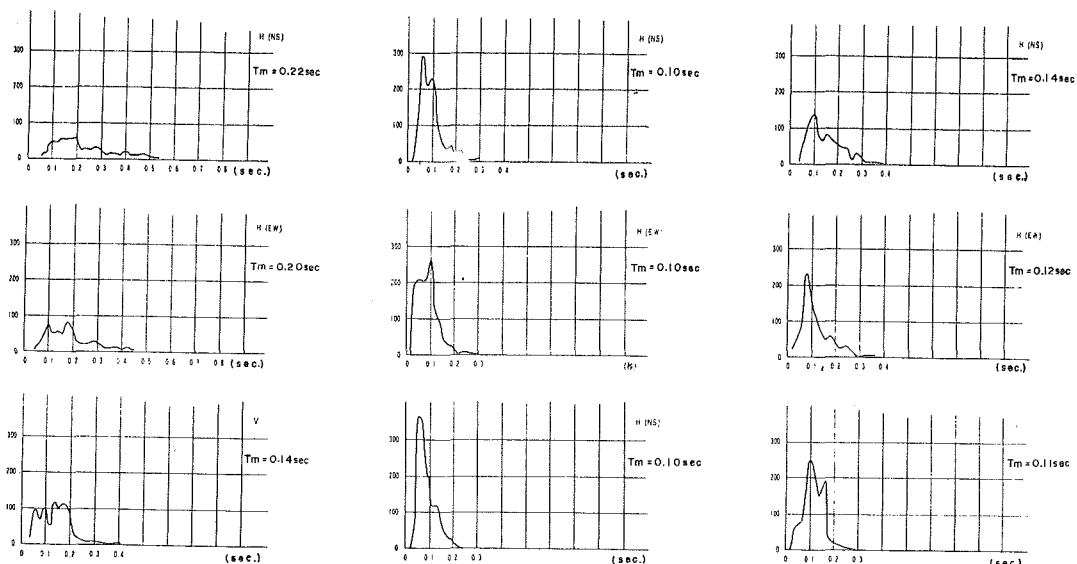
Hakodate college No. 1.  
The destroyed building

Hakodate College No. 2.  
The three-storied building

Hakodate College No. 3.  
Dormitory
