| Title | Mechanical Properties of Abandoned and Closed Roadways in the Kushiro Coal Mine, Japan |
| Author(s) | Yoshiaki, Fujii; Yoji, Ishijima; Yoshihisa, Ichihara et al. |

## Mechanical Properties of Abandoned and Closed Roadways in the Kushiro Coal Mine, Japan

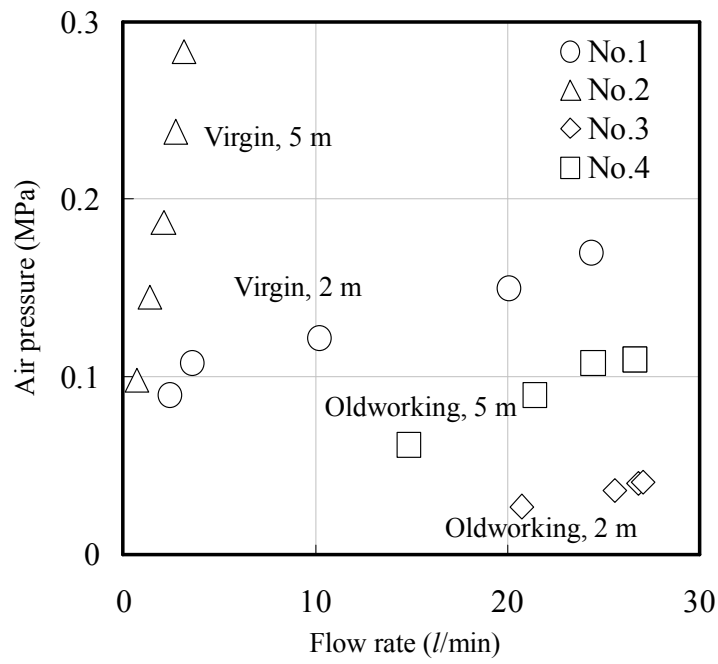
The 2-m hole in the closed old roadway showed the least pressure at the largest flow rate in the air test series (Fig. 16). It was impossible to raise pressure beyond than the critical pressure. The 5-m hole in closed old roadway and the 2-m hole in the virgin rock mass exhibited critical pressures beyond which the slope of the flow rate-pressure curves decreased. The 5-m hole in the virgin rock mass did not reach critical pressure up to 0.28 MPa.

Fig. 16 Injection pressure vs. flow rate obtained by Lugeon test when the compressed air was used as fluid.

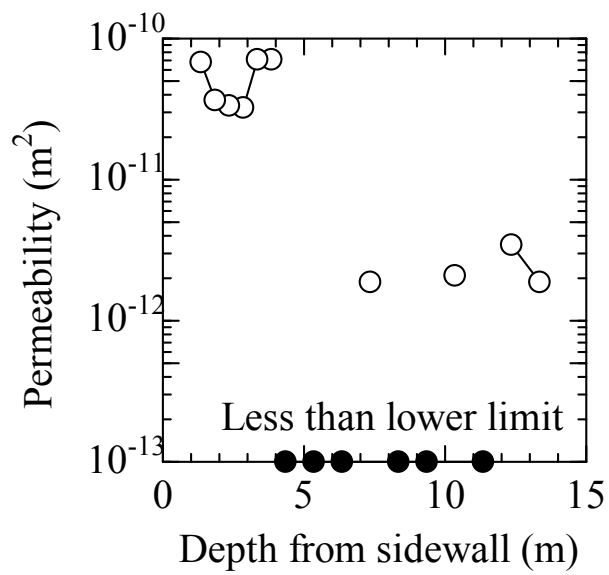
The instruments were almost the same, but a double packer was used to divide the pressurized part at 0.5 m. The test was carried out in a 15-m long and 15-degree upward borehole drilled in the sandstone seam at the tailgate of Jobu Hidari No. 5 SD (Fig. 2) before the abutment pressure appeared. Permeability was on the order of  $10^{-11}$  m<sup>2</sup> less than 4 m deep and on the order of  $10^{-12}$  m<sup>2</sup> or less for depths more than 4 m (Fig. 17). It is estimated that the rock mass within 4 m from the sidewall was an EDZ. It was impossible

Fig. 17 Permeability distribution along a borehole.

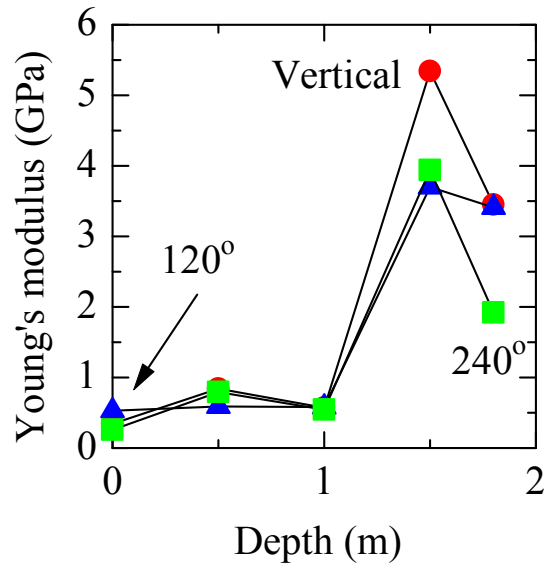
Young's modulus of rock mass was measured with a Goodman jack. Tests were carried out at the tailgate of Jobu Hidari No. 5 SD (Fig. 2). The first test was carried out for a horizontal borehole drilled from the sidewall into the virgin field of siliceous rock. The UCS and the Young's modulus of the intact saturated specimen were 52 MPa and 12 GPa, respectively. Loading was carried out in three directions: vertical and 120 degrees and 240 degrees from vertical. A significant anisotropy was not observed in this plane (Fig. 18). Young's modulus for rock mass within 1 m from the sidewall was much smaller than that for rock mass deeper than 1.5 m. The EDZ boundary was estimated to be between 1 m and 1.5 m from the sidewall.

Fig. 18 Distribution of Young's modulus along the borehole in siliceous rock.
