| Title | NON-DESTRUCTIVE TESTS APPLIED DURING REPAIR WORKS OF THE YODOGAWA BRIDGE |
| Description | The Thirteenth East Asia-Pacific Conference on Structural Engineering and Construction (EASEC-13), September 11-13, 2013, Sapporo, Japan. |

# NON-DESTRUCTIVE TESTS APPLIED DURING REPAIR WORKS OF THE YODOGAWA BRIDGE

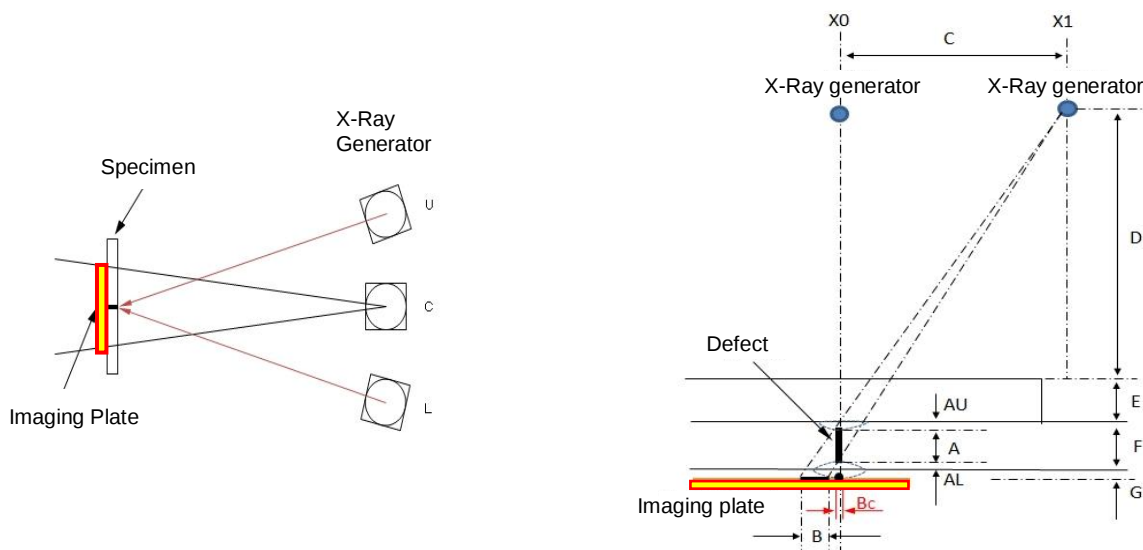
Figure 4: Scheme of the depth evaluation method

Based on Figure 4, the depth of the defect, A, can be calculated according to the following equations, assuming AU and AL to be 3mm.
