Geo-Disaster Report

# Reconnaissance report on geotechnical damage caused by 2018 Hokkaido Eastern Iburi earthquake with JMA seismic intensity 7

Tatsuya Ishikawa<sup>a,\*</sup>, Masayuki Yoshimi<sup>b</sup>, Koichi Isobe<sup>a</sup>, Shoji Yokohama<sup>a</sup>

<sup>a</sup> Faculty of Engineering, Hokkaido University, Japan

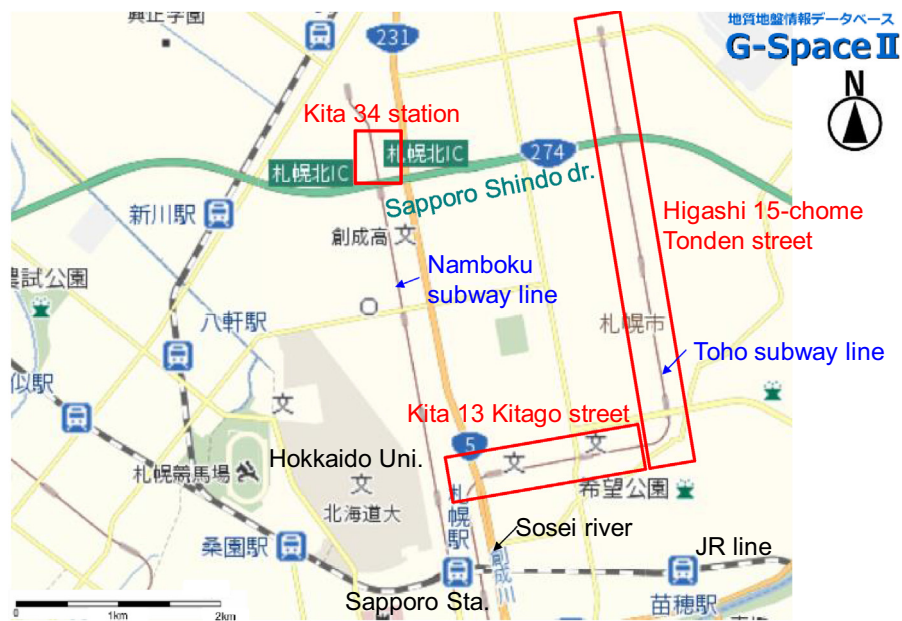
Fig. 13. Survey points on road damage along the subway lines at the Kita ward and Higashi ward in Sapporo City.

Severe liquefaction induced settlement of the road above the subway line was observed in the area around Kita 34 Station of the Namboku line in Kita-ward and the Higashi 15-chome Tonden street in Sapporo City after the earthquake, as shown in Fig. 13. A field investigation was conducted on September 8–9th 2018 corresponding to 2–3 after the earthquake.

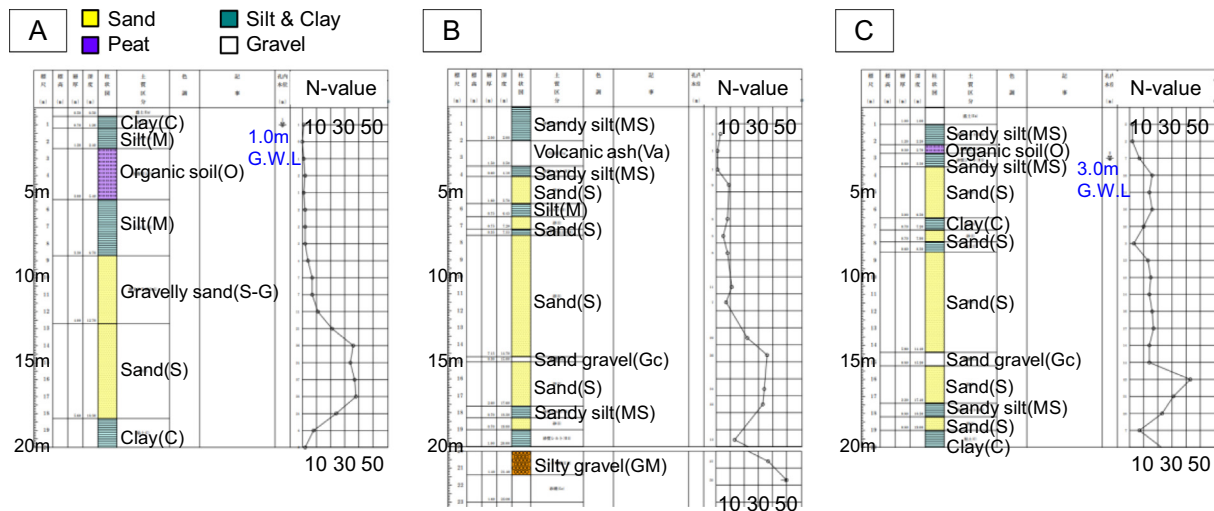
Fig. 16 shows the geological columns around the affected area obtained from the Geological and Geotechnical Information Database G-Space II in Japan. From this figure, it can be seen that the original ground around Kita 34 Station is mainly composed of clay and silt with a very small N value and sand with an N value of 10 or less, partially containing organic soil. Moreover, the groundwater level at the time of the earthquake occurrence is unknown, but in the geological column map, the groundwater level is at a depth of 1.0–3.0 m from the ground surface.

Fig. 16. Geological column diagram of the original ground around Kita 34 Station based on G-Space II.

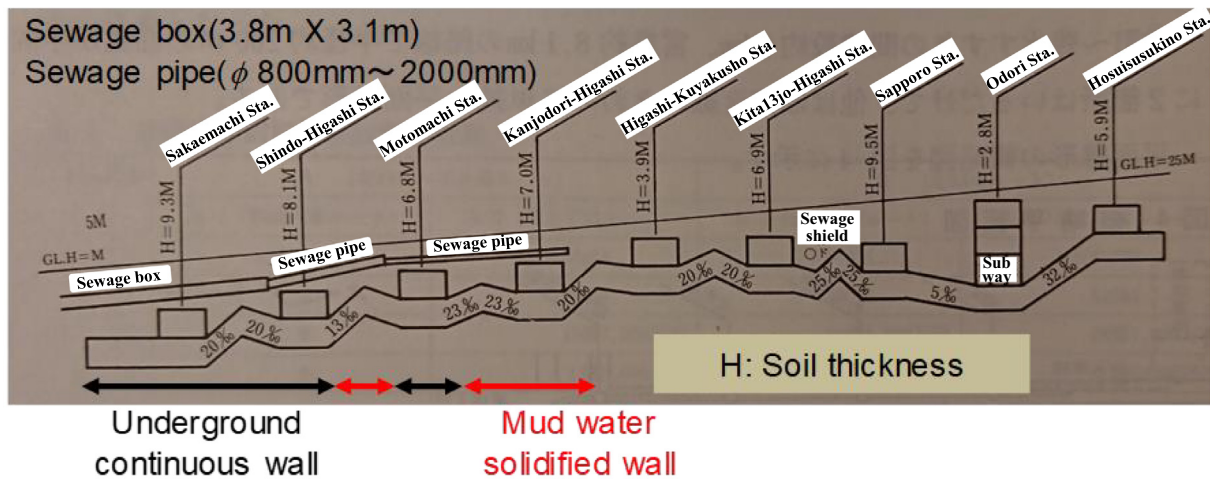
According to the Sapporo City High Speed Toho Subway Line construction history (between Sakaemachi and Hosui-Susukino) published by the Sapporo City Transportation Bureau Planning Department in 1989, in the 1970s to 1980s the Toho subway line was constructed by the open-cut method using underground continuous walls and muddy water solidified walls: these were the latest technique at that time. According to records, clean sand which was purchased for backfill soil was used. It can be inferred that the backfill soil was liquefied, and that the damage due to ground subsidence and road collapse was the result of this liquification. Figs. 19 and 20 show schematic longitudinal and geological profiles along the Toho subway line described in the same document. Here,  $H$  in Fig. 19 is the soil thickness at the center of the subway station, and the values on the subway line are the longitudinal grades. In the damaged area along Higashi 15-chome Tonden Street, peat and corroded soil layer with a layer thickness of 1–3 m exists near the ground surface, the cohesion soil

layer and the sandy soil layer alternate, and the gravel layer which is assumed to be bearing layer deposits below them. Along Kita 13 Kitago street, peat and corroded soil layer with a layer thickness of 1–3 m exists around 7–10 m from the ground surface below the alternative layers of cohesive soil and sandy soil. The gravel layer is deposited below it. In addition, the ground surface slopes gently toward the Sea of Japan, and the soil thickness of backfill soil reaches 9.3 m at Sakaemachi Station with the increase of the soft layer thickness. In addition, a sewage duct of  $3.8\text{ m} \times 3.1\text{ m}$  and a sewage pipe with a diameter of 800–2000 mm are buried along Higashi 15-chome Tonden street in the affected area. There is a construction record that an air mortar was filled between the subway structure and the retaining wall (25 cm) at the intersection with the main drive where only minor damage were observed. Based on the above, it is possible that the compaction of the backfill soil in the vicinity of the buried structure and between the subway structure and the retaining wall was insufficient.

Fig. 19. A schematic longitudinal profiles along the Toho subway line drawn in the reference (Sapporo City Transportation Bureau Planning Department, 1989).

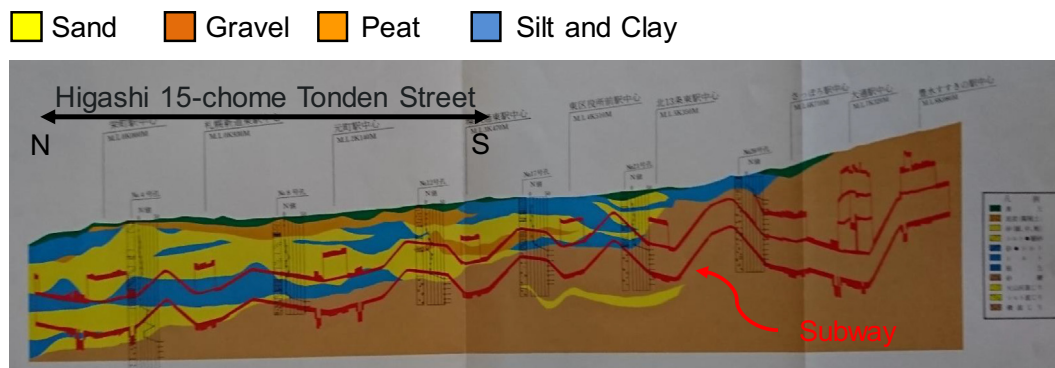
Fig. 20. A schematic longitudinal and geological profiles along the Toho subway line drawn in the reference (Sapporo City Transportation Bureau Planning Department, 1989).

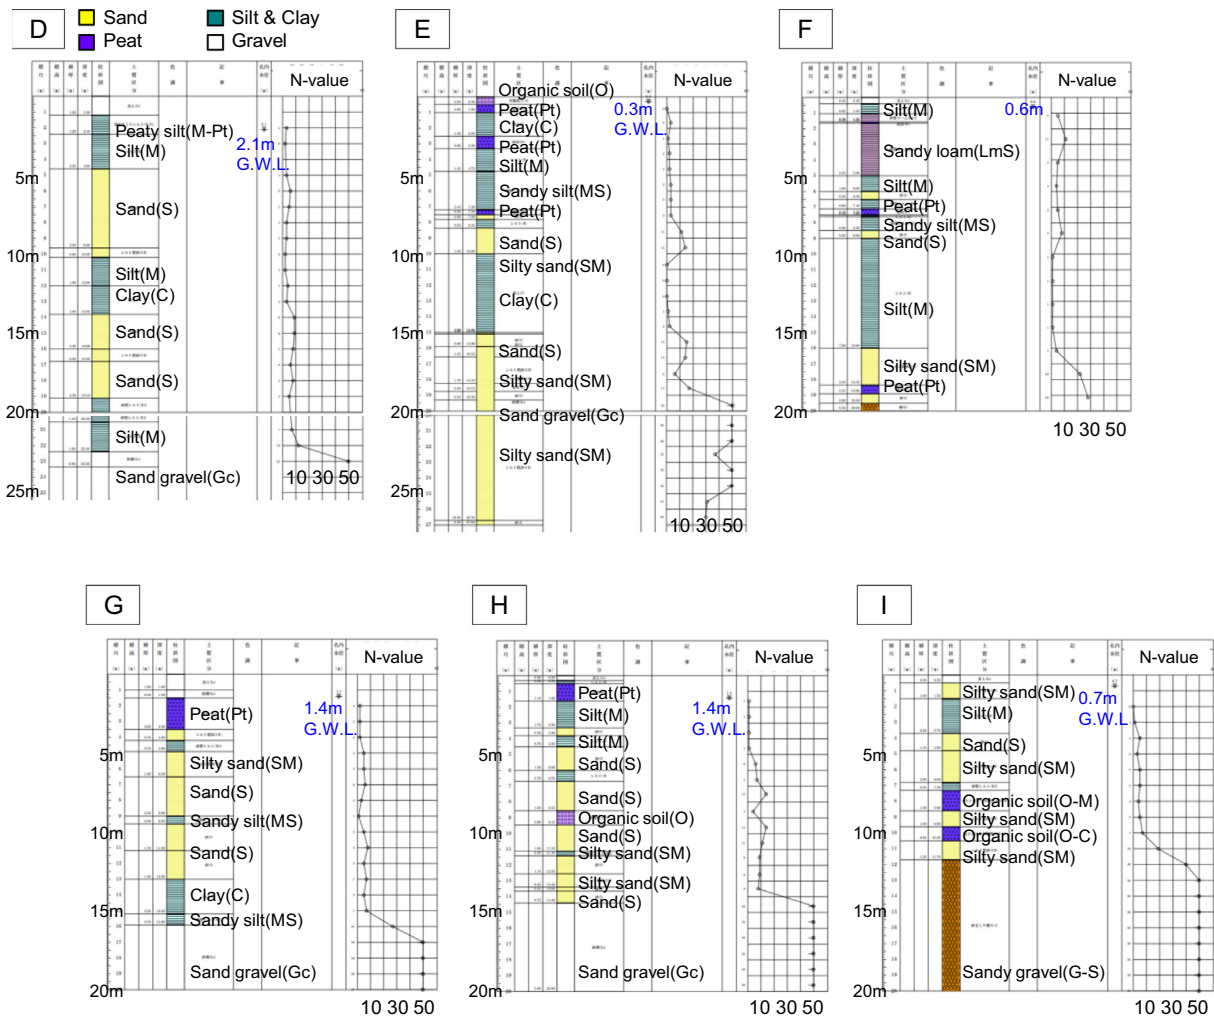
Fig. 21. Geological column diagram of the original ground along Higashi 15-chome Tonden street based on G-Space II.

showing the location in Fig. 17. It was found that the original ground around this area partially contained organic soil, clay and silt with very a low N value and sand with an N value of 10 or less are deposited to a depth of 15–20 m as the same as the schematic longitudinal and geological profile. From Kita 34 (Shindo Higashi Station) to Kita 22, thick layers of peat and organic soil are deposited up to about 3 m near the ground surface. The original ground around Kita 16 to Kita 13 and along Kita 13 Kitago Street also partially contained organic soil, clay and silt with a very low N value and sand with an N value of 10 or less are deposited to a depth of 10 m. This is less than that at the northern part. In addition, the peat and organic soil layers are deposited about 2 m around 7–10 m from the ground surface, indicating that the deposition is shallower than in the northern area. Moreover, the groundwater level at the time of the earthquake occurrence is unknown, but in the geological column map, the average groundwater level is approximately 2.0 m from the ground surface. It tends to decrease toward the Sosei River, which flows north and south on the west side of this area.

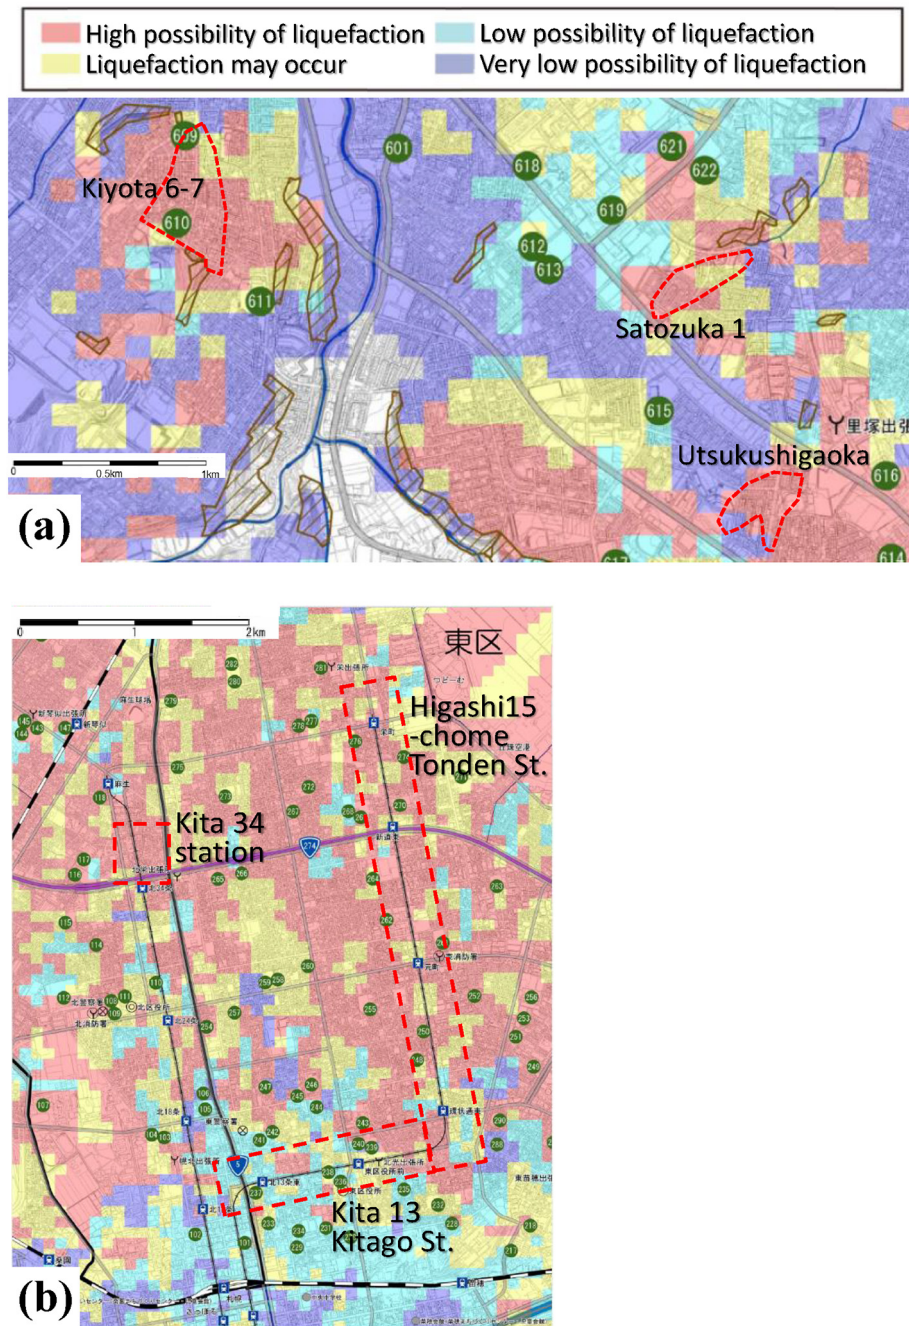
Many local governments in Japan have created and published a liquefaction hazard map for the area around their residence. Fig. 22 compares the liquefaction-damaged areas by the 2018 Hokkaido Eastern Iburi earthquake with the liquefaction hazard map made by Sapporo City (Sapporo, 2018). In this figure, the observed damaged areas are mainly classified into the area with the “Highest possibility of liquefaction” and four risk levels are included in the liquefaction hazard map of Sapporo City. This confirms the usefulness of this liquefaction hazard map.

However, although the risk of liquefaction is well captured, the risk of damage cannot be inferred from this map. In fact, as a result of this earthquake, depending on the thickness and distribution (inclination) of the liquefaction layer, the groundwater level, the depth at which liquefaction occurred from the ground surface, and the characteristics of the liquefied soil, the liquefaction damage was remarkably different, even between Kiyota ward (Fig. 12c) and Kita ward/Higashi ward (Figs. 15 and 19), or within Kiyota Ward (JGS, 2019). Therefore, it is necessary to realize that the damage caused by liquefaction is likely to be different even when the risk of liquefaction is at the same level in the liquefaction hazard map. After conducting a detailed ground survey in consideration of topographical and ground information (e.g. the boundary between cut slope and embankment), disaster prevention/mitigation measures should be taken assuming the damage mechanism according to the ground conditions.

Fig. 22. Liquefaction hazard map for Sapporo City (Sapporo, 2018) with liquefaction-damaged areas by the 2018 Hokkaido Eastern Iburi earthquake: (a) Kiyota ward, (b) Kita ward and Higashi ward.

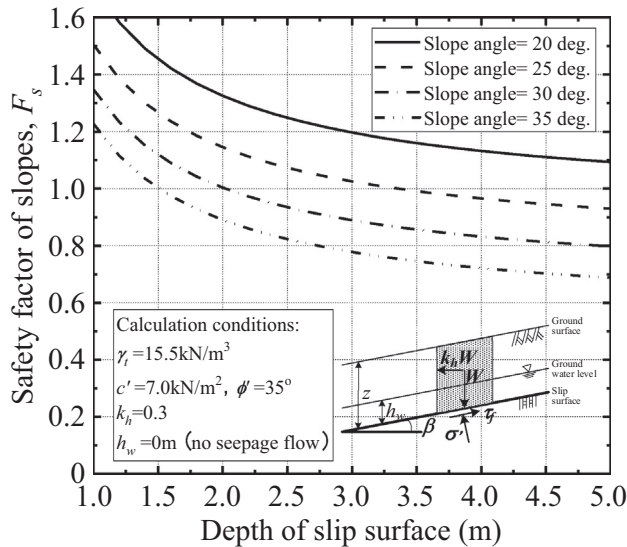
ness is thinner at the area where little slope failure was seen. From these facts, it is obvious that many slope failures occurred in the distribution area with thick pyroclastic deposits. When conducting the slope stability analysis under the assumed calculation conditions shown in Fig. 26 by referring to Amemiya (2019), the depth of the slip surface of the collapsed slope with a 25–35 deg range in the slope angle, which were frequently observed in Atsuma town, is between 1.5 m and 3.5 m. According to an estimation by the Ministry of Land, Infrastructure, Transport and Tourism (MLIT, 2018), the scale of slope collapses due to the 2018 Hokkaido Eastern Iburi earthquake was as follows: (a) the amount of collapsed sediment: 30.0 million  $\text{m}^3$ ; (b) the collapsed area 13.4  $\text{km}^2$ . The average collapse depth estimated from the amount of collapsed sediment and the collapse area is about 2.2 m. In addition, according to the results of field investigation, though the slip surface position varied depending on the location, in most cases the collapse depth was approximately 2–3 m in places where Ta-d and En-a are deposited. From these results, it is recognized that the depths of all the slip surfaces was similar, indicating that the slope failures seen around Atsuma town were strongly influenced by the geological structures. Therefore, it is necessary to discuss and to propose prevention and mitigation measures

Fig. 26. Results of slope stability analysis: depth of slip surface for the collapsed slopes under various slope angles.

for earthquake-induced slope failures by considering both the amplification-attenuation characteristics of the local site and the geological structures.
