Localized Corrosion in Copper Tubes and Its Inhibition by Surface Pretreatment with 2-Undecylimidazole

Takenori NOTOYA
(Received August 30, 1991)

ABSTRACT

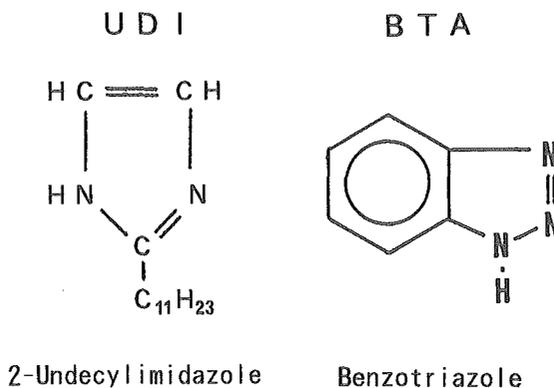
Figure 1 Chemical structure of inhibitors

As-received copper tubes were immersed in 0.1 M benzotriazole (BTA) solution at 60 °C for 3 min, and then rinsed in distilled water, and finally dried in air. During the treatment of the copper tubes with BTA solution, a polymeric structure of Cu^(II)-benzotriazolate (CuBTA) film is formed on top of Cu₂O interlayers on the copper surface.⁽³⁾⁽⁹⁾ This multilayer film (less than 60 Å), which is composed of Cu/Cu₂O/CuBTA, usually gives considerable protection even in a wet atmosphere.⁽¹⁰⁾ The chemical structure of 2-undecylimidazole and benzotriazole is shown in Figure 1.

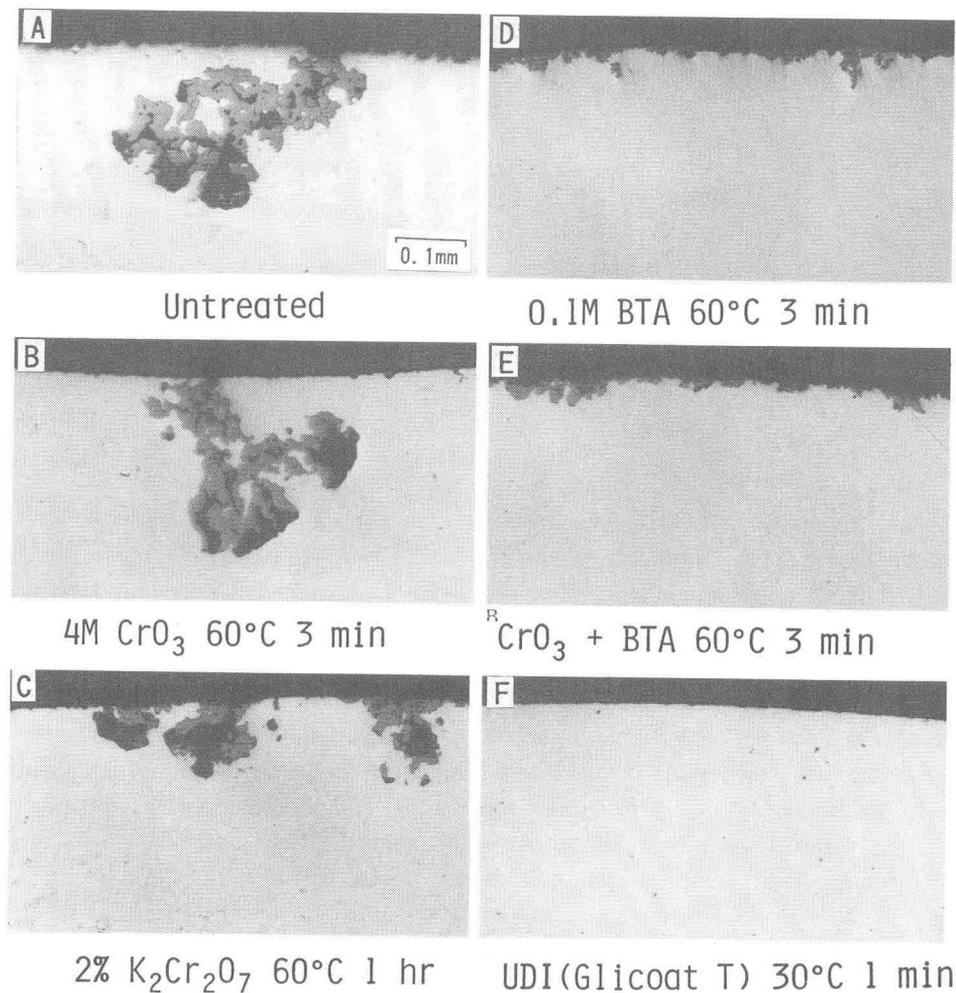
Cross-section of phosphorus deoxidized copper tubes after 40 days exposure to a humid air over 0.1 vol % formic acid.

Figure 2 shows cross sections of the top ends of treated and untreated PD copper tubes. Irregular-shaped pits were observed in untreated tubes, chromic acid-treated and potassium dichromate-treated copper tubes, e. g. pictures A, B and C, respectively. These pits are nearly all plugged with cuprous oxide (the grey parts) and there are microvoids in the copper oxide (the darker parts). Numerous shallow pits were observed in both BTA-treated (D) and chromic acid plus BTA treated (E) copper tubes. No pits were detected and the surface remained smooth for the Glicoat T-treated cop-

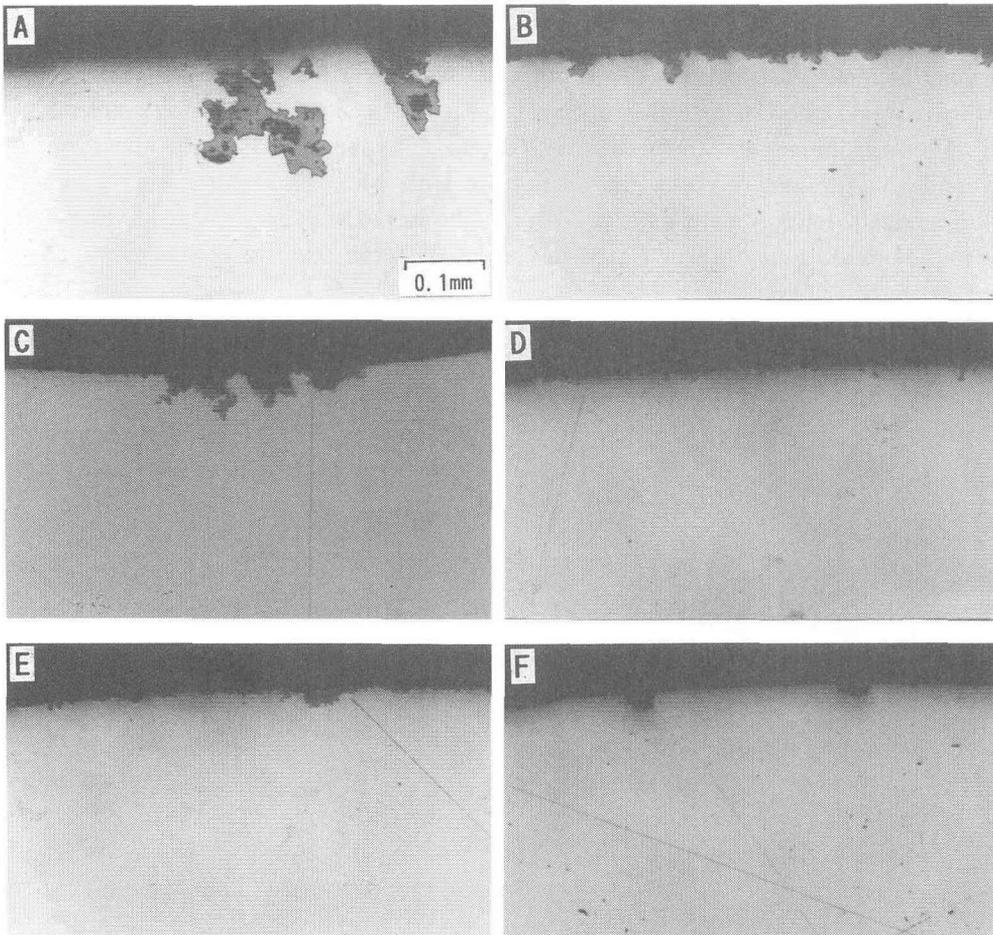
Cross-section of oxygen-free high-purity copper tubes of as-received(A, C, E) and treated with Glicoat T(B, D, F). These tubes had been exposed to humid air over 1 vol. % (A, B) formic acid, (C, D) acetic acid and (E, F) propionic acid for 20 days.

Figure 3 shows a cross-section of the top ends of untreated and Glicoat T-treated OF copper tubes. These copper tubes were exposed to humid air over 1 vol % formic acid HCOOH (pictures A and B), acetic acid CH_3COOH (pictures C and D) and propionic acid $\text{C}_2\text{H}_5\text{COOH}$ (pictures E and F) for a period of 20 days for comparison. The corrosion rate increased in the order $\text{C}_2\text{H}_5\text{COOH} < \text{CH}_3\text{COOH} < \text{HCOOH}$. This order agrees with the dissociation constant of the acids which reflects acid strength: $-\log k$ is 3.77 for HCOOH , 4.76 for CH_3COOH and 4.87 for $\text{C}_2\text{H}_5\text{COOH}$. Because of the relative acid strengths, HCOOH causes a more rapid corrosion than the other two. With HCOOH the corrosion shows an irregular cross section, which is similar to that in the PD copper. Again, all Glicoat T-treated copper tubes show less corrosion than untreated ones. A slight penetration was seen in the Glicoat T-treated copper tube (B) in Figure 3, as compared with (F) in Figure 2, where there is no penetration. This may be due to the higher concentration of HCOOH in Figure 3.

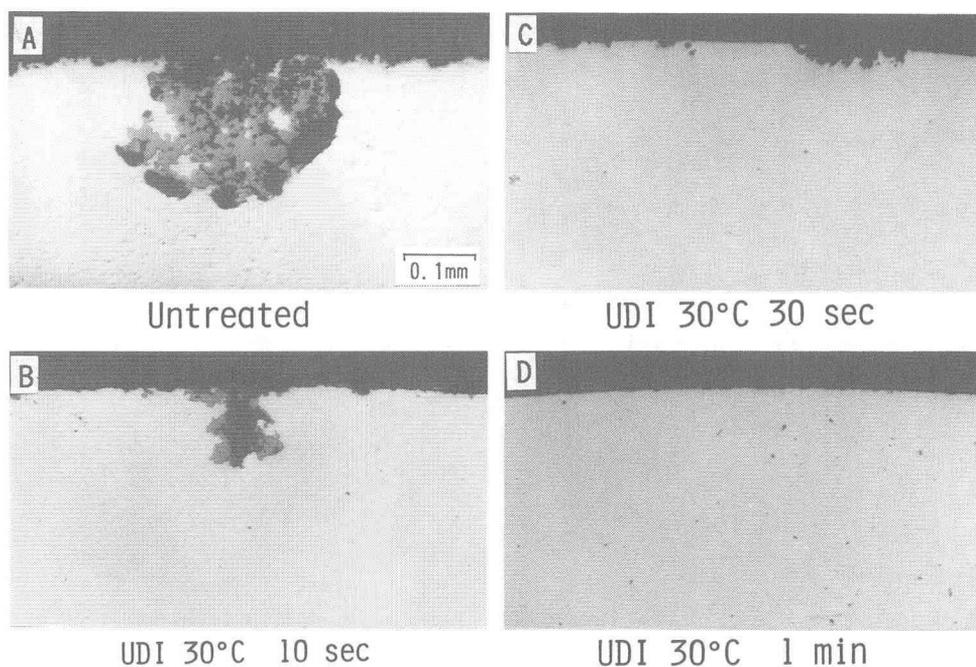
Cross-section of phosphorus deoxidized copper tubes after 40 days exposure to a humid air over 0.1 vol % formic acid.

Figure 4 shows a cross-section of untreated and Glicoat T-treated PD copper tubes with different immersion times in the Glicoat T solution. The thickness of undecylimidazole film on the copper surface varies with immersion time and it is about 0.17, 0.40 and 0.60 micron meters for 10, 30 and 60 sec, respectively. After 40 days exposure to a humid atmosphere of 0.1 vol % formic acid, the severity of the corrosion de-

creased relative to the increase in thickness of the Cu-undecylimidazole film. No pittings was observed in the copper tube which was treated with Glicoat T for 60 sec.
