# Localized Corrosion in Copper Tubes and Its Inhibition by Surface Pretreatment with 2-Undecylimidazole

Takenori NOTOYA  
(Received August 30, 1991)

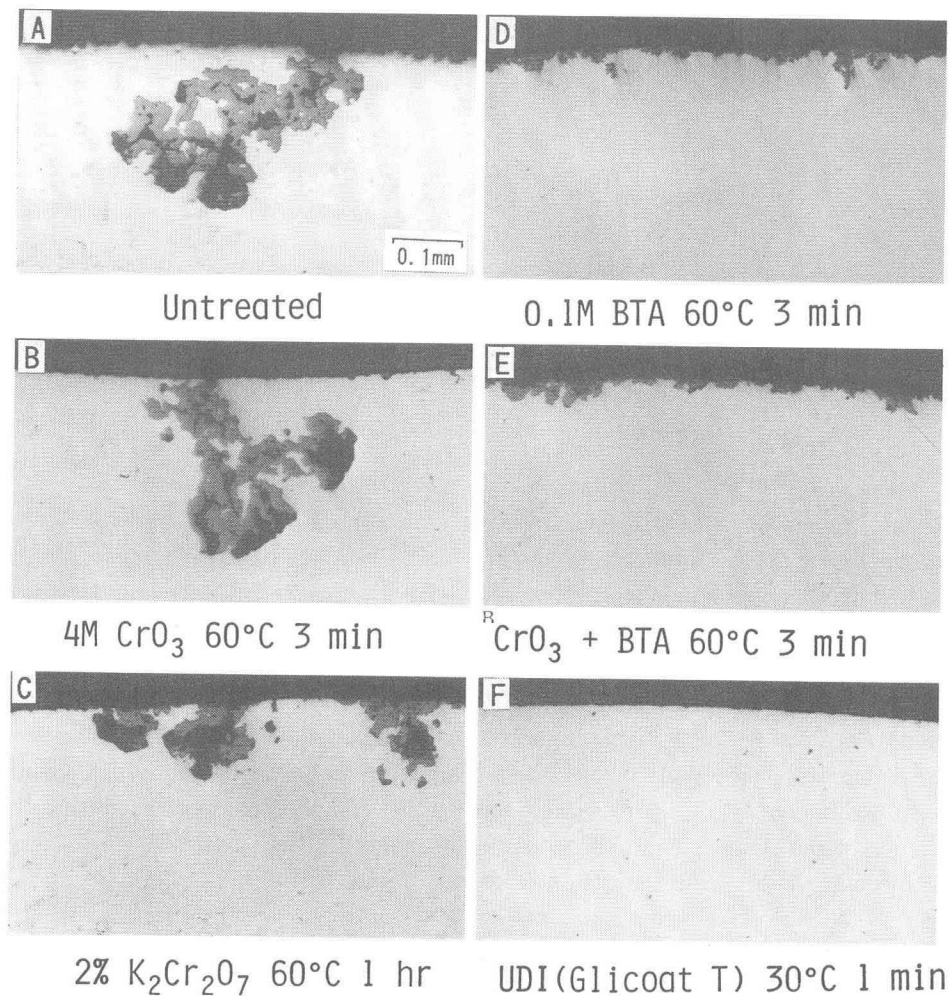
Cross-section of phosphorus deoxidized copper tubes after 40 days exposure to a humid air over 0.1 vol % formic acid.

Figure 2 shows cross sections of the top ends of treated and untreated PD copper tubes. Irregular-shaped pits were observed in untreated tubes, chromic acid-treated and potassium dichromate-treated copper tubes, e. g. pictures A, B and C, respectively. These pits are nearly all plugged with cuprous oxide (the grey parts) and there are microvoids in the copper oxide (the darker parts). Numerous shallow pits were observed in both BTA-treated (D) and chromic acid plus BTA treated (E) copper tubes. No pits were detected and the surface remained smooth for the Glicoat T-treated cop-

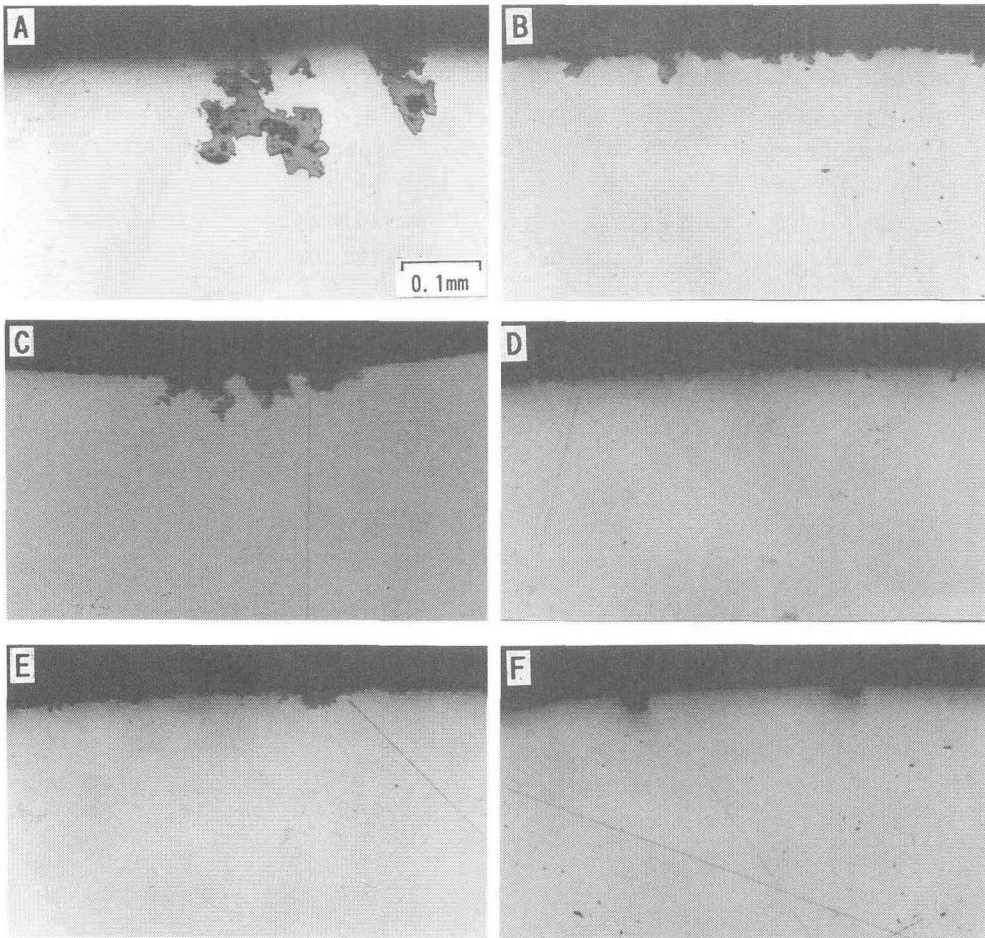
Cross-section of oxygen-free high-purity copper tubes of as-received(A, C, E) and treated with Glicoat T(B, D, F). These tubes had been exposed to humid air over 1 vol. % (A, B) formic acid, (C, D) acetic acid and (E, F) propionic acid for 20 days.

Figure 3 shows a cross-section of the top ends of untreated and Glicoat T-treated OF copper tubes. These copper tubes were exposed to humid air over 1 vol % formic acid  $\text{HCOOH}$  (pictures A and B), acetic acid  $\text{CH}_3\text{COOH}$  (pictures C and D) and propionic acid  $\text{C}_2\text{H}_5\text{COOH}$  (pictures E and F) for a period of 20 days for comparison. The corrosion rate increased in the order  $\text{C}_2\text{H}_5\text{COOH} < \text{CH}_3\text{COOH} < \text{HCOOH}$ . This order agrees with the dissociation constant of the acids which reflects acid strength:  $-\log k$  is 3.77 for  $\text{HCOOH}$ , 4.76 for  $\text{CH}_3\text{COOH}$  and 4.87 for  $\text{C}_2\text{H}_5\text{COOH}$ . Because of the relative acid strengths,  $\text{HCOOH}$  causes a more rapid corrosion than the other two. With  $\text{HCOOH}$  the corrosion shows an irregular cross section, which is similar to that in the PD copper. Again, all Glicoat T-treated copper tubes show less corrosion than untreated ones. A slight penetration was seen in the Glicoat T-treated copper tube (B) in Figure 3, as compared with (F) in Figure 2, where there is no penetration. This may be due to the higher concentration of  $\text{HCOOH}$  in Figure 3.

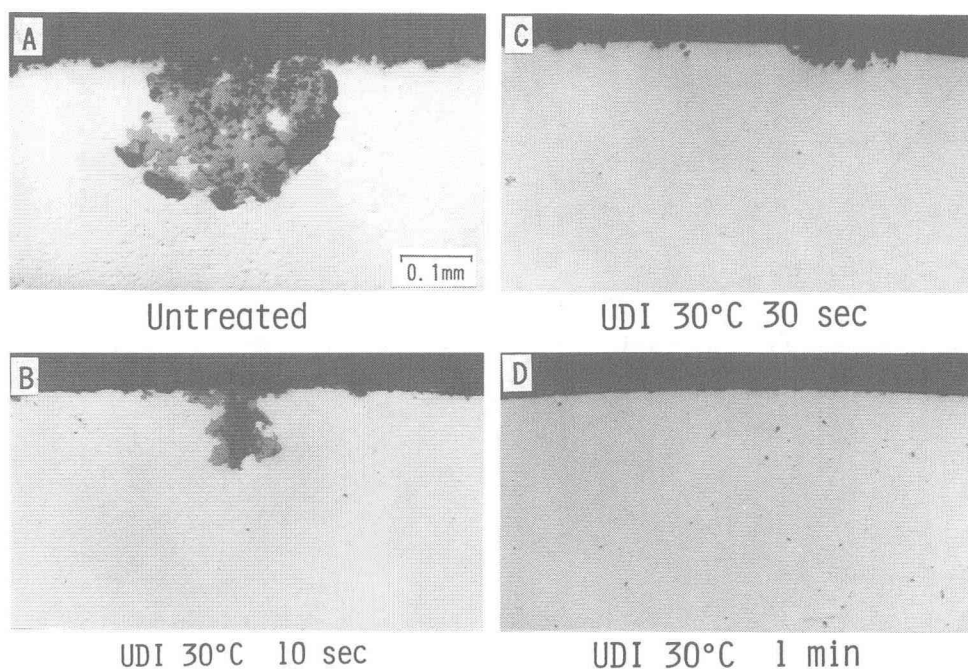
Cross-section of phosphorus deoxidized copper tubes after 40 days exposure to a humid air over 0.1 vol % formic acid.

Figure 4 shows a cross-section of untreated and Glicoat T-treated PD copper tubes with different immersion times in the Glicoat T solution. The thickness of undecylimidazole film on the copper surface varies with immersion time and it is about 0.17, 0.40 and 0.60 micron meters for 10, 30 and 60 sec, respectively. After 40 days exposure to a humid atmosphere of 0.1 vol % formic acid, the severity of the corrosion de-

creased relative to the increase in thickness of the Cu-undecylimidazole film. No pittings was observed in the copper tube which was treated with Glicoat T for 60 sec.
