# THE GPS CAMERA APPLICATION FOR THE EFFICIENCY IMPROVEMENT OF THE BRIDGE INSPECTION

T. KAMADA\*, F. KATSUKI, and M. NAKAGAWA

In this paper, we focus on the periodical data acquisition using GPS camera and stereo camera for bridge maintenance. Firstly, we took up some elements to take same photos. Additionally, we took photos under those elements and evaluated those photos. From experimental results, we have confirmed that we can take photos from same positions using GPS camera at the previous inspections. Secondary, we had already been able to acquire 3D data corresponding to close visual inspection. Therefore, we verified whether can accurately extract the cracks in 3D measurement at far position. As a results, we have defined condition constrains in a stereo measurement to acquire an accurate 3D data in periodical data acquisition. Finally, we have mentioned that our proposed methodology can evaluate a progress of bridge structure deterioration using photos.

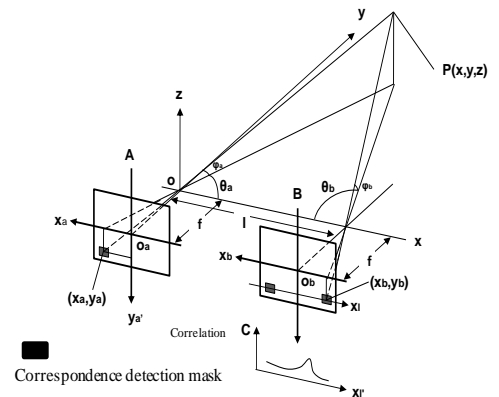
Figure 2: Stereo camera model.

Stereo measurement can obtain 3D position using corresponded points in stereo images, as shown in Figure 2.

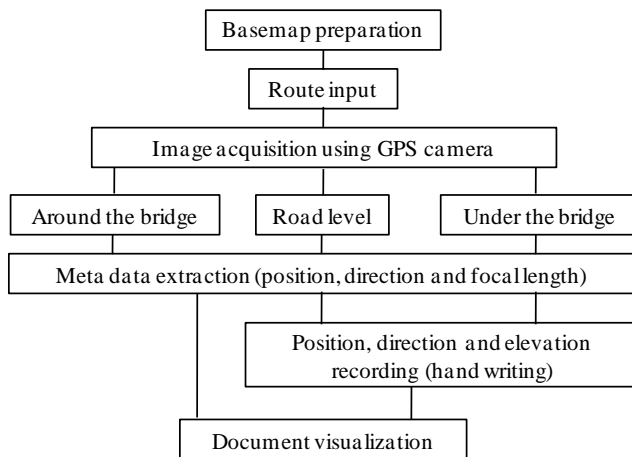
Figure 3: Image acquisition procedure.

In our experiments, we used GPS camera (Casio Exilim EX-H20G), as shown in Table 1. Our experiments consisted of image acquisition and image reference to simulate a daily infrastructure inspection using GPS camera. Firstly, photos are taken to prepare reference data in the image acquisition procedure, as shown in Figure 3. Secondly, navigation using taken photos is examined in the image reference procedure, as shown in Figure 4. Images were acquired at 30 points in three areas (a road level, river level under the bridge and river level around the bridge) around a road bridge across a river. Finally, we evaluated the navigation examination, as shown in Table 2. In the case of Figure 5, the original photo is Figure 6, the photo includes the object (crack) about 80%. Additionally, the photo includes something other than the object about 50%. Therefore, “A relevance ratio” is 2 points and “Something other than the object” is 2 points. As for other items, we scored in a similar way.

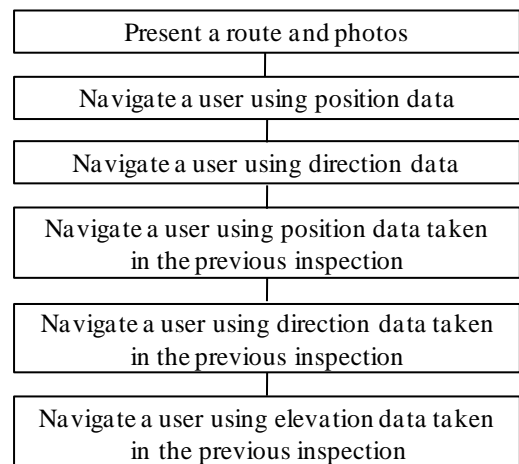
Figure 4: Image reference procedure.

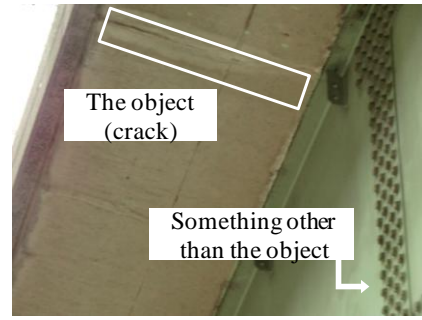
**Figure 6: Original image.**
