| Title | EXPOSURE TEST RESULTS FOR UNDERGROUND STRUCTURES DAMAGED BY ASR |
| Description | The Thirteenth East Asia-Pacific Conference on Structural Engineering and Construction (EASEC-13), September 11-13, 2013, Sapporo, Japan. |

# EXPOSURE TEST RESULTS FOR UNDERGROUND STRUCTURES DAMAGED BY ASR

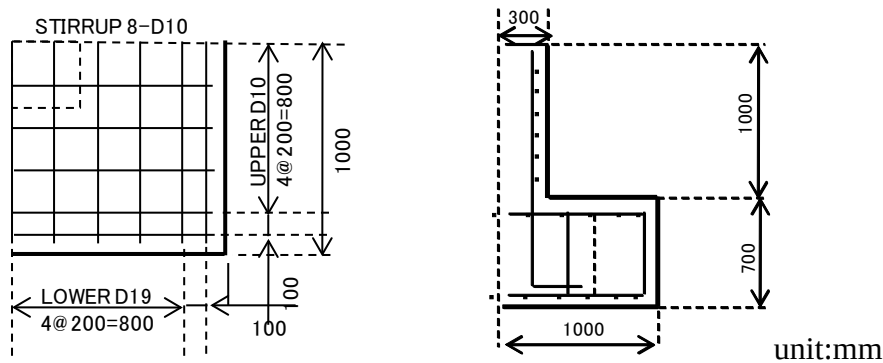
Fig-1 shows the details of the model. It is expected that structures damaged by ASR are those constructed before 1980. Hence, the models were designed with reference to the footings used at the time. The reinforcement used in the models was SD 295A, the ratio for the tensile reinforcement was 0.20%, and that for the compressive reinforcement was 0.05%.

Fig. 1 Drawing showing dimensions and bar arrangement of footing models (For Cases 1 and 2. Left: plane section for footing, Right: vertical section)

Three test models were used. They consisted of a pier and footing. The sizes of the footings were the same, the width and length being 2.0m and the height 0.7m. The width and length of the pier were 0.6m. The height of the pier was 1.0m in Cases 1 and 2, and 2.6m in Case 3. The cement used was ordinary Portland cement. The design strength of the concrete was  $21\text{N/mm}^2$ . The ratio of alkali reactive aggregate to non-reactive aggregate was 50:50 for the coarse aggregate, and 40:60 for the fine aggregate.

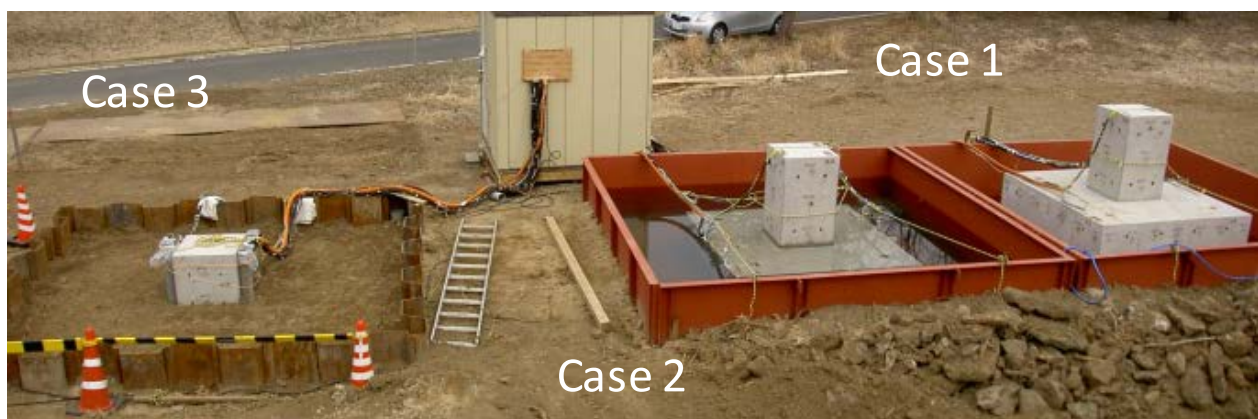
Table-1 shows the exposure test cases, and Figure-2 shows a photograph of the exposure test conditions. The test models for Cases 1 and 2 were exposed in water, and that for Case 3 was exposed underground. The groundwater level in Case 3 was around the footing, and the water level

in Case 1 was changed based on the groundwater level in Case 3. The water level in Case 2 did not change. The cracks and strain in the concrete surface and reinforcement were measured.

Fig. 2 Photograph showing exposure test conditions

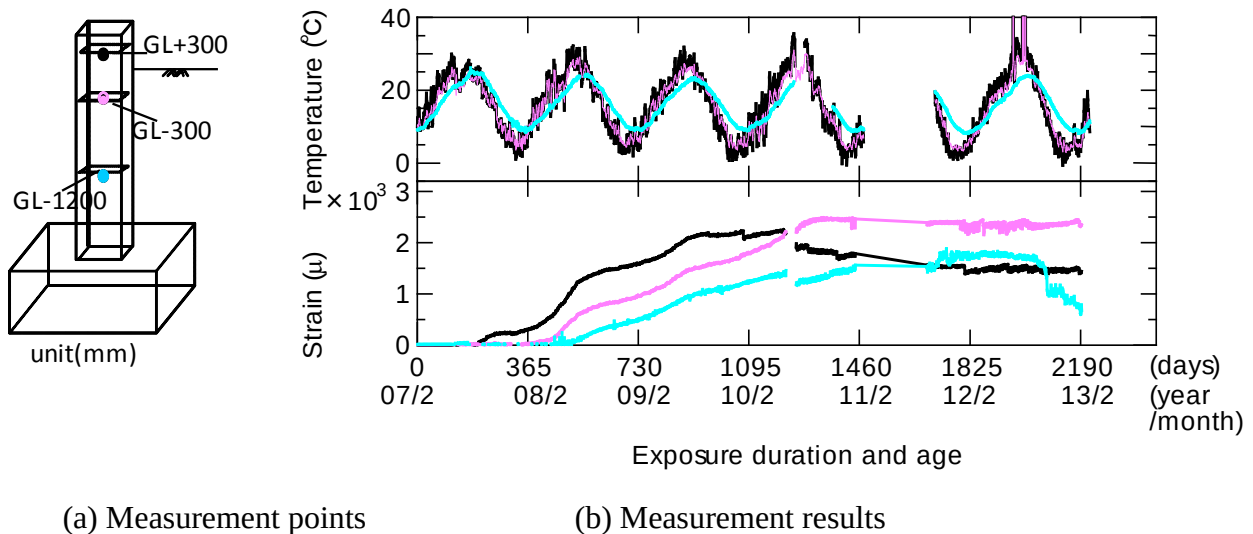
Figure-3 shows the variation of the groundwater level over time, and the temperature and strain in the reinforcement of the column in Case 3. Strain and temperature were measured at the same point. The groundwater level was below the bottom of the footing. The amount of reinforcement of the column does not vary with depth. Therefore, environmental conditions constitute the only reason for differences in the strain at each point.

Fig. 3 Time variation of steel strain and temperature in column

The variation of temperature over time shows that the closer the point of measurement to the ground surface, the higher was the maximum temperature, and the lower was the minimum temperature.

The trend toward increasing strain differs depending on depth. The strain measured at GL. + 300, which is the point at which the highest temperature was measured, had reached 2000 $\mu$  after around 760 days.

Conversely, the deeper the point at which the strain was measured, the later the onset of strain increase. For example, the strain measured at GL. -300 increased 1 year and 3 months after the exposure test began, and that at GL. -1200 increased at 1 year and 6 months. In addition, the deeper the point of measurement, the smaller was the increase in speed. Furthermore, the strain at GL. +300 did not increase in winter, during which the temperature became lower than 10 degrees. Conversely, at GL. -1200, the increase in speed was similar regardless of season. At this point, the temperature was close to exceeding 10 degrees. From these results, it can be seen that the trend toward increasing strain is dependent on temperature.

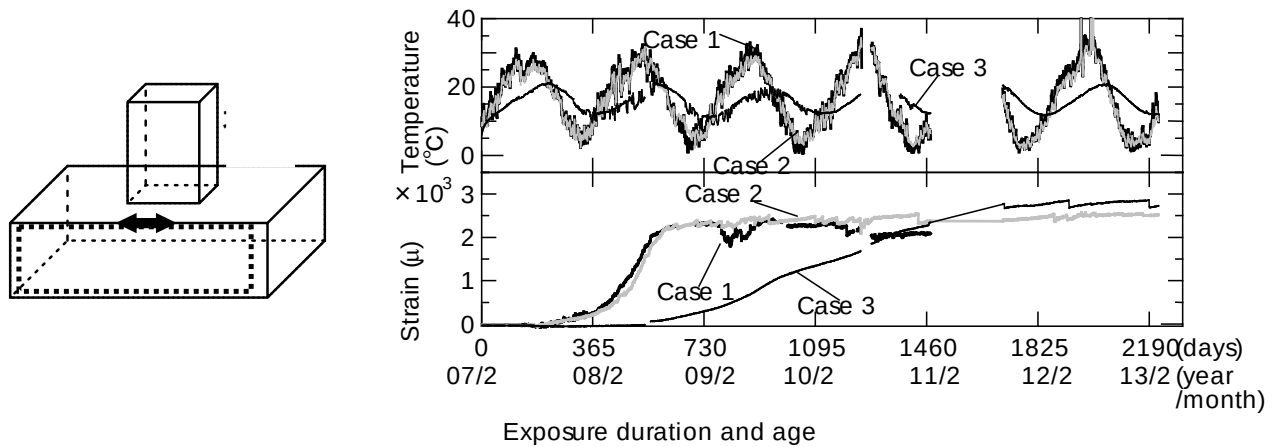
Figure-4 shows the strain and temperature values measured in the upper steel of the footings. The temperatures measured in Cases 1 and 2 were almost the same. In contrast, the temperatures measured in Case 3 were different from those in Cases 1 and 2, both the maximum and minimum temperatures in Case 3 being lower. These results are similar to those shown in Figure-3.

(a) Measurement points

(b) Measurement results

Fig. 4 Time variation of steel strain and temperature in footings

The strain results for the exposure tests show that strain values increased in all cases. However, these cases show differences in the trends that they exhibit. The strain value in Cases 1 and 2 started increasing at around 180 days. In contrast, the strain value in Case 3 started increasing at around 560 days. In addition, the speed of increase in Case 3 was similar regardless of season, but that in Cases 1 and 2 was larger in the summer when the temperature was high, and smaller in the winter when the temperature was low.

The strain values in Cases 1 and 2 converged 9 months after commencement of the exposure test. In contrast, those in Case 3 had still not converged after 2 years. However, after 4 years, the strain values in Case 3 became higher than those in Case 2. From this result, it can be concluded that the strain resulting from exposure at low temperature increases more slowly but reaches a higher final value than that resulting from exposure at high temperature.
