Title	Vibration analysis during grass harvesting according to ISO vibration standards
Author(s)	Kang, Tae-Hwan; Kaizu, Yutaka
Citation	Computers and Electronics in Agriculture, 79(2), 226-235 https://doi.org/10.1016/j.compag.2011.10.003
Issue Date	2011-11
Doc URL	http://hdl.handle.net/2115/48178
Туре	article (author version)
File Information	CEA79-2_226-235.pdf

1	Vibration Analysis during Grass Harvesting According to ISO Vibration
2	Standards
3	Tae-Hwan Kang <sup>a</sup> , Yutaka Kaizu <sup>b,*</sup>
4	
5	<sup>a</sup> Department of Biosystems Engineering, College of Agriculture, Life and Environment Science,
6	Chungbuk National University,
7	12 Gaesindong, Heungdukgu, Cheongju, Chungbuk 361-763, Korea
8	<sup>b,*</sup> Graduate School of Agriculture, Hokkaido University,
9	Kita 9, Nishi 9, Kita Ku, Sapporo 060-8589, Japan;
10	Corresponding author's email: kaizu@bpe.agr.hokudai.ac.jp
11

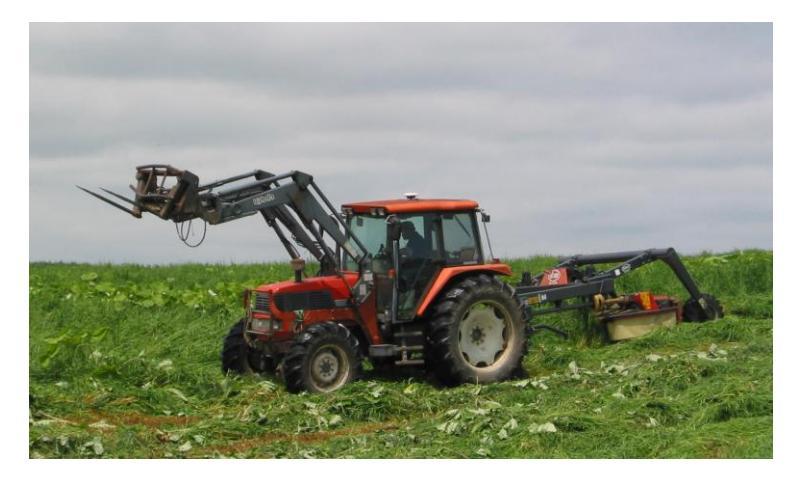
Fig. 1 Grass harvesting at Hamanaka grassland.

The field experiment was performed at Hamanaka, Hokkaido grassland in 2007. The total 11 area of the grassland is 3.6 ha, but the GIS map covered only an area of 2.4 ha, where the 1213vibration during grass harvesting was actually measured using a Kubota MD 107 (78 kW) 14tractor. During grass harvesting, a mower conditioner with a mowing width of 3 m was 15attached to the tractor and vibration data was collected while driving at a work speed of 3.0 m  $s^{-1}$ . This speed was the normal practical speed for this operation. The working speed was 16almost constant. The data sets recorded during turning were omitted and only those of straight 1718paths were used for analysis. We interviewed the operator to determine the regions where he felt it was difficult to work. We will refer to the combination of factors, including the risk of 1920the tractor rolling over on the operator, an increase in the drag of the mower conditioner, and unstable work postures of an operator during harvesting, as workability. Fig. 1 shows the MD 2122107 harvesting grass at the Hamanaka grassland and Table 1 shows the tractor's main 1 specifications.

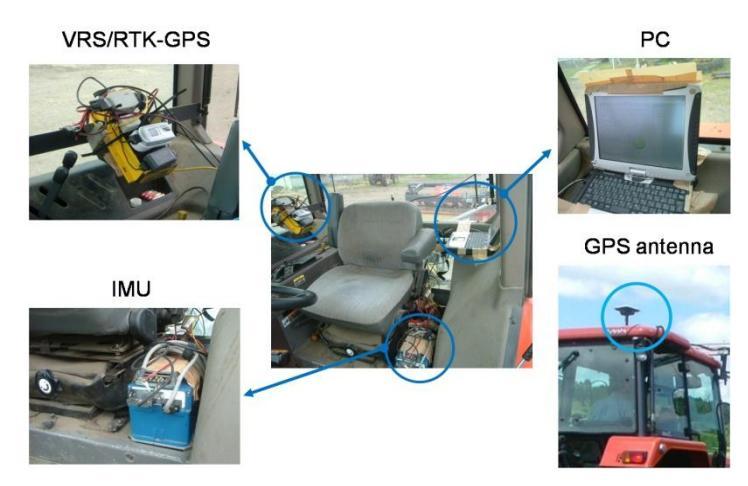
Fig. 2 Installation of the tractor vibration data-acquisition system.

$\mathbf{2}$ An RTK-GPS (MS750, Trimble Navigation Ltd., Sunnyvale, CA) and an IMU (Japan Aviation Electronics Industry Ltd., Tokyo, Japan) installed in a tractor normally used by 3 farmers during actual grass harvesting measured the positions and vibrations. A virtual 4 reference station (VRS)/RTK-GPS receiver with 2-cm precision acquired the position data at  $\mathbf{5}$ 6 a data frequency of 20 Hz. The acceleration in the  $a_x$ ,  $a_y$ , and  $a_z$  directions was measured by  $\overline{7}$ the IMU with a frequency of 25 Hz. The acceleration data in the three directions was 8 corrected by subtracting gravity. These data were stored in a laptop through an RS-232C 9 interface. Fig. 2 shows the locations of the installed sensors. For studying vibration acceleration, the location of the vibration acceleration sensor is most important. ISO 10 8041(2003) and JIS B 7760-1(2004) stipulate that the sensor should be installed in the same 11 plane as the seat surface for measurement. In this study, however, installing the vibration 1213acceleration sensor on the seat interfered with the operator during harvesting; thus, it was installed on the side of the operator's seat to perform measurements without obstructing the 1415work.

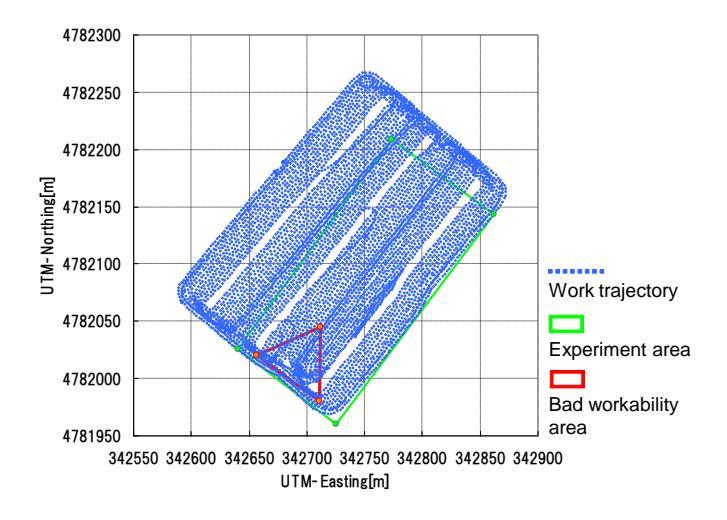
Fig. 3 Working trajectory of the tractor during grass harvesting and workability investigation locations.

Fig. 3 illustrates the tractor's working trajectory, measured by the RTK-GPS during grass harvesting at Hamanaka. The area enclosed by the red triangle indicates poor workability.

As shown in Fig. 3, the length of one working path is about 200 m. Windowing the complete vibration acceleration data in a single path, as shown in Fig. 4, associated the position with spectral information. After performing a discrete Fourier transform, the center of

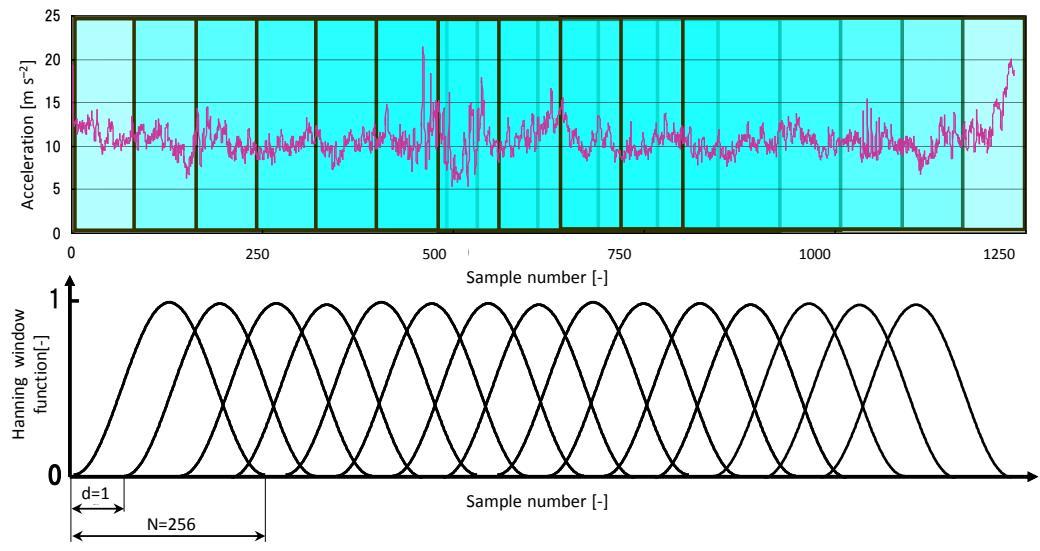
Fig. 4 Applying the Hanning window function to the sampling data

1 the window serves as the representative position. In this study, we used 256 samples within  $\mathbf{2}$ the window at a sampling frequency of 25 Hz. Because the vibration acceleration data was acquired at a work speed of 3 m s<sup>-1</sup> and 25 Hz, the sampling distance corresponds to a special 3 distance of about 0.12 m. Thus, the frequency and intensity measurements of vibration 4 acceleration in the test space are accurate to within 0.12 m. The 256 samples used for the  $\mathbf{5}$ Fourier transform correspond to the data acquired during 10.24 s and include the vibration 6 acceleration data for a distance of about 30 m. A Hanning window function, used as in Eq. (1),  $\overline{7}$ 8 diminished the effect of the sampling data on both ends. Fig. 4 shows the application of a 9 Hanning window function on a specified number of vibration acceleration data samples acquired from straight-line work and the sampling data interval. 10

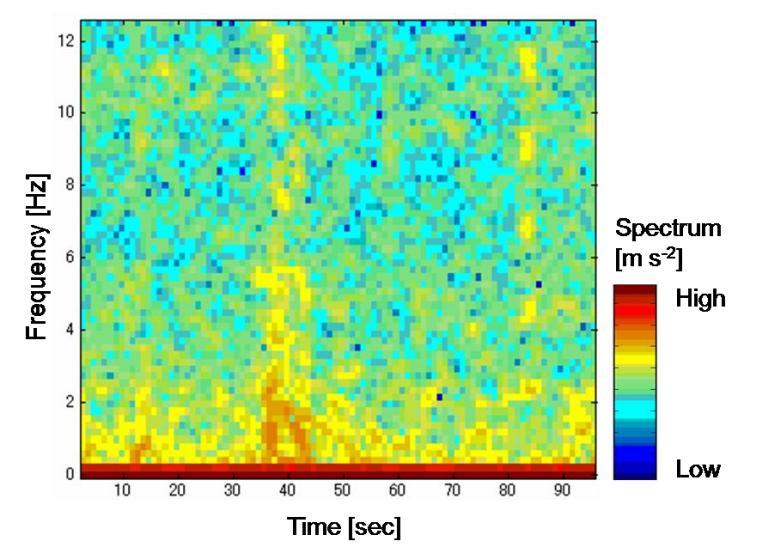
Fig. 5 Vibration strength at each frequency according to the Fourier transformation.

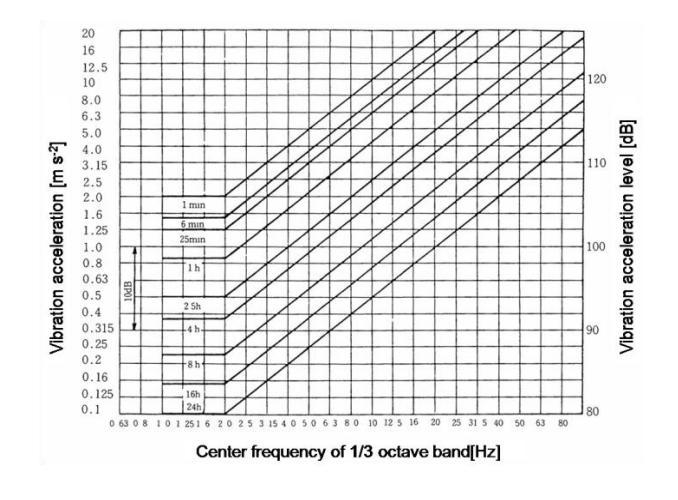
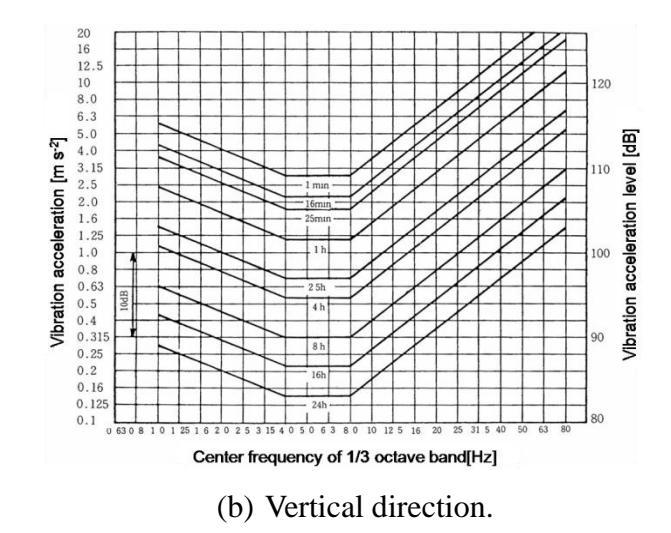
(a) Longitudinal and lateral direction.

Fig. 6 Vibration strength levels of fatigue work efficiency decrease along the three axes.

Fig. 6 illustrates the deterioration of work efficiency due to fatigue and the vibration strength level of comfort along the three axes with the 1/3 octave band specified in ISO 2631(1974) as the center frequency. As shown in Fig. 6, the vibration strength level of fatigue and deterioration of work efficiency is low in the  $a_x$  and  $a_y$  directions in the range 1–2 Hz; that in the  $a_z$  direction is low in the range 4–10 Hz. The lowest frequency on each axis negatively affects fatigue, work efficiency, or comfort.

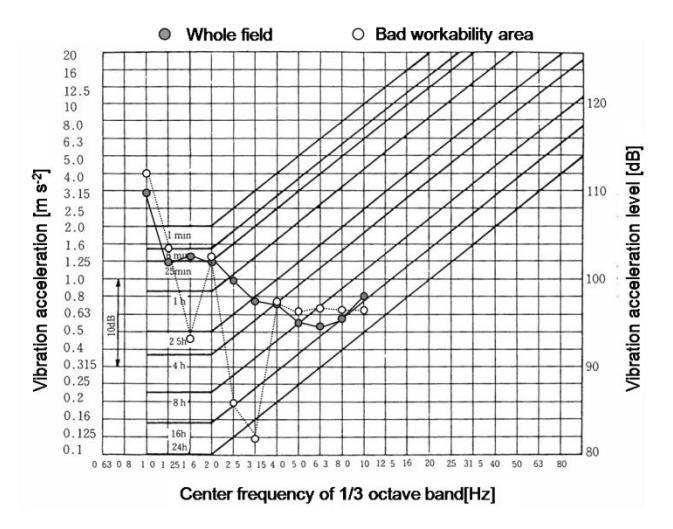
Fig. 7 Vibration strength levels of fatigue work efficiency decrease according to the vibration acceleration in the longitudinal direction  $(a_x)$ .

Fig. 7 compares the average vibration acceleration in the  $a_x$  direction. The level of 4 vibration strength work efficiency decreases in the 1/3 octave band center frequency range  $\mathbf{5}$ 1.0–10 Hz for the whole field and areas with poor workability. The gray and white points are 6 the averaged vibration acceleration values in the  $a_x$  direction for the entire field and the area  $\overline{7}$ 8 pointed out by the operator having poor workability, respectively. As shown in Fig. 7, the average of vibration acceleration for the whole field reached 3.033 m s<sup>-2</sup> at 1.0 Hz. 9 Calculating the work time from the average value of the vibration acceleration of the whole 10 field, we get 25 min below 2.0 Hz, where work fatigue increases and work efficiency 11 decreases. Even in the crucial areas identified by the operator, the vibration acceleration is 1213highest at 1.0 Hz, and the work time, based on fatigue work efficiency at 1.0 Hz, 1.25 Hz, and 2.0 Hz decreases below 6 min. Table 2 shows the statistics of vibration acceleration in the  $a_x$ 14 direction for the whole field and poor workability areas for the center frequency. 15

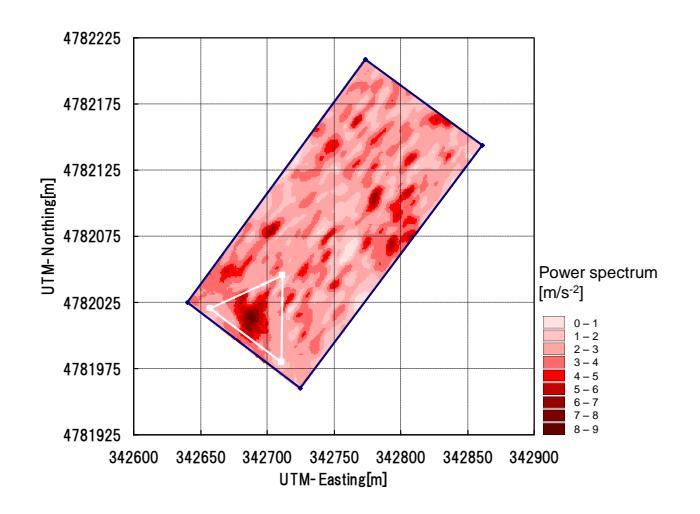
Fig. 8 GIS map of the maximum vibration acceleration in the longitudinal direction  $(a_x)$  for

Fig. 8 shows the GIS map of the maximum vibration acceleration in the  $a_x$  direction for 16the center frequency range 1.0-10 Hz. Over the whole field, the maximum vibration 17acceleration in the  $a_x$  direction exceeded 1.0 m s<sup>-2</sup>, and for specific areas, it exceeded 4.0 m 18 $s^{-2}$ . Within poor workability areas, many areas exhibit maximum vibration acceleration in 19 excess of 5 m s<sup>-2</sup>. Fig. 9 shows the GIS map of the entire field for each 1/3 octave band center 20frequency and illustrates the maximum vibration acceleration. The center frequency of the 1/321octave band that showed maximum acceleration in the  $a_x$  direction is below 2.0 Hz. Note 22that the maximum vibration acceleration at 1.0 Hz covers 80% of the entire field. Even in 23

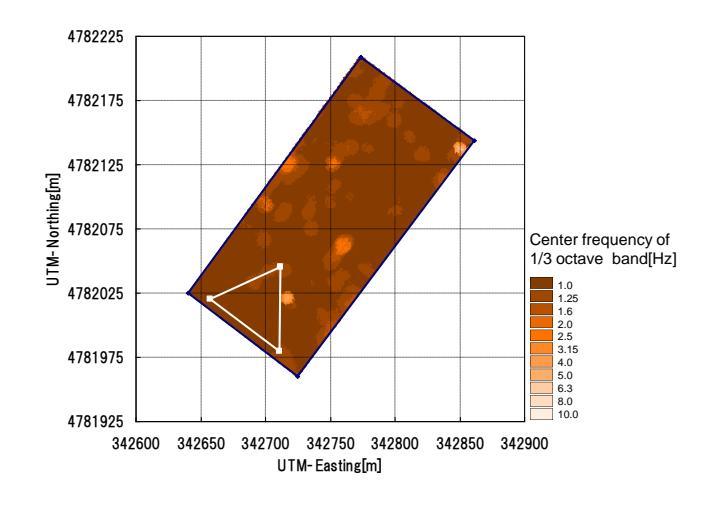
Fig. 9 GIS map of the 1/3 octave band centre frequency distribution for maximum vibration acceleration in the longitudinal direction  $(a_x)$ .

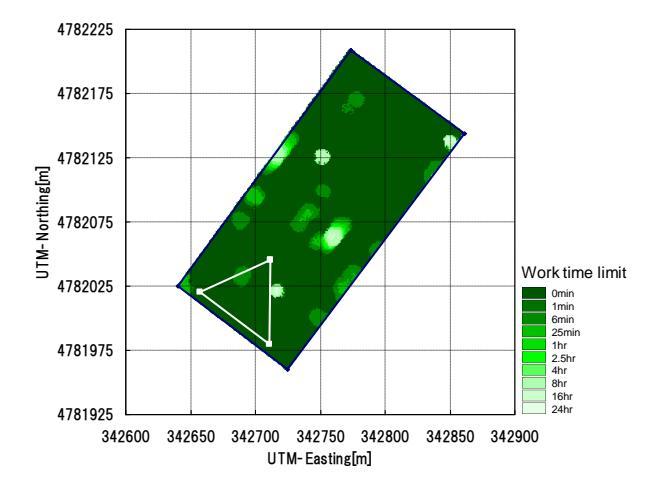
Fig. 10 GIS map of work time limit for vibration acceleration in the longitudinal direction  $(a_x)$ .

Fig. 10 shows the GIS map created by calculating the maximum vibration acceleration for 3 the entire field in the  $a_x$  direction (as shown in Fig. 8) from the vibration strength level for 4 the deterioration of work efficiency from fatigue, as specified in ISO 2631(1974). The work  $\mathbf{5}$ time limit for the maximum vibration acceleration in the  $a_x$  direction is mainly distributed 6  $\overline{7}$ below 1 min for the whole field owing to the 1/3 octave band center frequency of 1.0 Hz, as 8 shown in Fig. 9. These results show that, in this experiment, the vibration acceleration in the 9 direction of movement caused operator fatigue or deterioration of work efficiency at work times below 1 min owing to a center frequency of 1.0 Hz. 10

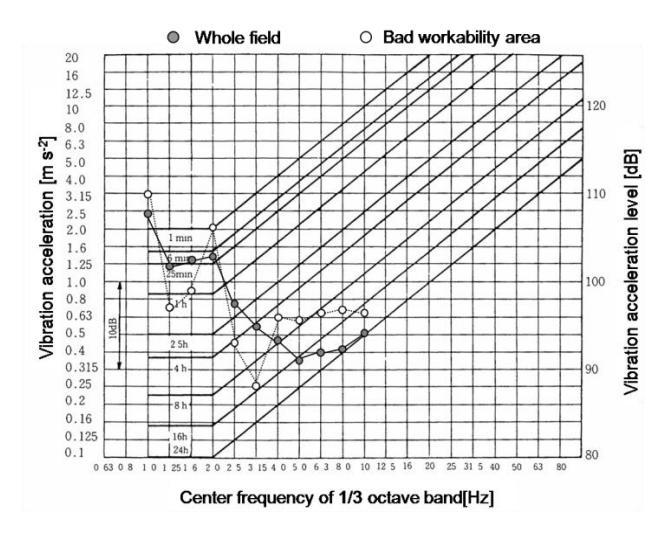
Fig. 11 Vibration strength levels of fatigue work efficiency decrease according to the vibration acceleration in the lateral direction  $(a_y)$ .

Fig. 11 compares the average vibration acceleration in the  $a_v$  direction and the vibration 11 strength level of work efficiency for the whole field and poor workability areas. The gray 1213points are the average values of vibration acceleration for the whole field; the white points are the averages of vibration acceleration in the  $a_y$  direction. The average vibration acceleration 14for the field reached a maximum of 2.478 m s<sup>-2</sup> at 1.0 Hz; below the 1/3 octave band 15vibration center frequency of 2.0 Hz, the vibration acceleration exceeded 1.150 m s<sup>-2</sup>—higher 16 than that above 2.0 Hz. In the area of poor workability, the vibration acceleration was also 17higher at 1.0 Hz and 2.0 Hz than at the other frequencies. Calculating the work time limit 18based on the average vibration acceleration yielded a work time below 25 min for the whole 19field at a center frequency below 2.0 Hz; in areas of poor workability, work times below 1 20min at 1.0 Hz and 2.0 Hz resulted in fatigue or deterioration of work efficiency. Table 3 shows 21the statistical values for vibration acceleration in the  $a_y$  direction for the whole field and 2223areas of poor workability at each 1/3 octave band center frequency.

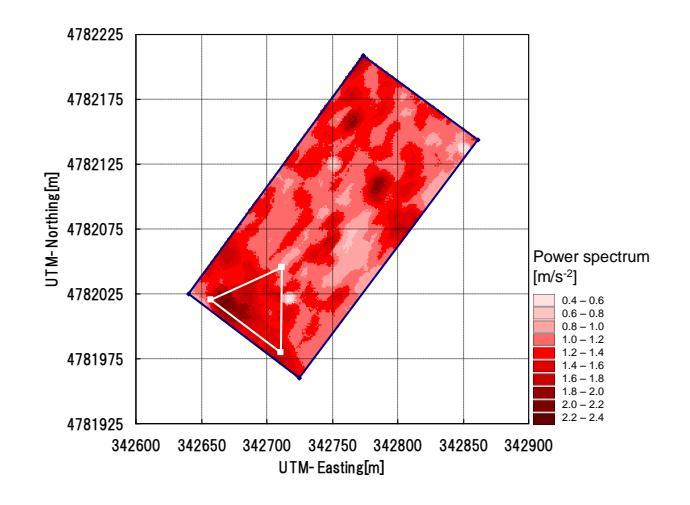
Fig. 12 GIS map of the maximum vibration acceleration in the lateral direction  $(a_y)$  for 1–10

Fig. 12 shows the GIS map of the maximum vibration acceleration in the  $a_y$  direction for 1 the 1/3 octave band center frequencies 1.0–10 Hz. The maximum vibration in the  $a_y$  $\mathbf{2}$ direction for the whole field was mainly distributed in areas over  $1.0 \text{ m s}^{-2}$ . In the white line 3 triangle area within the poor workability area, the maximum vibration acceleration exceeds 4 1.4 m s<sup>-2</sup> throughout, while areas over 2.2 m s<sup>-2</sup> also exist. Fig. 13 shows the GIS map of 1/3  $\mathbf{5}$ 6 octave band center frequencies of 1.0-10 Hz, showing the maximum vibration acceleration for each area of the field. As shown in Fig. 13, the 1/3 octave band center frequency showing 78 the maximum vibration acceleration exceeds 90% of the whole field area at frequencies below 1.6 Hz. Areas of poor workability showed tendencies similar to those of the whole field. Fig. 9 14 shows the GIS map of the calculated work time limit that causes fatigue or deterioration of 10 11 work efficiency using the maximum vibration acceleration in the  $a_{y}$  direction, according to 12ISO 2631(1974). The work time limit for the maximum vibration acceleration in the  $a_y$ 13direction is mainly distributed below 1 min for the whole field owing to the effect of the 1/3 octave band center frequencies below 2.0 Hz; similar results were observed in areas of poor 1415workability.

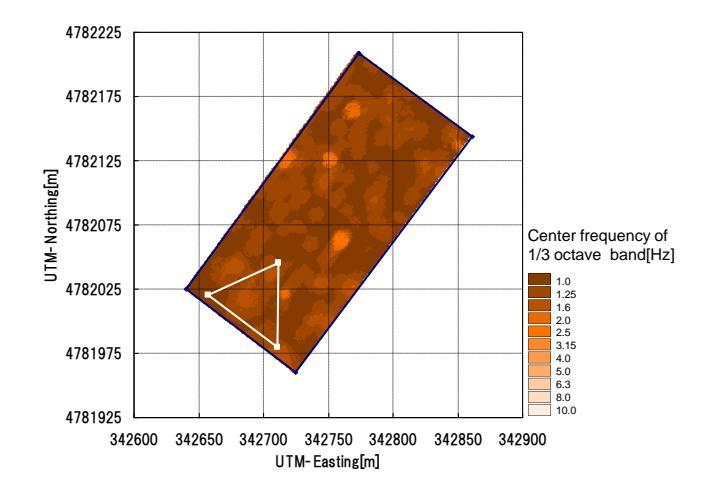
Fig. 13 GIS map of the 1/3 octave band center frequency distribution for maximum vibration acceleration in the lateral direction  $(a_y)$ .

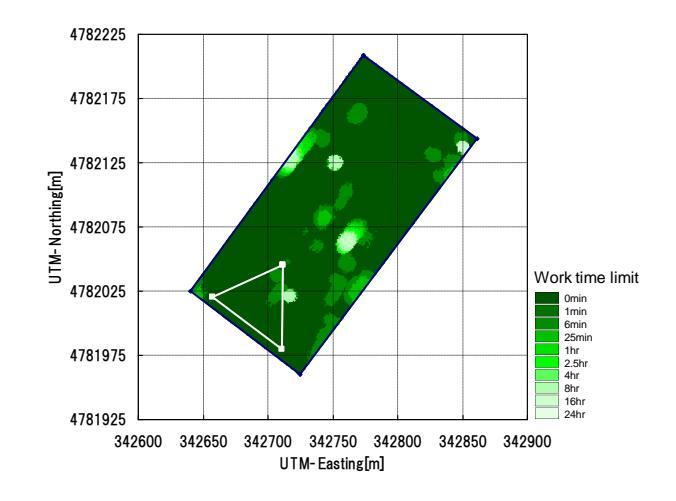
Fig. 14 GIS map of work time limit for vibration acceleration in the lateral direction  $(a_y)$ .

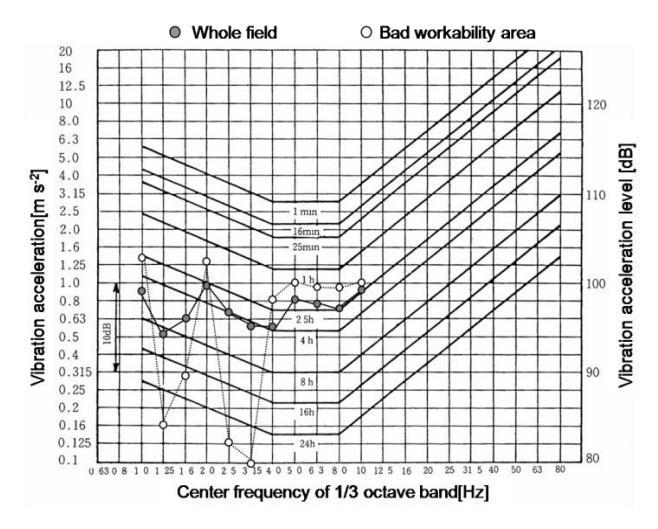
Fig. 15 Vibration strength levels of fatigue work efficiency decrease according to vibration acceleration in the vertical direction  $(a_z)$ .

Fig. 15 compares the average vibration acceleration in the  $a_z$  direction and the vibration strength level of fatigue work efficiency for the whole field and poor workability areas for the 1/3 octave band center frequencies in the range 1.0–10 Hz. The gray points are the average values of vibration acceleration for the whole field calculated for each center frequency. The white points are the average values of the vibration acceleration in the  $a_z$  direction in areas of poor workability. As shown in Fig. 15, the average vibration acceleration showed high values  $0.909 \text{ ms}^{-2}$  and  $0.985 \text{ ms}^{-2}$  at 1.0 Hz and 2.0 Hz, respectively. In addition, the average of vibration acceleration at center frequencies 5.0–10 Hz with low deterioration of work efficiency was above 0.7 m s<sup>-2</sup>.

At the 1/3 octave band center frequency range 5.0–10 Hz, workability decreases to 1 h. In areas of poor workability, the average vibration acceleration is the highest at 1.0 Hz and 2.0 Hz. The work time in the range 4.0–10 Hz with low vibration strength of work fatigue efficiency deterioration is below 2.5 h. Table 4 summarizes the statistical values of the vibration acceleration in the  $a_z$  direction of the whole field and areas of poor workability for each center frequency.

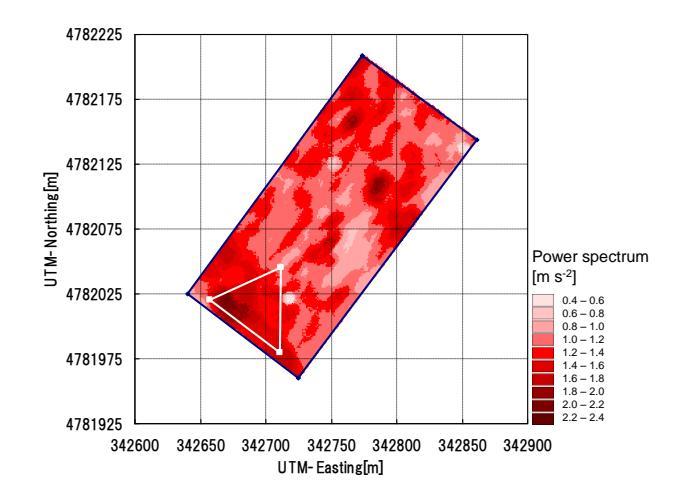
Fig. 16 GIS map of maximum vibration acceleration in the vertical direction  $(a_z)$  for 1–10 Hz.

Fig. 16 shows the GIS map of the maximum vibration acceleration in the  $a_z$  direction for center frequencies 1.0–10 Hz. The maximum vibration for the whole field in the  $a_z$  direction was mainly distributed in areas over 0.6 m s<sup>-2</sup>. In the poor workability area, the maximum vibration acceleration exceeds 1.2 m s<sup>-2</sup>.

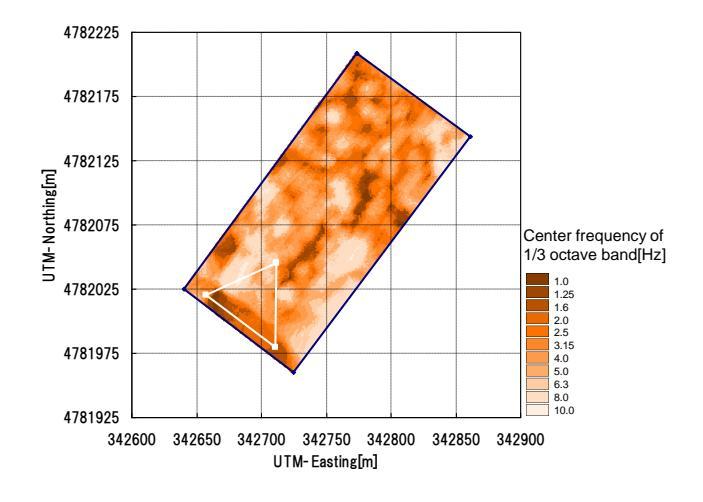
Fig. 17 GIS map of the 1/3 octave band center frequency distribution for the maximum vibration acceleration in the vertical direction ( $a_z$ ).

15Fig. 17 shows the 1/3 octave band center frequency map with the maximum vibration acceleration in the  $a_z$  direction for the whole field. The center frequency of the 1/3 octave 16band with the maximum vibration acceleration in the  $a_z$  direction is broadly distributed from 171.0 to 10 Hz; however, 80% of the field was at 4.0-10 Hz. Even in the identified poor 18workability areas, the center frequencies were broadly distributed in the 1.0–10 Hz range. Fig. 1918 shows a GIS map obtained by calculating the maximum vibration acceleration in the  $a_{z}$ 20direction from the vibration strength level according to deterioration of work efficiency, as 21specified by ISO 2631(1974). In Fig. 18, the work time for the vibration acceleration in the 22 $a_{z}$  direction at which work efficiency decreased was 1 h in the whole field and poor 23

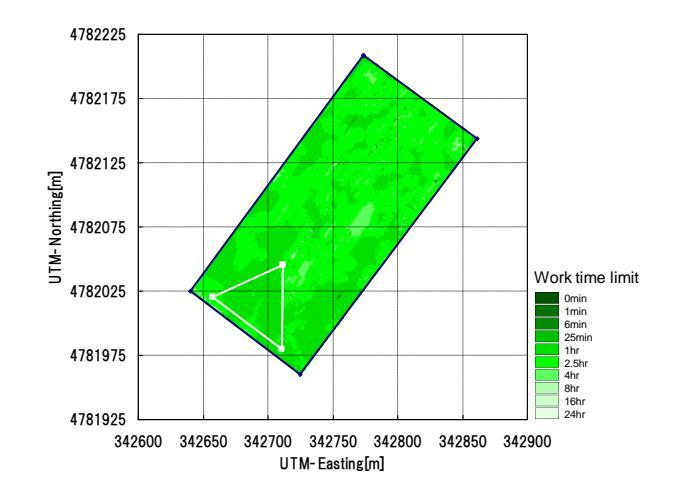
Fig. 18 GIS map of work time limit for vibration acceleration in the vertical direction  $(a_z)$ .

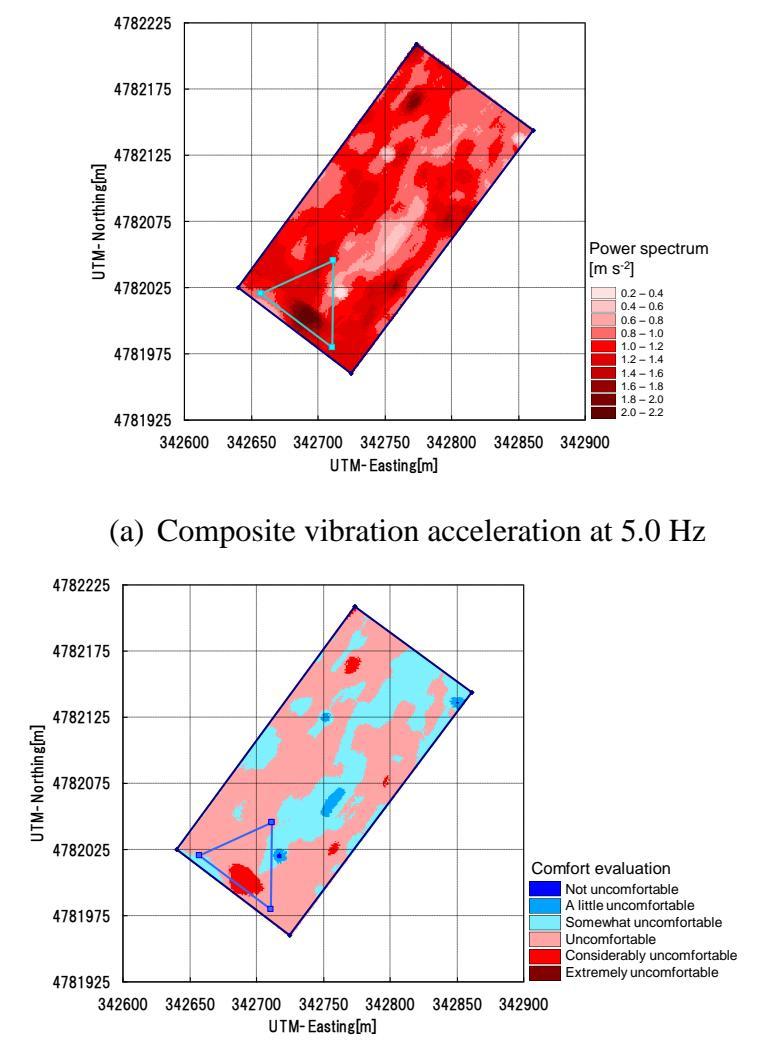
(b) Comfort evaluation using the composite vibration acceleration at 5.0 Hz

Fig. 19 GIS map of composite vibration acceleration at the1/3 octave band centre frequency of 5.0 Hz and a comfort evaluation.

In Fig. 19, the composite vibration acceleration and degree of comfort at the center 11 frequency of 5.0 Hz are shown as a GIS map for each whole field. Fig. 19(a) shows that 12composite vibration accelerations over  $1.0 \text{ m s}^{-2}$  are widely distributed in the whole field. In 13particular, the composite vibration value of the grass harvesting areas pointed out by the 14operator as high exceeded 2.0 m s<sup>-2</sup>, which was 1.0 m s<sup>-2</sup> higher than that at other locations. 15The comfort evaluation shown in Fig. 19(b) evaluated 70% of the whole field as 16 17"uncomfortable," while it rated the poor workability areas identified by the operator as "considerably uncomfortable." Fig. 20 shows the GIS map evaluating the composite vibration 18 acceleration and comfort at 8.0 Hz; Fig. 20(a) shows that the area with a composite vibration 19acceleration of over 0.6 m s<sup>-2</sup> is widely distributed over the field. The poor workability areas 20showed a high composite vibration value of 1.2 m s<sup>-2</sup>, and thus, they were evaluated as being 2122"considerably uncomfortable."

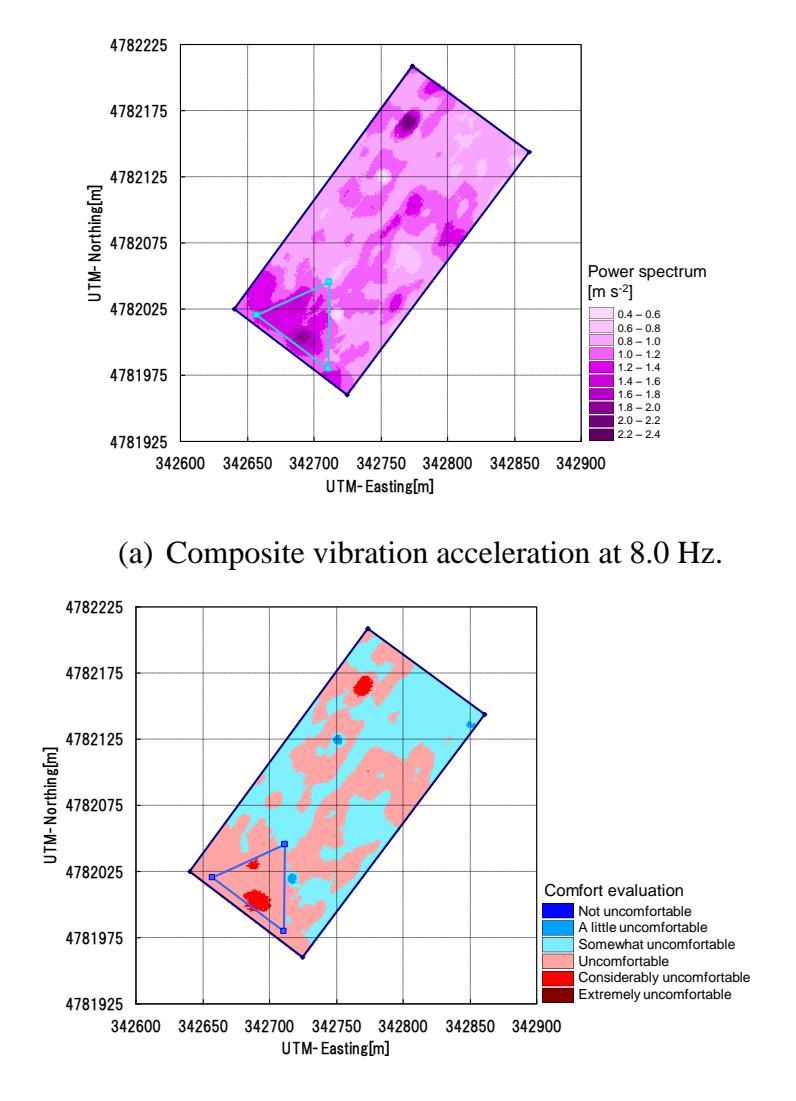
(b) Comfort evaluation using the composite vibration acceleration at 8.0 Hz.Fig. 20 GIS map of composite vibration acceleration at the 1/3 octave band center frequency of 8.0 Hz and a comfort evaluation.

## We used the composite vibration acceleration along the three axes to evaluate the level of comfort, according to the specifications in JIS B 7760-1(2004) and JIS B 7760-2(2004). This was achieved by calculating the composite vibration acceleration. In this paper, the maps for the center frequencies of 5 and 8 Hz are shown because these two maps show the distinguished difference between normal and poor workability areas. Table 5 summarizes the comfort evaluation method according to the composite vibration acceleration specified in JIS B 7760-1(2004) and JIS B 7760-2(2004).
