THE GPS CAMERA APPLICATION FOR THE EFFICIENCY IMPROVEMENT OF THE BRIDGE INSPECTION

T. KAMADA*, F. KATSUKI, and M. NAKAGAWA

Department of Civil Engineering, Shibaura Institute of Technology, Japan

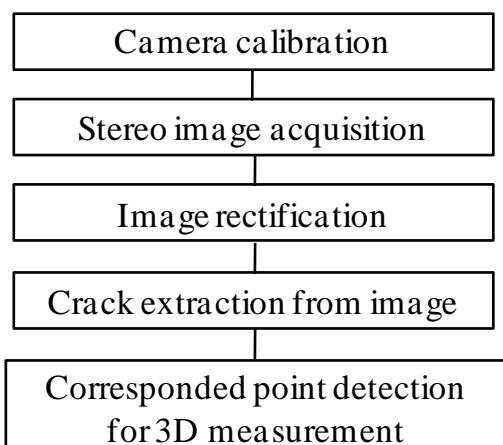
Figure 1: Processing flow for a crack extraction.

Our proposed flow is shown in Figure 1. First, a stereo camera is calibrated. Next, stereo images are acquired. Then, stereo images are rectified using calibration parameters. After that, crack was extracted from stereo images. Finally, 3D data are generated using stereo images with corresponded points.

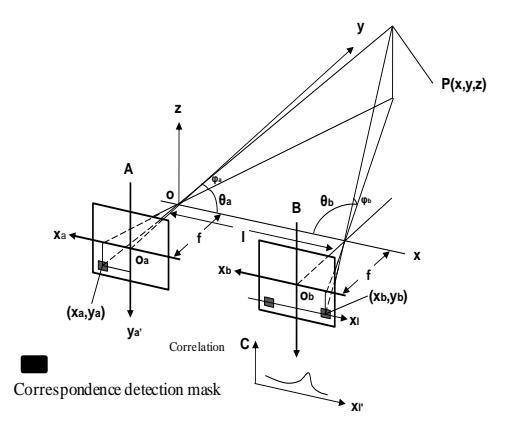
Figure 2: Stereo camera model.

Stereo measurement can obtain 3D position using corresponed points in stereo images, as shown in Figure 2.

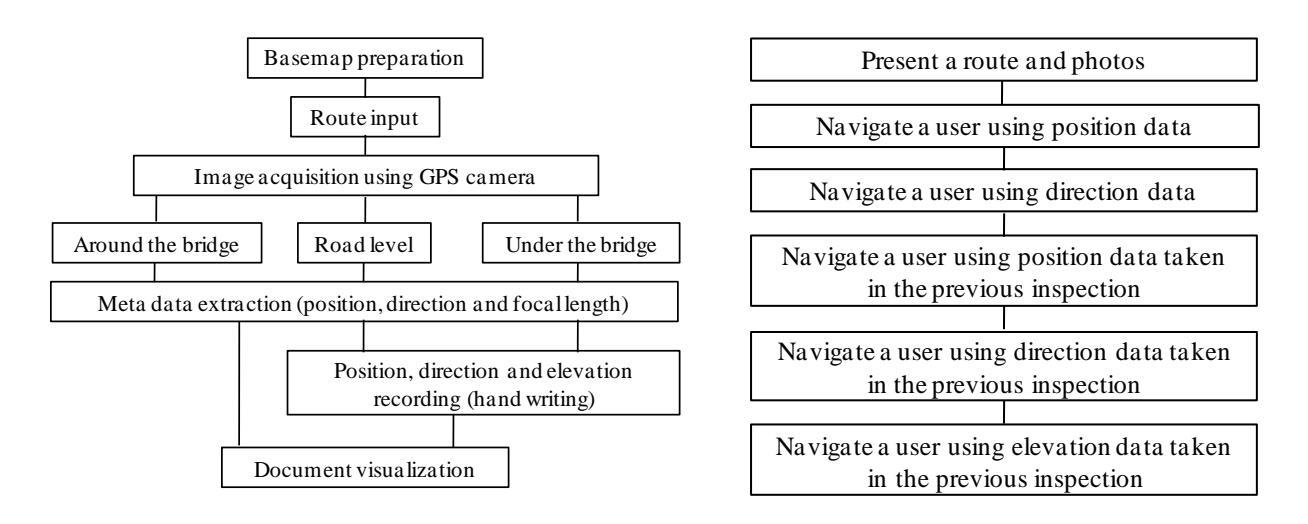
Figure 3: Image acquisition procedure.

Figure 4: Image reference procedure.

In our experiments, we used GPS camera (Casio Exilim EX-H20G), as shown in Table 1. Our experiments consisted of image acquisition and image reference to simulate a daily infrastructure inspection using GPS camera. Firstly, photos are taken to prepare reference data in the image acquisition procedure, as shown in Figure 3. Secondary, navigation using taken photos is examined in the image reference procedure, as shown in Figure 4. Images were acquired at 30 points in three areas (a road level, river level under the bridge and river level around the bridge) around a road bridge across a river. Finally, we evaluated the navigation examination, as shown in Table 2. In the case of Figure 5, the original photo is Figure 6, the photo includes the object (crack) about 80%. Additionally, the photo includes something other than the object" is 2 points. As for other items, we scored in a similar way.

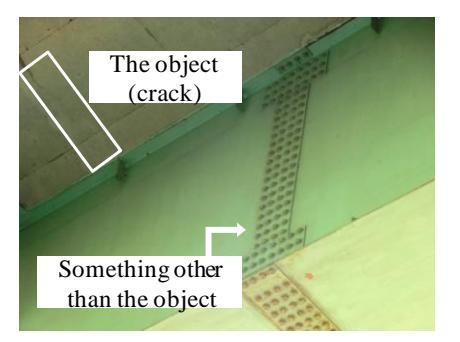
The object (crack) Something other than the object

Figure 5: Image Acquisition (Using position data).

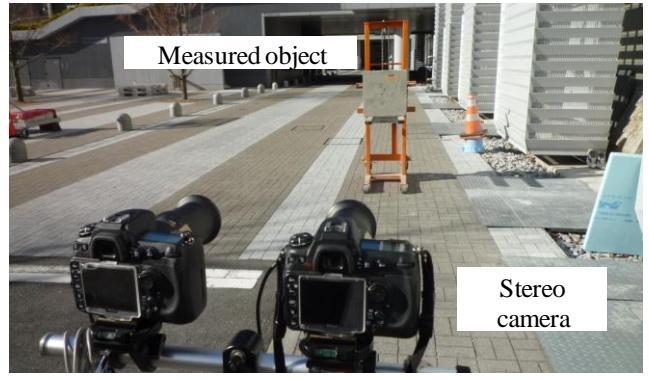
Figure 7: Experiment environment.

An actual crack inspection requires 0.1mm spatial resolution to recognize a crack. Measurement accuracy is also required less than 0.1 mm. Thus, we assembled our stereo camera system with 0.2 mm spatial resolution. Moreover, we applied subpixel image estimation to improve the spatial resolution virtually. Then, we estimate 3D coordinate values with 0.033 mm accuracy at 5 m distant. Figure 7 shows our experiment environment. The specification of our stereo camera is shown in Table 3.

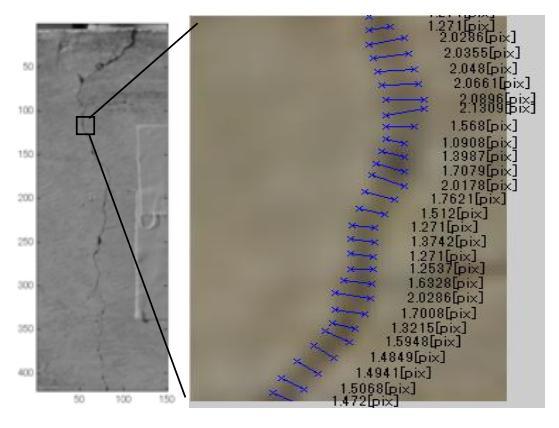
Figure 8: Extracted crack boundaries from image at 5 m distant.

The result of the baseline, direction of camera and measuring accuracy are shown in Table 6. Moreover, we have confirmed that cracks can be extracted at 5m distant (Figure 8). Camera parameter estimation was stable in gazing camera arrangement. However, lens distortion parameter estimation depends on overlapped area in stereo images in our system. Therefore, in parallel camera arrangement, the camera parameter estimation was unstable, because of small overlapped area in stereo images. We can extract a crack with a robust feature tracking approach based on feature extraction from images. Generally, threshold is prepared to detect crack features in manual in conventional approaches. However, our approach can estimate a threshold to detect crack features on concrete surface automatically.
