DYNAMIC LOADING TESTS CARRIED OUT AFTER REPAIR WORKS OF THE YODOGAWA BRIDGE

L. H. ICHINOSE^{1*†}, Y. NATSUAKI², K. MASUDA³ and M. SAKANO⁴

ABSTRACT

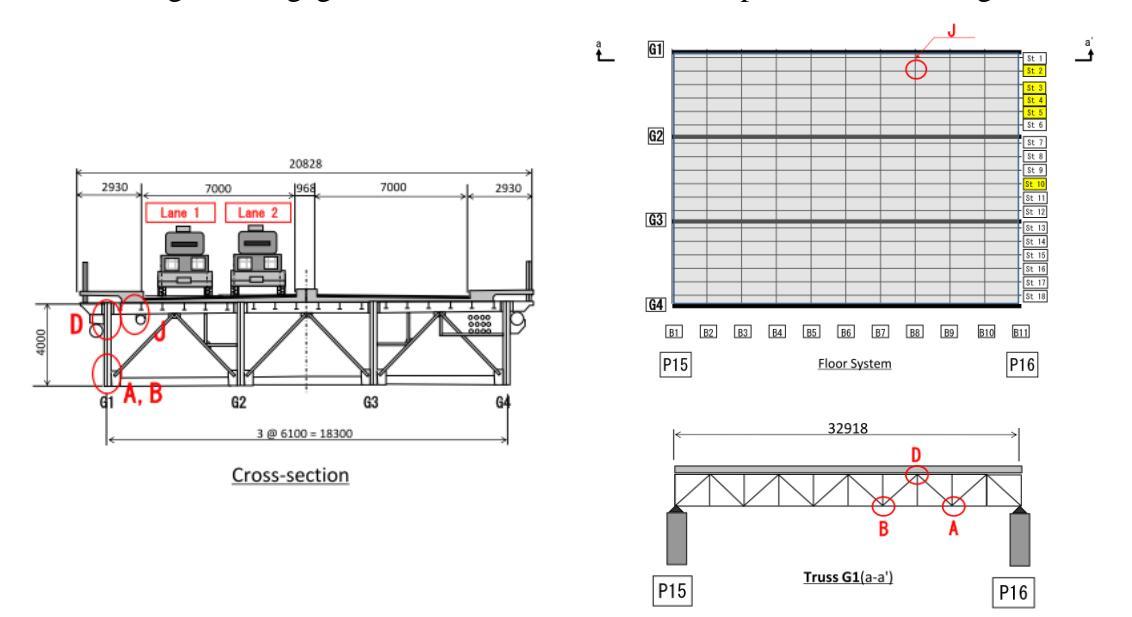
Figure 2: Measurement points

Based on the deterioration scenario obtained from the series of investigations carried out in 2011 (Natsuaki et al., Kohno et al., Ichinose et al., 2011), critical members were selected for repair and, after the execution of repair works, stress measurements were carried. Stress measurements were carried out through strain gages installed at the measurement points shown in Figures 2 and 3.

Dynamic loading tests were carried out by loading the test vehicle shown in Figure 4 on the two traffic lanes shown in Figure 2. The vehicle moved at a velocity of about 40 km/h and stress measurements were carried out at night when the number of vehicles crossing the bridge is relatively small and the influence of temperature can be considered small.

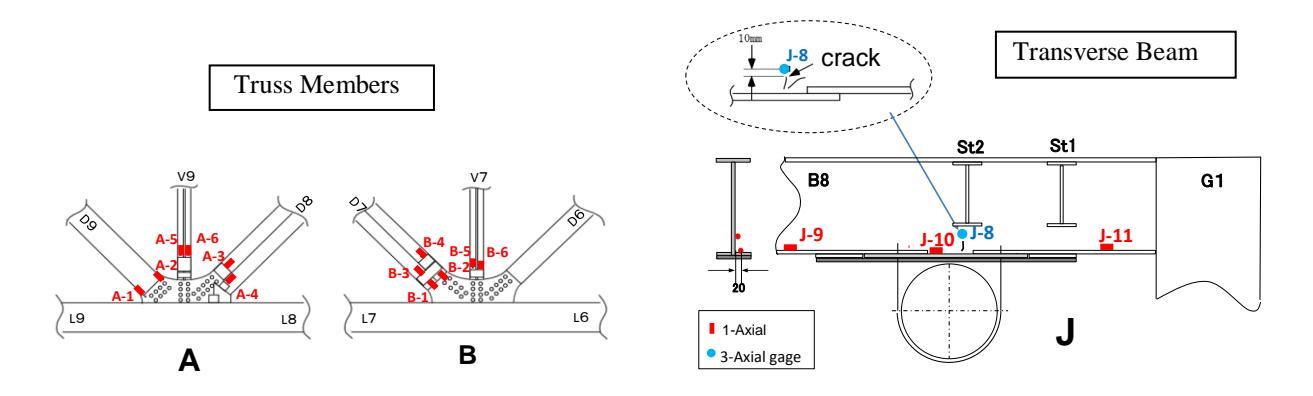
Figure 3: Example of strain gage installation

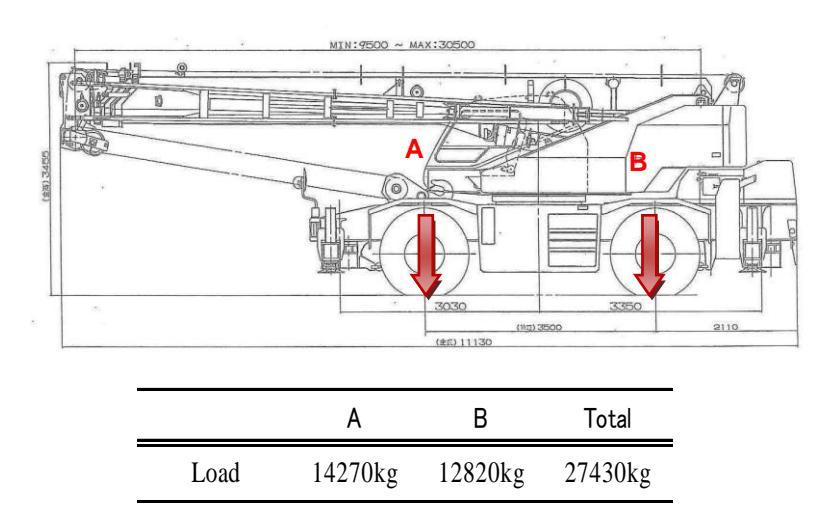
Figure 4: Test vehicle

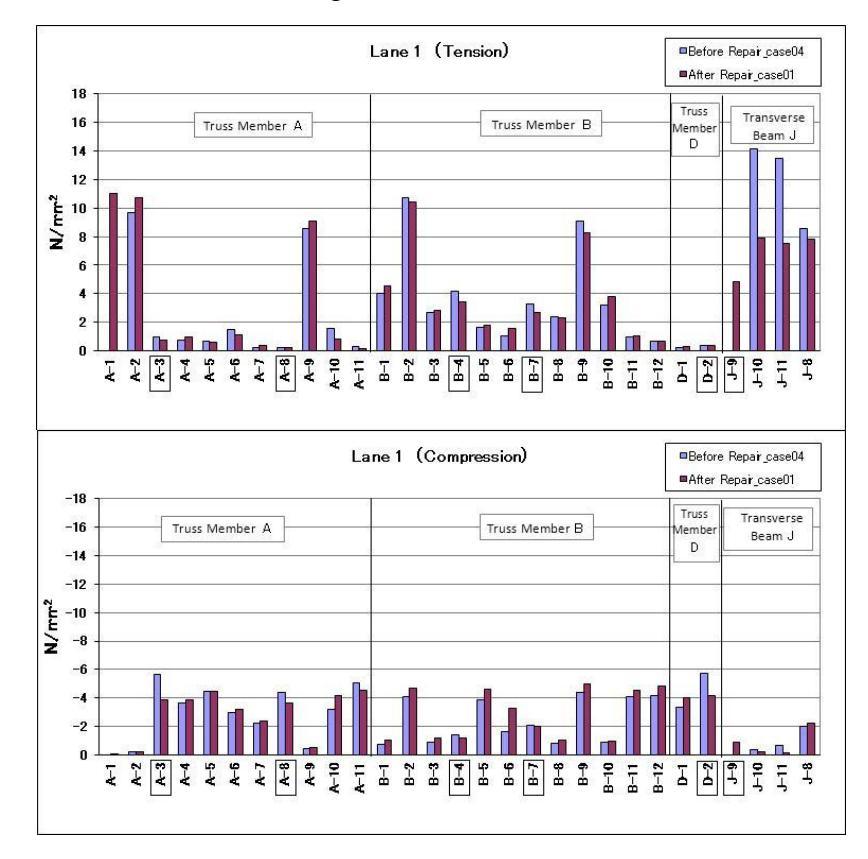
The results of the dynamic loading test, compared to the results obtained in measurements carried out before the execution of repair works, showed relatively small differences for stresses measured in the truss members, whereas considerable improvements were observed in the transverse beam stresses. Measurements results for lane 1 are shown in Figure 5. The figure presents the measured stresses for the structure before and after the execution of repair works. In particular, it was observed that stresses at the lower flange of the repaired transverse beam presented a considerable reduction of stress (about 40%) after being retrofitted.

Figure 5: Stresses before and after repair works (Dynamic loading test)

In the dynamic loading tests, stresses at the truss members did not present considerable differences compared to that measured before the execution of retrofitting works, whereas the stresses at the lower flange of the reinforced transverse beam presented considerable stress reduction (40%), proving the effectiveness of the retrofitting works.

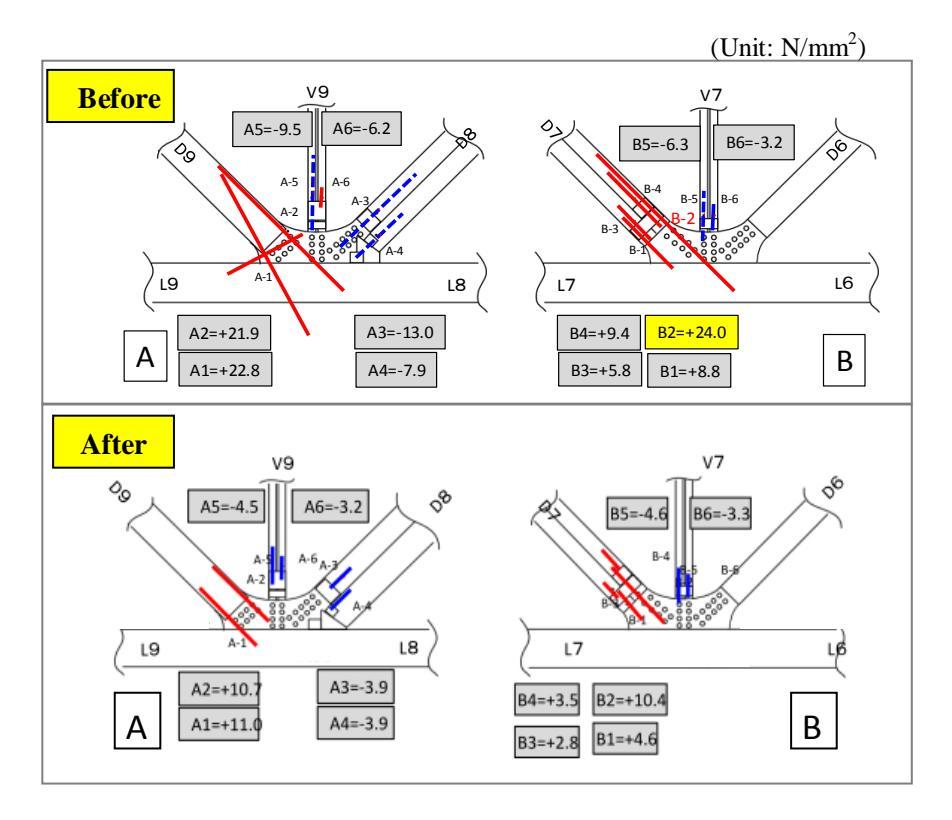
Figure 7: Stresses under traffic load before and after repair works (truss members)

The stresses measured during the 72 hours (3 consecutive week days) presented relatively small values, being most of them within the fatigue limit. Maximum stresses observed in truss members and transverse beam during the measurements are shown in Figure 7 and 8, respectively.

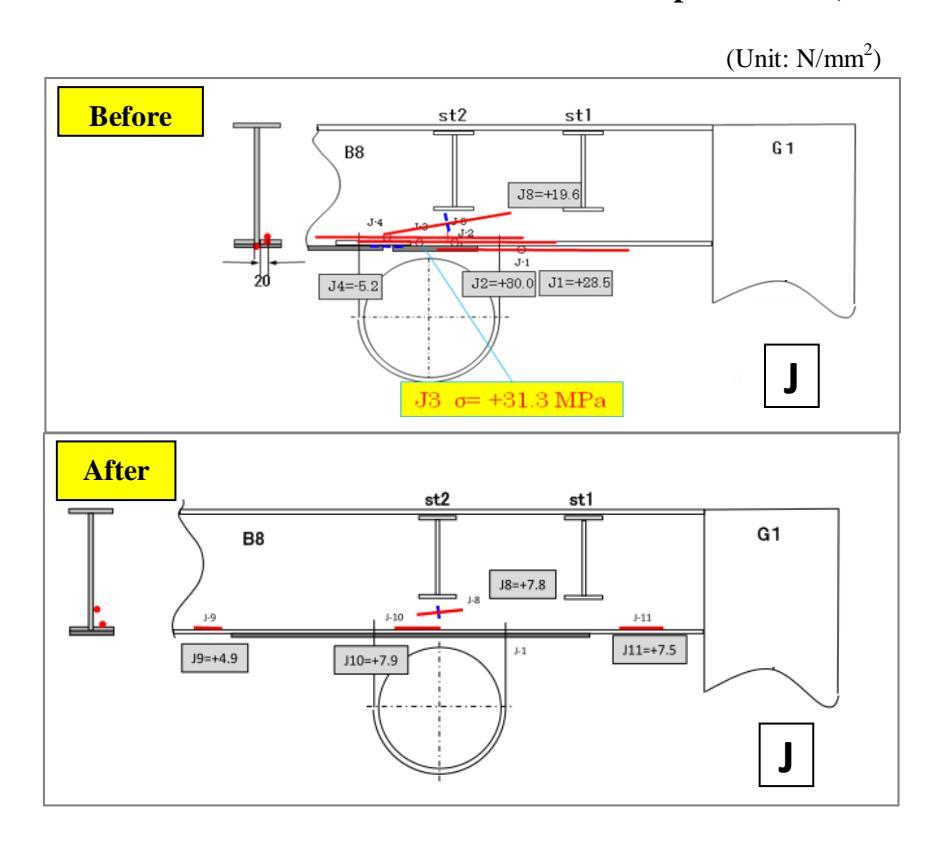
Figure 8: Stresses under traffic load before and after repair works (transverse beam)

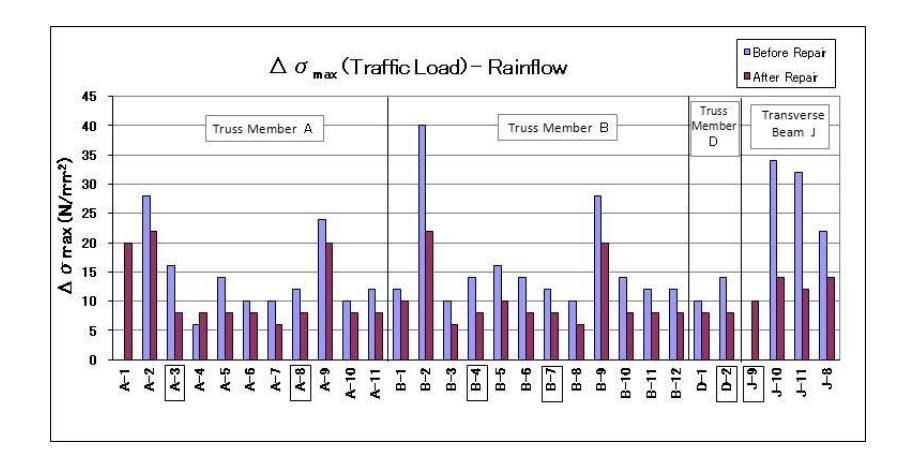
Figure 9: Maximum stress range before and after repair works (Traffic load)

Under traffic load, stresses were considerably improved in both truss members and the transverse beam, what can be also seen in Figure 9 which shows a decrease in the stress range ($\Delta\sigma$) after the execution of repair works for almost all the measurement points. The transverse beam, in particular,

had its predicted fatigue life extend to more than 10 times of that of before the execution of repair works.

Measurements carried out under traffic load showed improvements in the stress range for almost all the measurement points. However, the fatigue life obtained based on these measurement results did not show dramatic changes in the fatigue lives of most measured members, except for the lower flange of the retrofitted transverse beam, which presented a fatigue life improved to 10 times of that of before retrofitting .
