ON THE DETERIORATION TENDENCY OF BRIDGE SLABS AFTER REPAIR WORK (IN THE CASE OF A LOCAL AUTONOMY)

Hiroyuki Sugimoto^{1*†}, and Naotaka Shibuya²

¹Faculty of Engineering, Hokkaigakuen University, Japan ²SHIBUYA Co., Ltd., Japan

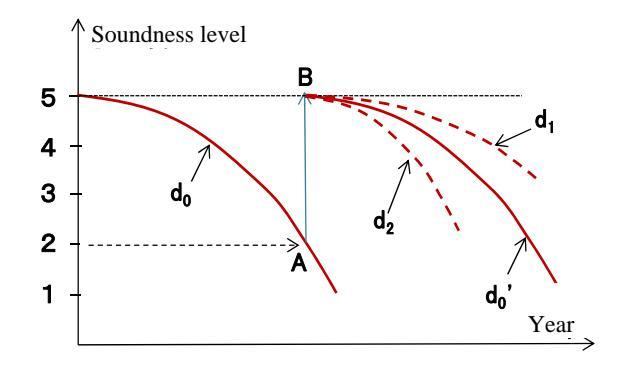
Figure 1 shows the relationship between the deterioration curves and repair of a component. It was assumed that the inspection results were evaluated on a scale of 1 (bad) to 5 (good). First, the degree of aging deterioration was calculated using the deterioration curve d_0 . For example, it was assumed that repair was conducted when this component's soundness level became 2, which is shown as Point A in the figure. Conventionally, the soundness level was assumed to return to 5, and the deterioration curve d₀', which was the same as the initial curve d₀, was used to calculate the degree of deterioration. These assumptions present two problems: 1) whether the soundness level actually returns to 5 (Point B in the figure), and 2) whether deterioration progresses with the same slope as that of the initial deterioration curve. In regard to the former, although some argue that the level may be higher than 5 depending on how repair is implemented, it is safe to assume that the value returns to 5 after repair because the initial value itself is not reached even with strict performance evaluation. Post-repair performance is also included in the slope of the deterioration curve after repair. Deterioration should be slow if the repair is good and fast if it is not. Figure 1 highlights the problem of what the actual condition of d_1 or d_2 is. As it is considered difficult to determine these values theoretically, post-repair deterioration was examined based on actual floor slab data in this study. The soundness level on the vertical axis of the figure is used to represent the degree of deterioration.

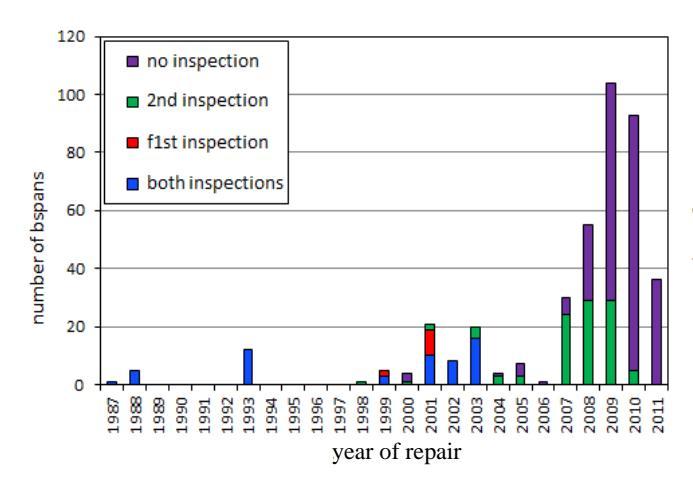
Figure 2 shows years and the number of spans (379 in total) on which partial slab repair has been conducted since 1987. The details of slab repair were not recorded before this time. The number increased dramatically from 2007.

In the figure, blue shading represents the number of spans for which results from the first and second rounds of inspection were found. The red and green areas indicate those for which only results from the first or second round, respectively, were found. Purple represents spans for which no inspections had been conducted since recent repair.

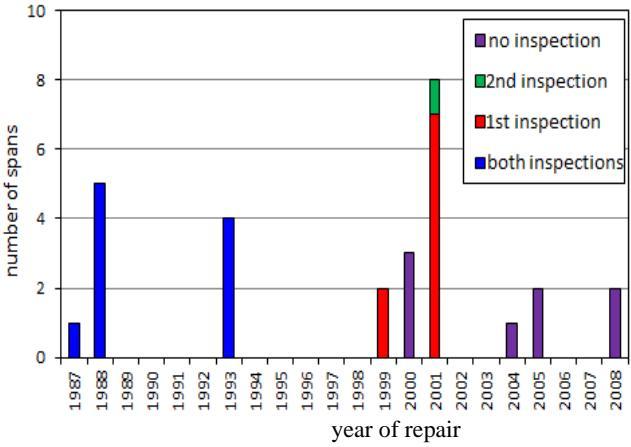
with full-length slab repair since 1987

Figure 3 shows years and the number of spans (28 in total) in which full-length slab replacement has been conducted since 1987. No yearly characteristics are seen, presumably because the work was conducted for reasons other than slab deterioration response. The color-coding of the bars in the figure is the same as that for Fig. 2.

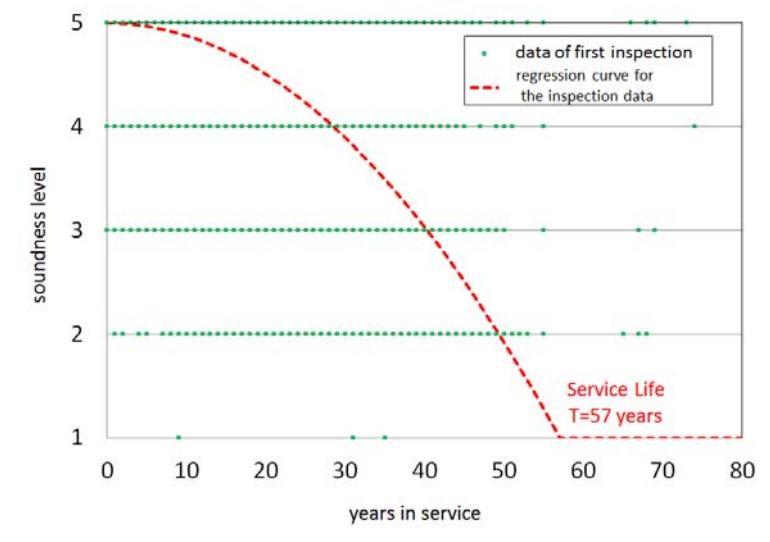
Fig. 4 Deterioration curve using the first round inspection (6,468 data)

Figure 4 shows the slab deterioration curve found from the results of the first round of inspections with data on 6,468 spans. Figure 5 shows curves found in the same way from the results of the second round with data on 6,378 spans. The green dots indicate individual data samples, and the red dashed lines were found using the least squares method on the data. The two curves show almost the same tendency.

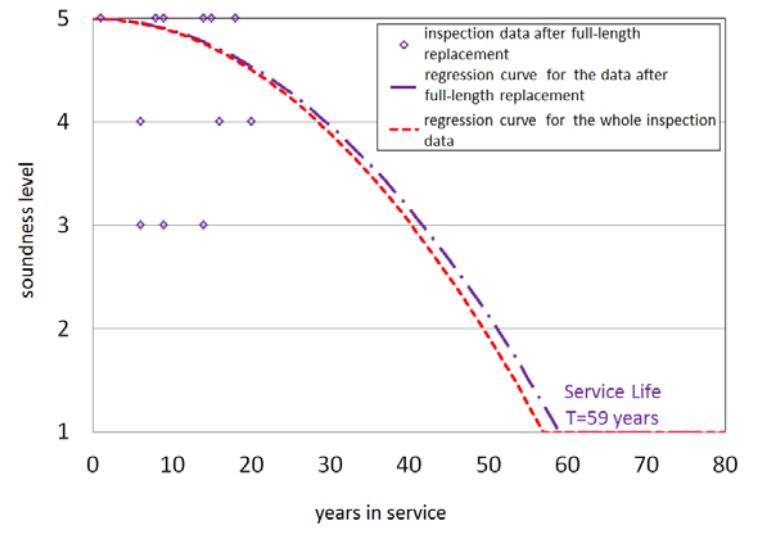
Fig. 6 Deterioration curves using the inspection data after full-length replacement (31 data)

Figure 6 shows slab deterioration curves found from the results of inspection after full-length slab replacement. The purple \diamond symbols represent inspection data; the corresponding number of spans

is 21. However, as the spans inspected in both the first and second rounds were counted twice, there were actually 31 data samples. The purple dashed-dotted lines indicate curves found using the least squares method. As seen in the figure, the lines exhibit almost the same tendency as the standard curves shown in figs. 4 and 5. This suggests that with slab repair based on full-length replacement, post-repair deterioration will show a tendency of progress similar to that of the standard slab deterioration curves.

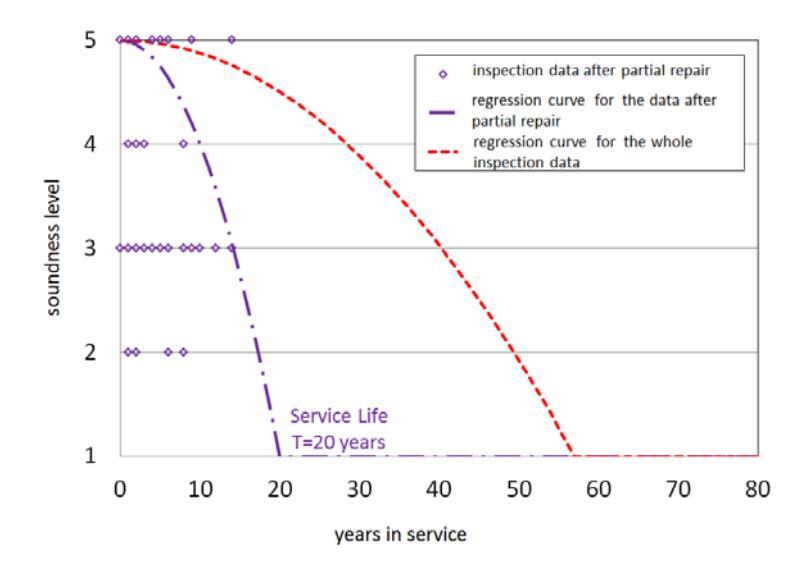
Fig. 7 Deterioration curves using the inspection data after partial replacement (177 data)

Figure 7 shows slab deterioration curves found from the results of inspection after partial repair. The purple \diamond symbols represent inspection data. The number of data samples is 177 for 132 inspected spans for the reason outlined above. The purple dashed-dotted line indicates the curve found using the least squares method. Compared to that for full-length replacement, the deterioration curve indicates a much faster rate of decline. While the number of years until the soundness level reaches 1 is approximately 57 on the standard deterioration curve, it is 20 years after partial repair (approximately a third of the standard), indicating that deterioration progresses three times as quickly.
