APPLICATION OF DETERIORATION MONITORING SYSTEM TO CONCRETE SUPERSTRUCTURE OF OPEN-TYPE WHARF

E. KATO^{1*}, Y. KAWABATA¹, and M. IWANAMI²

¹ Structural Mechanics Group, Port and Airport Research Institute, Japan ² Department of Civil Engineering, Tokyo Institute of Technology, Japan

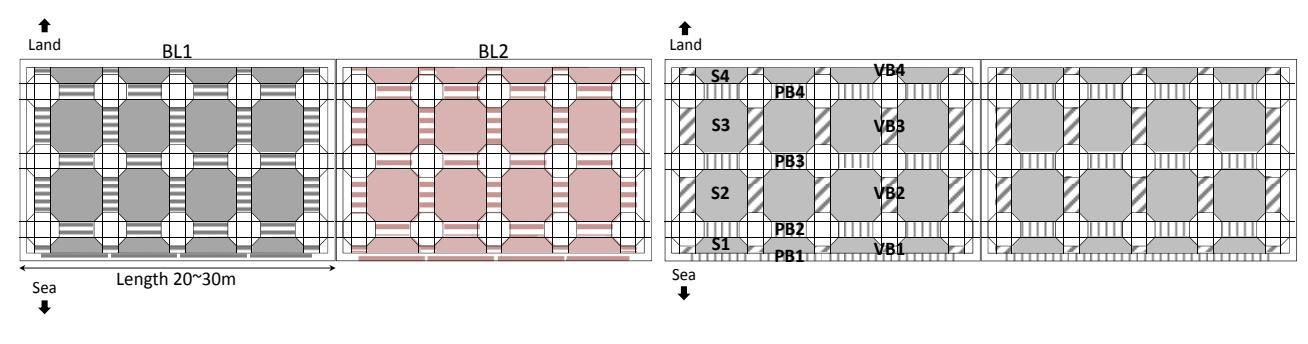
In general, maintenance work on the superstructure of an open-type wharf is carried out on each block; that is, the deterioration rates of RC beams and slabs are evaluated in each block as shown in Figure 1a). In this study, the deterioration rate at each relative location in a superstructure, as shown in Figure 1b), was evaluated in addition to the representative deterioration rates of RC beams and slabs for each block. RC members were classified into three types, parallel beams against face line (PB), vertical beams against face line (VB), and parallel slabs against face line (S). The relative location of the RC member from the face line was indicated by number. For example, PB2 is a beam located in the second parallel line from the face line.

a) General evaluation

b) Evaluation in this study

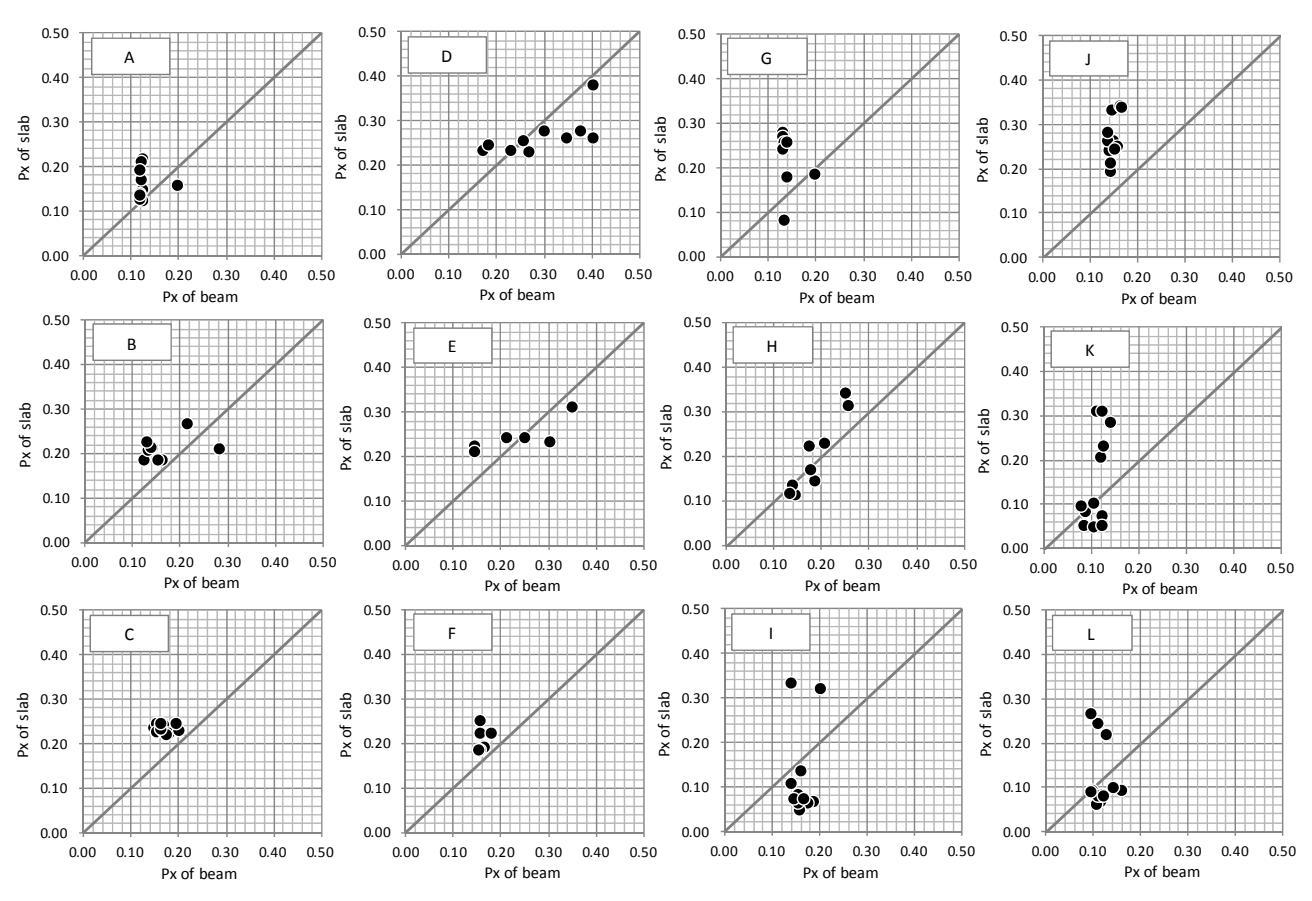
Figure 2: Deterioration rate of RC beams and slabs

Figure 2 shows the deterioration rates of RC beams and slabs in all blocks of each structure. X and Y axes show the deterioration rate of RC beams and that of RC slabs, respectively. When the deterioration rate of RC beams is equal to that of RC slabs in a block, that data is plotted on the straight line shown in Figure 2. In comparing the deterioration rates of RC beams and those of RC

slabs, almost all plots are on the line in C, F and H; that is, the deterioration rates of RC beams and those of RC slabs in each block were roughly the same in those structures, respectively. In A, B, G, J and K, deterioration rates of RC beams were smaller than those of RC slabs in almost all blocks in each structure. In D and E, deterioration rates of RC beams were widely distributed compared with those of RC slabs. Whether the deterioration rate of RC beams and that of RC slabs becomes higher was not easily evaluated. It could be concluded that the priority of applying the deterioration monitoring system should not be determined by the type of the RC member, beam or slab.

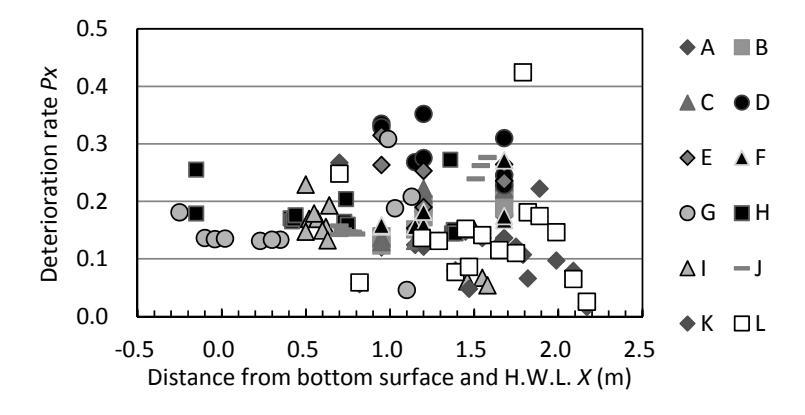
Figure 3: Deterioration rate vs. distance from bottom surface and H.W.L.

Figure 3 shows the relationship between deterioration rates of RC members and distance from the bottom surfaces of RC members to H.W.Ls. in each structure. In general, When the type (PB, VB and S) and the relative location from the face line (indicated by number) are the same, the distance from bottom surface and H.W.L. are equal in those RC members. Hence, deterioration rates in Figure 3 show those at each relative location in each superstructure, respectively. Figure 3 clearly shows that deterioration rates were not directly related to the distances from the bottom surfaces of RC members to H.W.Ls. Deterioration grade was judged from the appearance of the concrete surface caused as a result of corrosion of reinforcing bars due to chloride attack. This result

indicates that the deterioration rate doesn't necessarily become high by increasing the chloride ion supply to concrete surface. It could be concluded that the priority of applying the deterioration monitoring system should not be determined by the distance from the bottom surface and H.W.L. of the RC member.

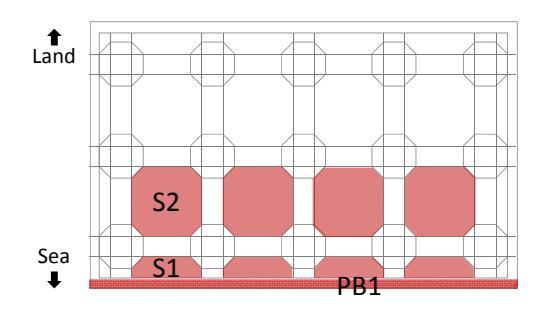
Figure 4: RC member with higher deterioration rate

In this study, it was found that it was possible for PB1, S1 and S2 (shown in Figure 4) to have a higher deterioration rate than other RC members. Therefore, the priority of the deterioration sensor installation in a superstructure of an open-type wharf becomes higher at those RC members. The symptoms of deterioration in a superstructure will be efficiently detected by applying the deterioration monitoring system to those RC members. As a result, remedial measures, such as performing detailed inspection and repair work, can be planned in the early stage of deterioration process. Generally, the earlier appropriate repair work is performed, the higher its effect will be and, in turn, the higher becomes the possibility of cost-effective maintenance implementation on an open-type wharf.

- 1. Type and relative location of RC member must be considered in the prioritization of applying the deterioration monitoring system.
- 2. The first sea-side parallel beam, the first and the second sea-side slabs should be monitored to detect symptoms of deterioration in a superstructure.
