CFRP LAMINATES TO STRENGTHEN REINFORCED CONCRETE FLAT SLABS AGAINST PROGRESSIVE COLLAPSE

Kai Qian^{*}, and Bing Li

ABSTRACT

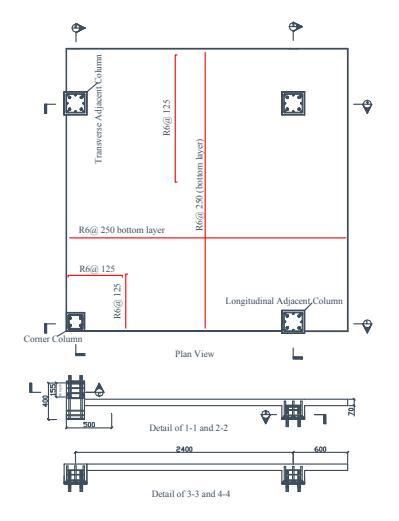
Fig. 1: Dimensions of the test specimens

The Control Specimen C was designed in accordance with ACI-08 (2008). The dead load of the prototype structure due to 210.0 mm thick slab was 5.1 kPa. The additional dead load was assumed to be 1.0 kPa. The equivalent additional dead load due to the weight of in-fill walls was 2.25 kPa. The live load was assumed to be 2.0 kPa. One-third scaled substructures were cast and tested in this study. For detail derivation, please refer to Qian and Li (2012a). Fig. 1 illustrates the dimensions and reinforcement details of the Control Specimen C. As shown in the figure, one corner column stub, three enlarged columns and a slab with 70 mm thickness were cast monolithically. The column stub in the corner represented the remnants of a removed column. The size of the corner stub was 200 mm × 200 mm. The size of the remaining columns was 250 mm× 250 mm. It was enlarged to prevent damage occurring in these columns and to ensure equivalent fixed constraints applied on these columns. The slab reinforcement in the middle strip comprised of R6 rebar at 250.0

mm in two layers at the top and bottom whereas the column strip was composed of two layers of R6 rebar spaced at 125.0 mm and 250.0 mm at the top and bottom, respectively. Moreover, reinforcements were installed in the slab-corner column connection to prevent or delay possible brittle failure of the specimen within the small deformation stage due to punching shear.

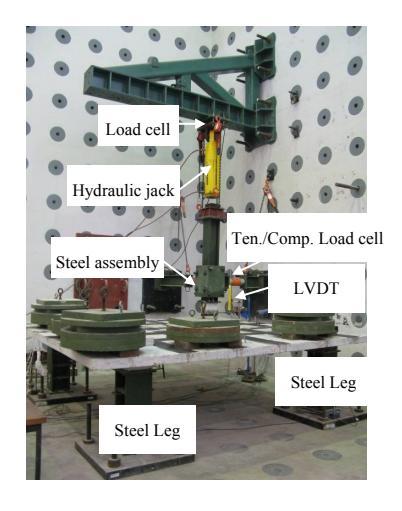
Fig. 2: A CFRP strengthened specimen ready for test

A schematic of the experimental setup is shown in Fig. 2. A hydraulic jack was utilized to apply vertical displacement on the corner stub. It should be noted that the loading process was force-controlled before the specimens reaching their first peak capacities. After that, a displacement-controlled loading process with 10 mm interval was applied. Vierendeel action can be characterized by relatively vertical displacement between slab-column connections and double curvature deformations of column strips and columns. In order to equivalently simulate Vierendeel action applied on the test specimens or create positive bending moment (tensile at bottom) at the column strip near the corner column, a steel assembly was specially designed. For the detailing of design of the steel assembly, please refer to Qian and Li (2013b). Furthermore, three steel legs were utilized to support the specimens and to provide equivalent fixed support conditions on the adjacent and interior columns. Finally, in order to partially simulate the influence of the continuity of the slabs on the overall performance, the slab was extended beyond the fixed-support by one-fourth of the span in both directions. Five steel weight assemblies were applied on the extended part of the slab to simulate the influence of the continuity of surrounding slabs on the response of the specimens.

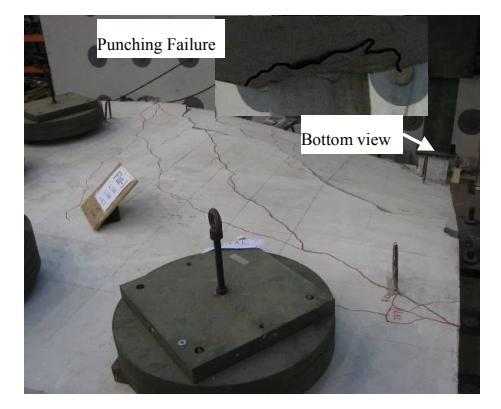
The failure mode of Control Specimen C is shown in Fig. 3. As shown in the figure, severe diagonal cracks passed through the center of the slab. Flexural cracks were not only observed in the top face of the slab near the adjacent column, but also in the bottom face near the corner column due to Vierendeel action. No damage was observed at the corner column. For detailed description of the failure modes and crack pattern development, please refer to Qian and Li (2013b).

Fig. 3. Failure modes of Control Specimens C

The failure modes of control specimens (refer to Fig. 3) had indicated that severe flexural cracks were observed in the top slab-adjacent column interfaces and bottom slab-corner column interfaces. Thus, in order to upgrade the resistant capacity of the flat slabs, the flexural strength of the column strips should be strengthened. As shown in Fig. 5, one layer of CFRP L-wrap (Step 1 in Fig. 5a) was applied at each slab-column interface. The CFRP sheet was bent at 90 degrees and thereafter extended 50 mm along the column and 540 mm along the slab. Although the theoretical width of the flange of the slab is four times of the slab depth (Park and Paulay 1975), the width of 225 mm and 200 mm was selected for CFRP L-wrap near the adjacent column and corner column respectively for easy connection with the columns. The length of the CFRP L-wrap (540 mm) along the slab was designed to coincide with the cut-off point of the slab top reinforcement. 0.3 times of the clear span, as recommended in ACI-08 (2008). Then, a CFRP L-wrap along the slab and delay the debonding of CFRP L-wrap at the slab-column interfaces. It should be emphasized that both top and bottom faces of the column strips were flexurally strengthened as the flat slabs not only had possibility of losing corner columns, but also had possibility of losing exterior or interior columns.

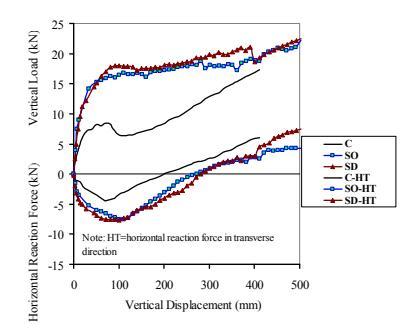
The vertical load-displacement curves of test specimens are shown in Fig. 4. As seen from the figures, significantly tensile membrane action was observed in the load-displacement curve at large displacement stage. It should be noted that punching failure was observed in the slab-corner column connection. However, the punching failure did not prevent the development of tensile membrane action may be due to 'Hanging Effects' by bottom integrity reinforcement.

Fig. 4: The vertical load versus the vertical displacement of the test specimens

The failure modes of Strengthened Specimens SO and SD are shown in Figs. 6a and 6b, respectively. The failure of strengthened specimen is controlled by de-bonding of CFRP strips. As shown in Fig. 4, the Strengthened Specimen SO had its first peak capacity, initial stiffness, peak tensile membrane action, and dynamic ultimate strength increased by 97.7 %, 77.6 %, 28.9 %, and

74.0 % respectively compared with the Control Specimen C. However, for Strengthened Specimen SD, the first peak capacity, initial stiffness, peak tensile membrane action, and dynamic ultimate strength were increased by 111.8 %, 90.3 %, 30.1 %, and 82.0 % respectively. It should be noted that the initial stiffness was defined as the secant stiffness at the first yield strength in this study.

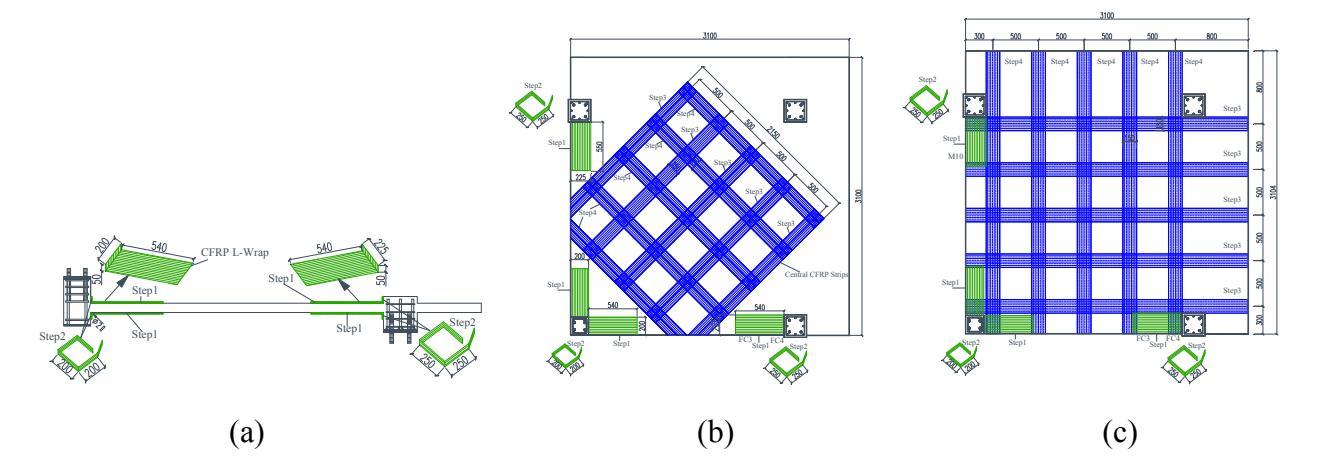
It should be noted that severe diagonal cracks were observed in the center slab as no top reinforcements were installed in the center of the slab. Thus, flexural strength of the center slab also had to be strengthened for reducing the crack width and increase the resistant capacity. For strengthening Scheme 1 (SO), the flexural strength of the center slab was strengthened via externally bonded orthogonal (0-90 degrees) CFRP strips with 150 mm width on the top face of the slab (refer to Fig. 5b). For strengthening Scheme 2 (SD), as shown in Fig. 5c, CFRP strips with 150 mm width were diagonally (45-135 degrees) bonded on the top face of the slab. It was understandable that Scheme 1 (0-90 degrees) was an easier application compared to the Scheme 2 (45-135 degrees).

Fig. 5: Proposed strengthening schemes: (a) elevation view of strengthening of column strips, (b) plan view of strengthening scheme 1 (SO), (c) plan view of strengthening scheme 2 (SD)

- 3. The failure of the strengthened specimens was mainly due to debonding of the CFRP laminates and severe cracks concentrated in the cutoff point of the CFRP sheets and strips. To increase the effectiveness of strengthening, it is suggested that fiber anchors or other mechanical anchors be applied to CFRP laminates and to apply continual CFRP sheets (Step 1 in Fig. 5a) for column strip retrofitting and continual central CFRP strips (Step 3 in Fig. 5c) for central slab retrofitting in real practice.

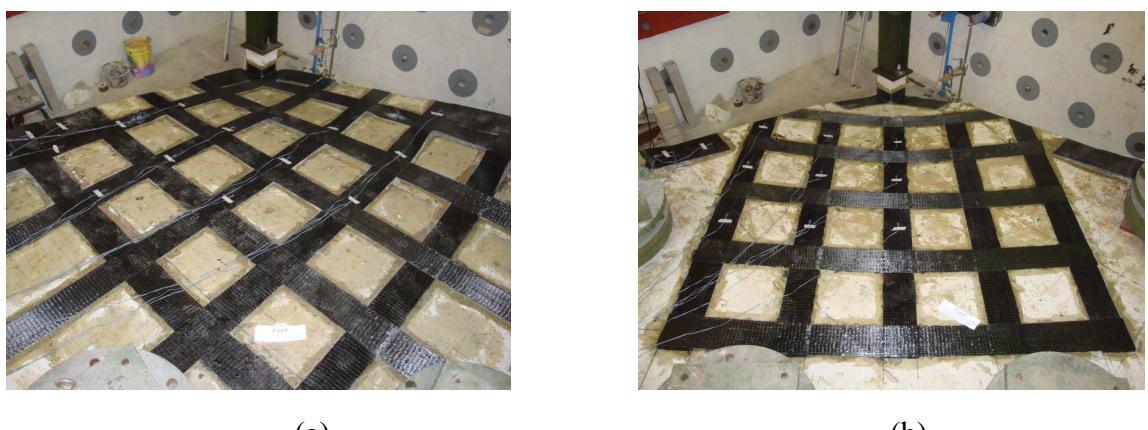
Fig. 6: Failure mode of strengthened specimens: (a) SO, (b) SD

Comparing the performance of SD with that of SO, it can be seen that SD generally performed slightly better than SO. This was possibly due to the central CFRP strips were placed directly perpendicular with the diagonal crack (along the principal tensile stress) in Scheme 2 (45-135 degrees). As explained in above, theoretically, Scheme 1 (0-90 degrees) could increase the bending moment capacity similar as Scheme 2 (45-135 degrees). In reality, the interaction of the orthogonal strips could possibly jeopardize the effectiveness.
