Effect of Temperature Gradient in Ash on High-Temperature Corrosion of Super-Heater Material in a Waste Power Generation Boiler

T. Furugaki, H. Takahashi, S. Hayashi

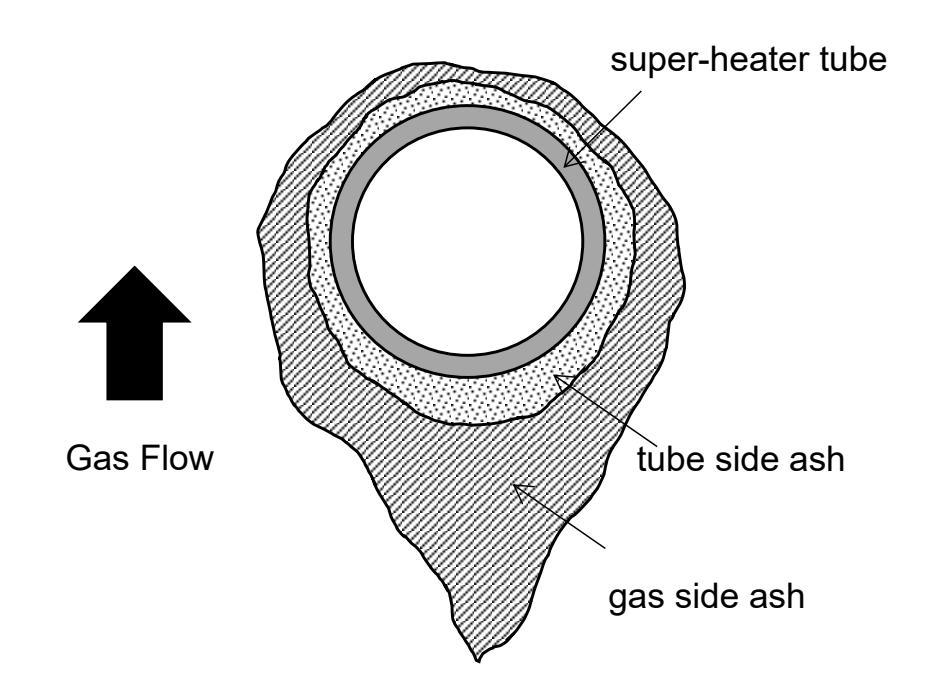
Figure 1 Schematic cross-section of combustion ash deposited on super-heater tube

In this study, combustion ash deposited on the surface of super-heater tubes in an actual waste incineration boiler was used in the corrosion tests. Figure 1 shows a schematic cross-section of the combustion ash deposited on a super-heater tube, and Table 2 shows the composition of the combustion ash sampled at different depths of the deposit by XRF (X-ray fluorescence). The alkali chloride content in the tube side ash was much higher at 31.3 mass% in comparison to the gas side ash at 11.4 mass%. Conversely, the oxide content in the gas side ash was higher than that in the tube side ash. Of these ash samples, the tube side ash, which was rich in alkali salts and highly corrosive, was used for the corrosion tests. The melting point of the tube side ash was confirmed by TG-DTA to be 519°C.

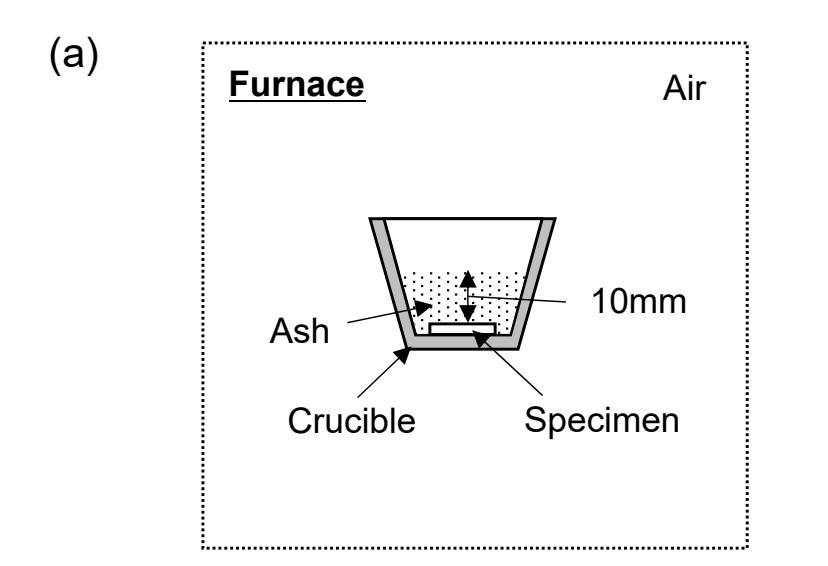
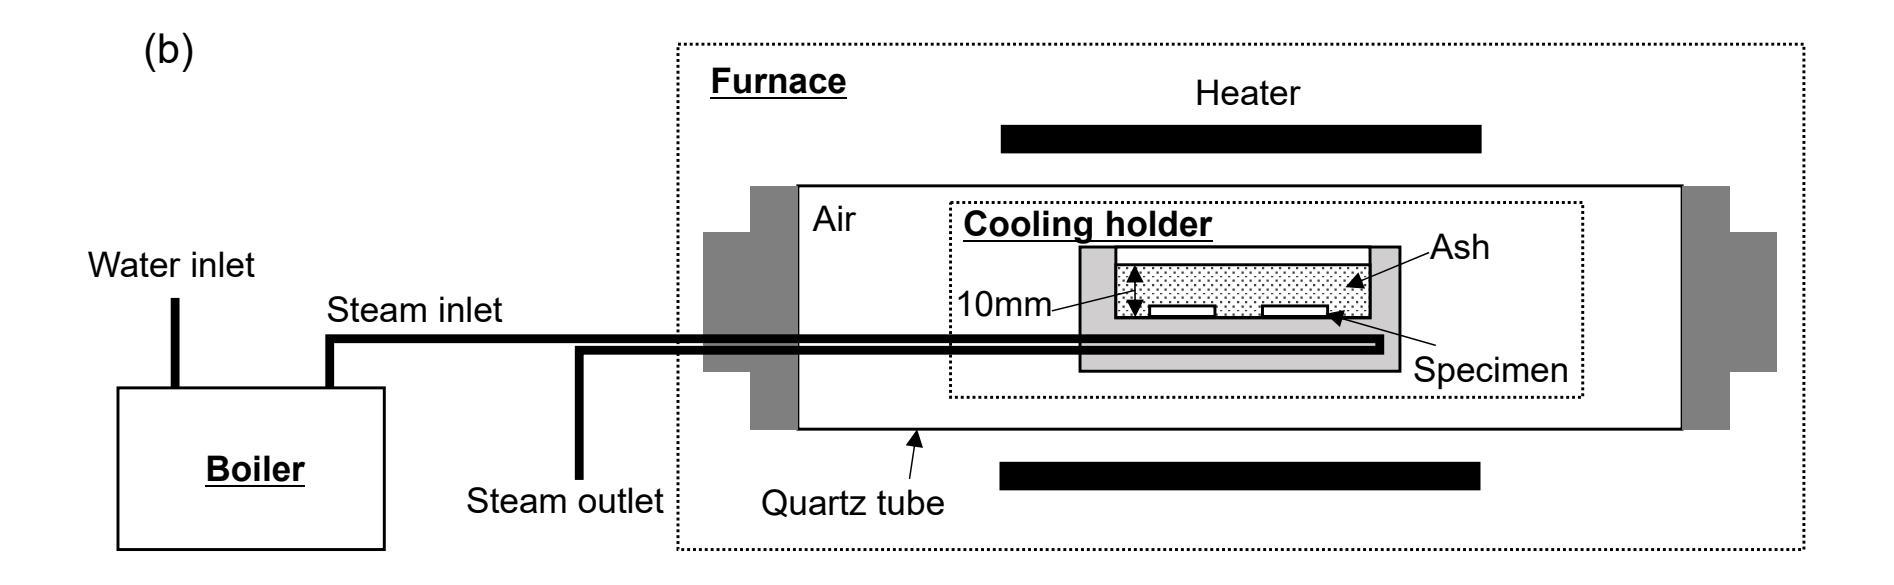
Figure 2 Schematic of corrosion equipment: (a) isothermal corrosion test, (b) temperature gradient corrosion test

Corrosion tests were performed in a furnace in air for 100 h. Tests were conducted either isothermally, where the atmosphere and specimens were set to the same temperature, or non-isothermally, i.e., the temperature of the atmosphere was set higher than that of the specimens. The isothermal corrosion tests were performed in a box furnace at 460 °C, as illustrated in Figure 2(a). The specimens were embedded in the ash at a depth of 10 mm from the ash surface in an Al_2O_3 crucible. The non-isothermal corrosion tests were performed in an open horizontal tube furnace, as illustrated in Figure 2(b). The specimens were embedded in the ash at a depth of 10 mm from the specimen holder and cooled by

feeding steam into the specimen holder. During corrosion tests, the temperature of the atmosphere was set to 685 °C and that of the specimens was set to 460 °C. The temperature was monitored by thermocouples inserted in the reaction tube and the specimen holder.

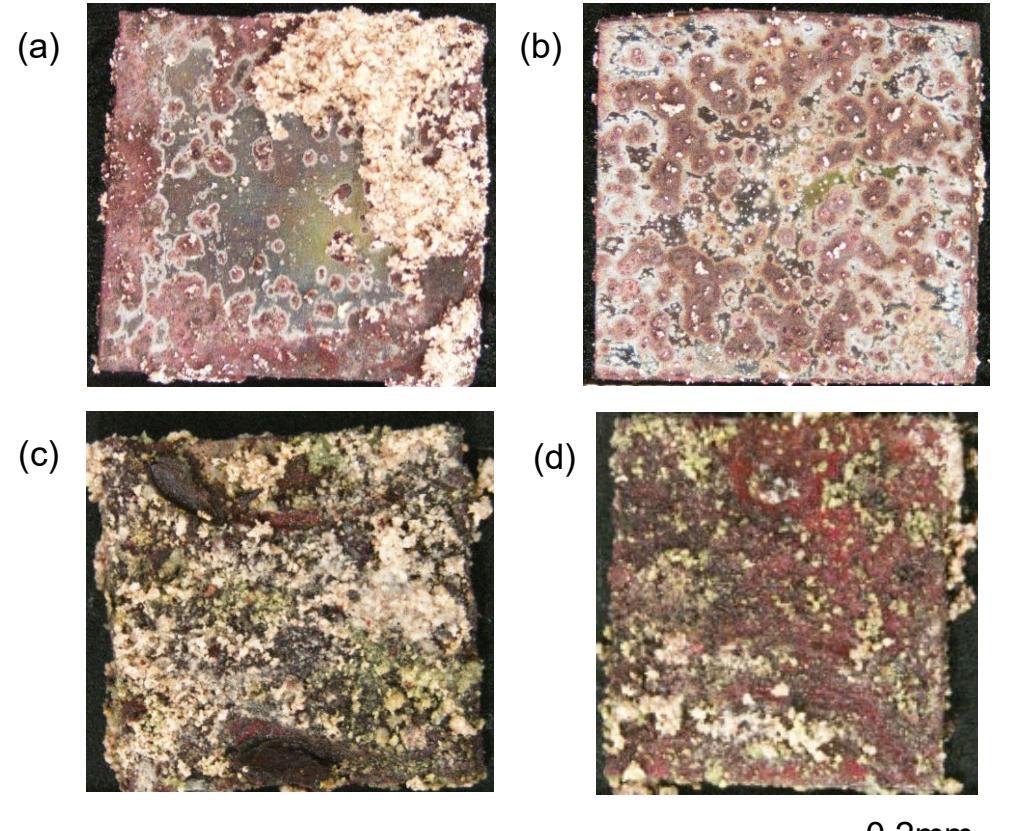
Figure 3 Surface observations of specimen after corrosion for 100 h:

(a) SUS310S after isothermal corrosion test, (b) QSX5 after isothermal corrosion test,

(c) SUS310S after temperature gradient corrosion test, (d) QSX5 after temperature gradient corrosion test

Figure 3 shows the surface appearance of the specimens after undergoing corrosion for 100 h. After the isothermal corrosion test, localized areas of the specimen surface changed to a bright brown color, and the metallic regions with interference color remained in other areas. In addition, the bright brown corroded areas appear to extend around those places where ash had accumulated. On the other hand, after the temperature gradient corrosion test, the corroded areas extended over the entire surface of the specimens with the corrosion products appearing as a dark brown color. Yellow and green colored reaction products can also be locally observed on the dark brown colored corrosion products combined with the white ash. These corrosion products are presumed to be Fe-rich oxides and Ca chromate, as described below.

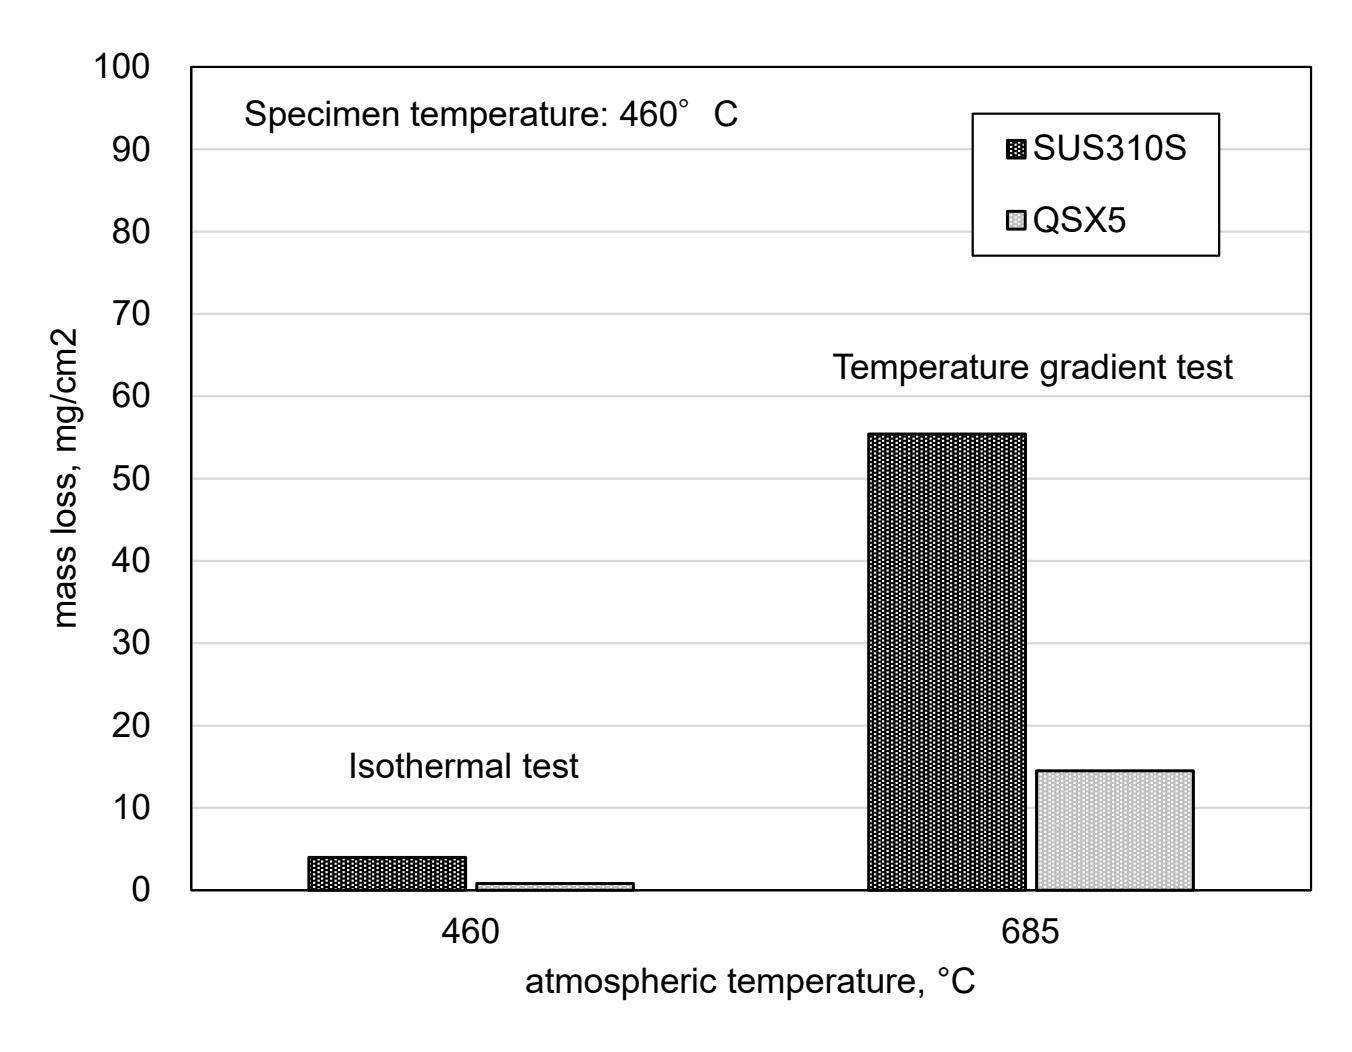
Figure 4 Mass loss after corrosion for 100 h

Figure 4 shows the mass loss of specimens after undergoing corrosion for 100 h. The corrosion mass loss of both steels was small in the isothermal corrosion test, but the mass loss of SUS310S tended to be greater than that of QSX5. However, in the temperature gradient corrosion test, it is obvious that the corrosion mass loss of SUS310S was much greater than that of QSX5, and the corrosion mass loss of both steels was more than 10 times greater than that which occurred during the isothermal corrosion test. This finding indicates that the temperature gradient in the ash accelerates the corrosion rate even though the specimen temperature is the same.

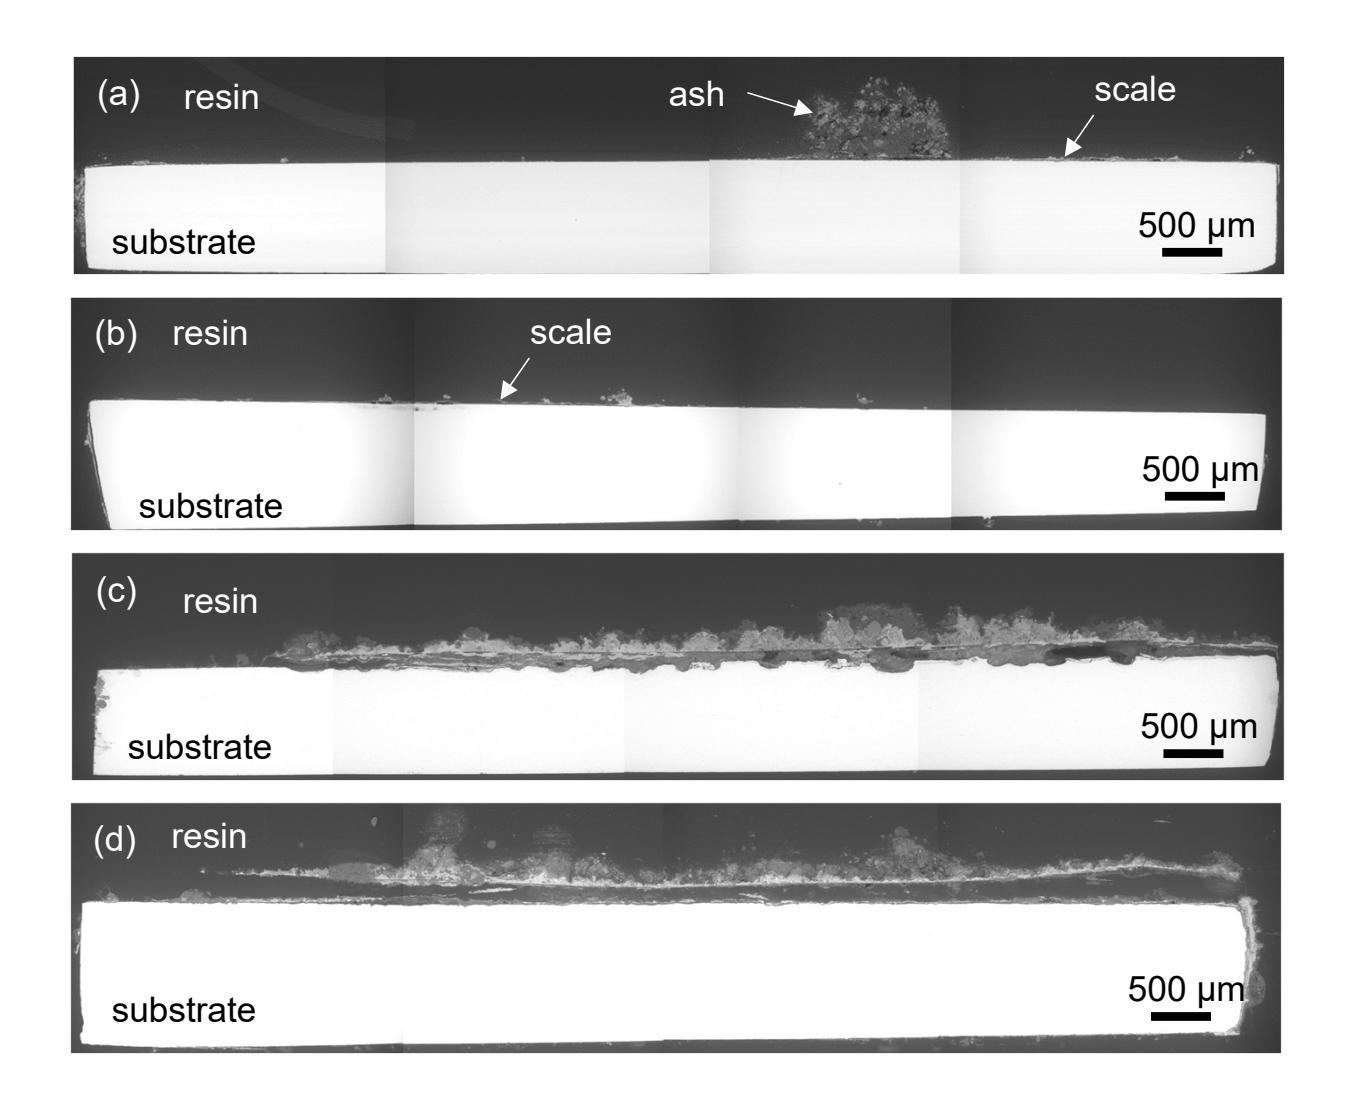
Figure 5 Cross-sections after corrosion for 100 h:

(a) SUS310S after isothermal corrosion test, (b) QSX5 after isothermal corrosion test,

(c) SUS310S after temperature gradient corrosion test, (d) QSX5 after temperature gradient corrosion test

Figure 5 shows the cross-sections of the specimens after corrosion for 100 h. A thin oxide scale formed on part of the specimen surface, but no penetration of corrosion products into the specimen can be observed following the isothermal corrosion test as shown in Figures 5(a), (b). However, almost the entire surface of both specimens became covered by a thick oxide scale following the temperature gradient corrosion test. Significant inward attack by can be observed in SUS310S and the surface of the specimen became very rough due to local penetration of corrosion products, as shown in Figure 5(c). However, such penetration of corrosion products was not clearly evident on the QSX5 specimen as shown in Fig. 5(d). This finding suggests that QSX5 has higher resistance to corrosion than SUS310S under the corrosion conditions present in this test.

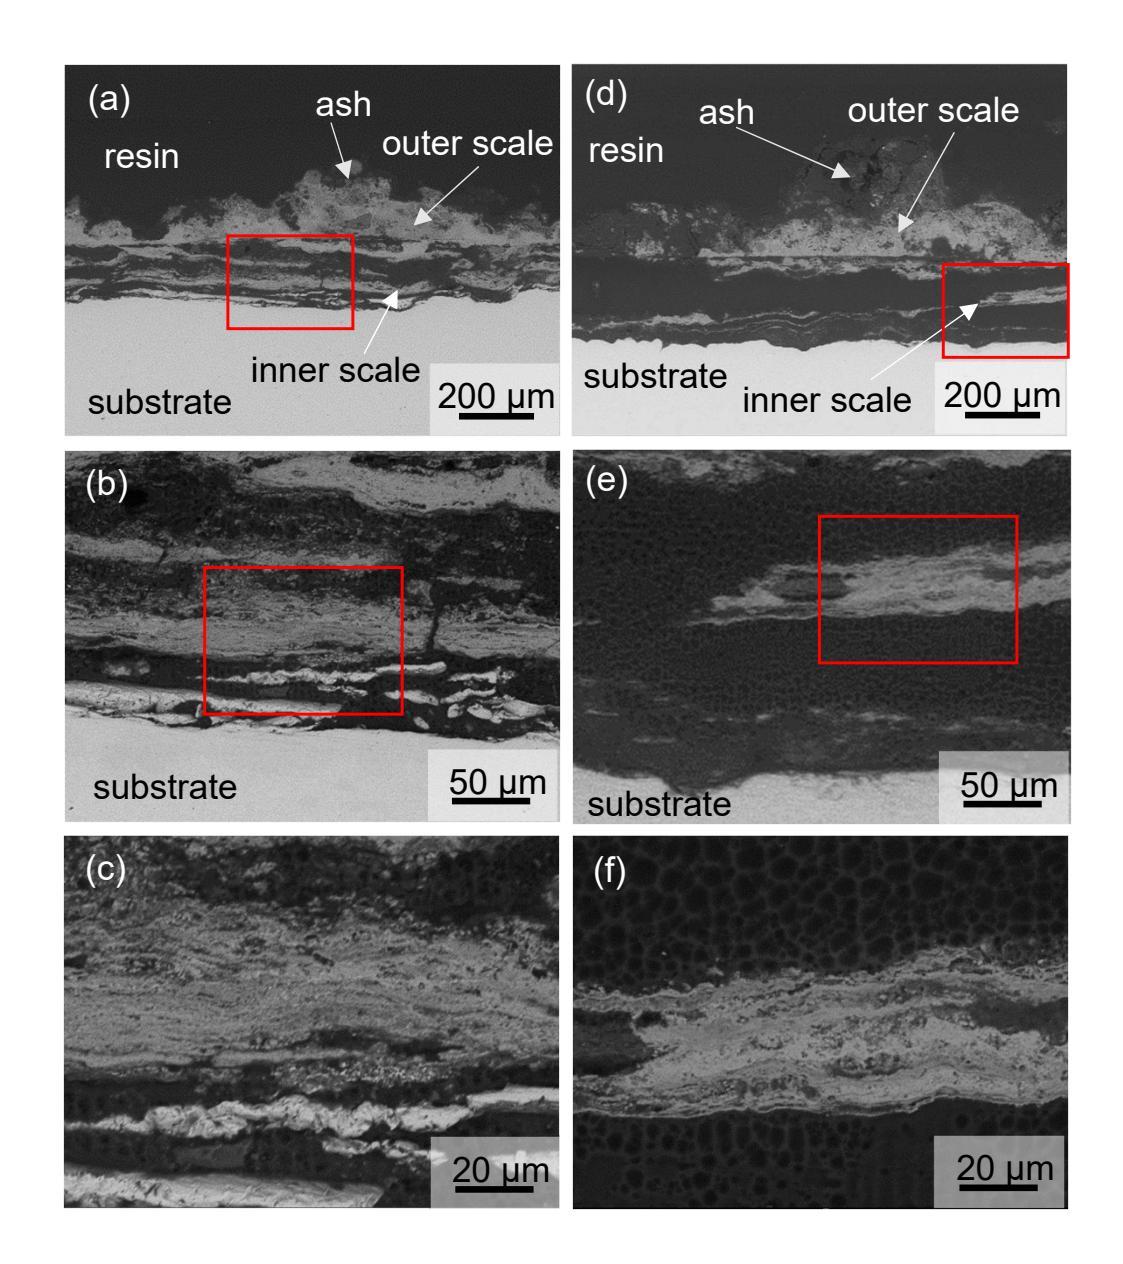
Figure 7 Cross-sections after temperature gradient corrosion test for 100 h: (a), (b) and (c) SUS310S, (d), (e) and (f) QSX5

Figure 6 shows enlarged cross-sections of the specimen following the temperature gradient corrosion test for 100 h. The scale structure was similar for both steels, and the scale formed on the steels can be divided into two parts. The outer part of the oxide scale is very porous, and the ash has been incorporated into the oxide scale. The inner part of the oxide scale has a layer-by-layer structure and appears to penetrate into the alloy substrate.

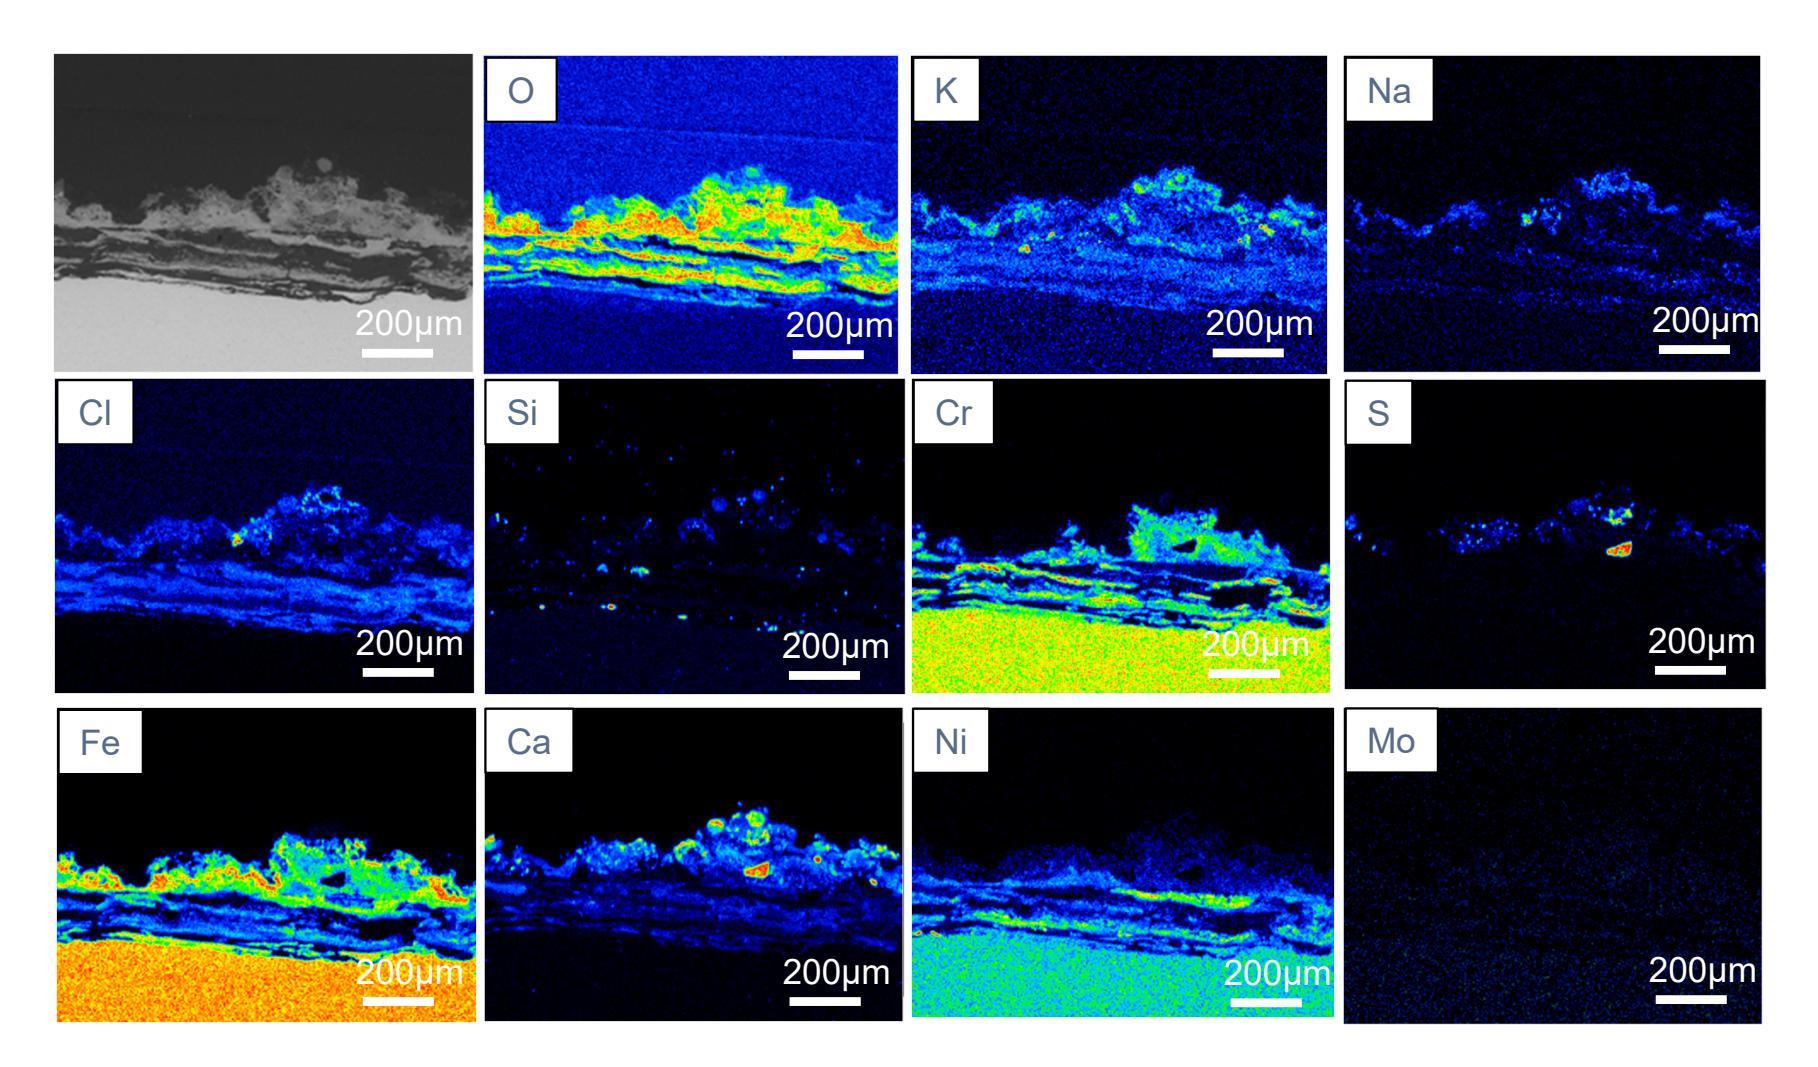
Figure 7 Elemental distribution maps of the cross-section of SUS310S after temperature gradient corrosion test

Figure 7 shows an electron probe microanalyzer (EPMA) map of each element in the oxide scale that formed on the SUS310S specimen after the temperature gradient corrosion test for 100 h. Although chlorine was detected over a wide area in the oxide scale, this might be due to contamination from the remaining ash and which occurred during polishing by oil. The regions where a strong chlorine signal was detected mainly corresponded to the ash, thus it was difficult to confirm chloride formation in the corrosion product based on this EPMA analysis. The outer porous oxide scale mainly consisted of an Fe-rich oxide and Cr is also detected in the Fe-rich oxide scale. The inner scale with a layer-by-layer structure mainly consisted of Cr-rich oxide but Ni+Fe oxides were also detected. Ca, K and Na were found not only in the ash but also in the areas of Cr oxide in the outer and inner oxide scale, suggesting that alkaline chromates had formed. Figure 8 shows the EPMA maps of each element in the oxide scale formed on the QSX5 specimen after the temperature gradient corrosion test for 100 h. The outer porous oxide scale consisted of mainly Fe-rich oxide, which contains a relatively high Ni content. Cr oxide was also observed locally below the outer Fe-rich oxide scale. Ca and Na were also detected in the inner Cr-rich oxide scale. K was mainly detected in the ash area. The inner scale with a layered structure mainly consisted of Cr-rich oxide scale of the ash area. The inner scale with a layered structure mainly consisted of Cr-rich oxide scale in the ash area. The inner scale with a layered structure mainly consisted of Cr-rich oxide, but Fe, Ni, Mo, and Si were also detected. Indistinct chlorine distribution in the oxide scale in Figure 8 could be also due to contamination during specimen preparation as mentioned above.

From the EPMA analysis results in Figs. 7, 8 and XRD in Fig. 9, the formation of chromates was confirmed. The vapor pressures of NaCl and KCl in the combustion ash at 460 °C were calculated using FactSage as $P_{NaCl} = 3.53 \times 10^{-9}$ atm and $P_{KCl} = 1.05 \times 10^{-8}$ atm, respectively. Then, the free-energy changes of K₂CrO₄ or Na₂CrO₄ formation by formulas (7) and (8) were calculated with chlorine and oxygen potential in the atmosphere, P_{Cl2} (T = 460°C, in the atmosphere) = 8.1×10⁻⁹ atm and P₀₂=0.2 atm as $\Delta G_{K2CrO4} = -18$ kJ, and $\Delta G_{Na2CrO4} = -26$ kJ, respectively.

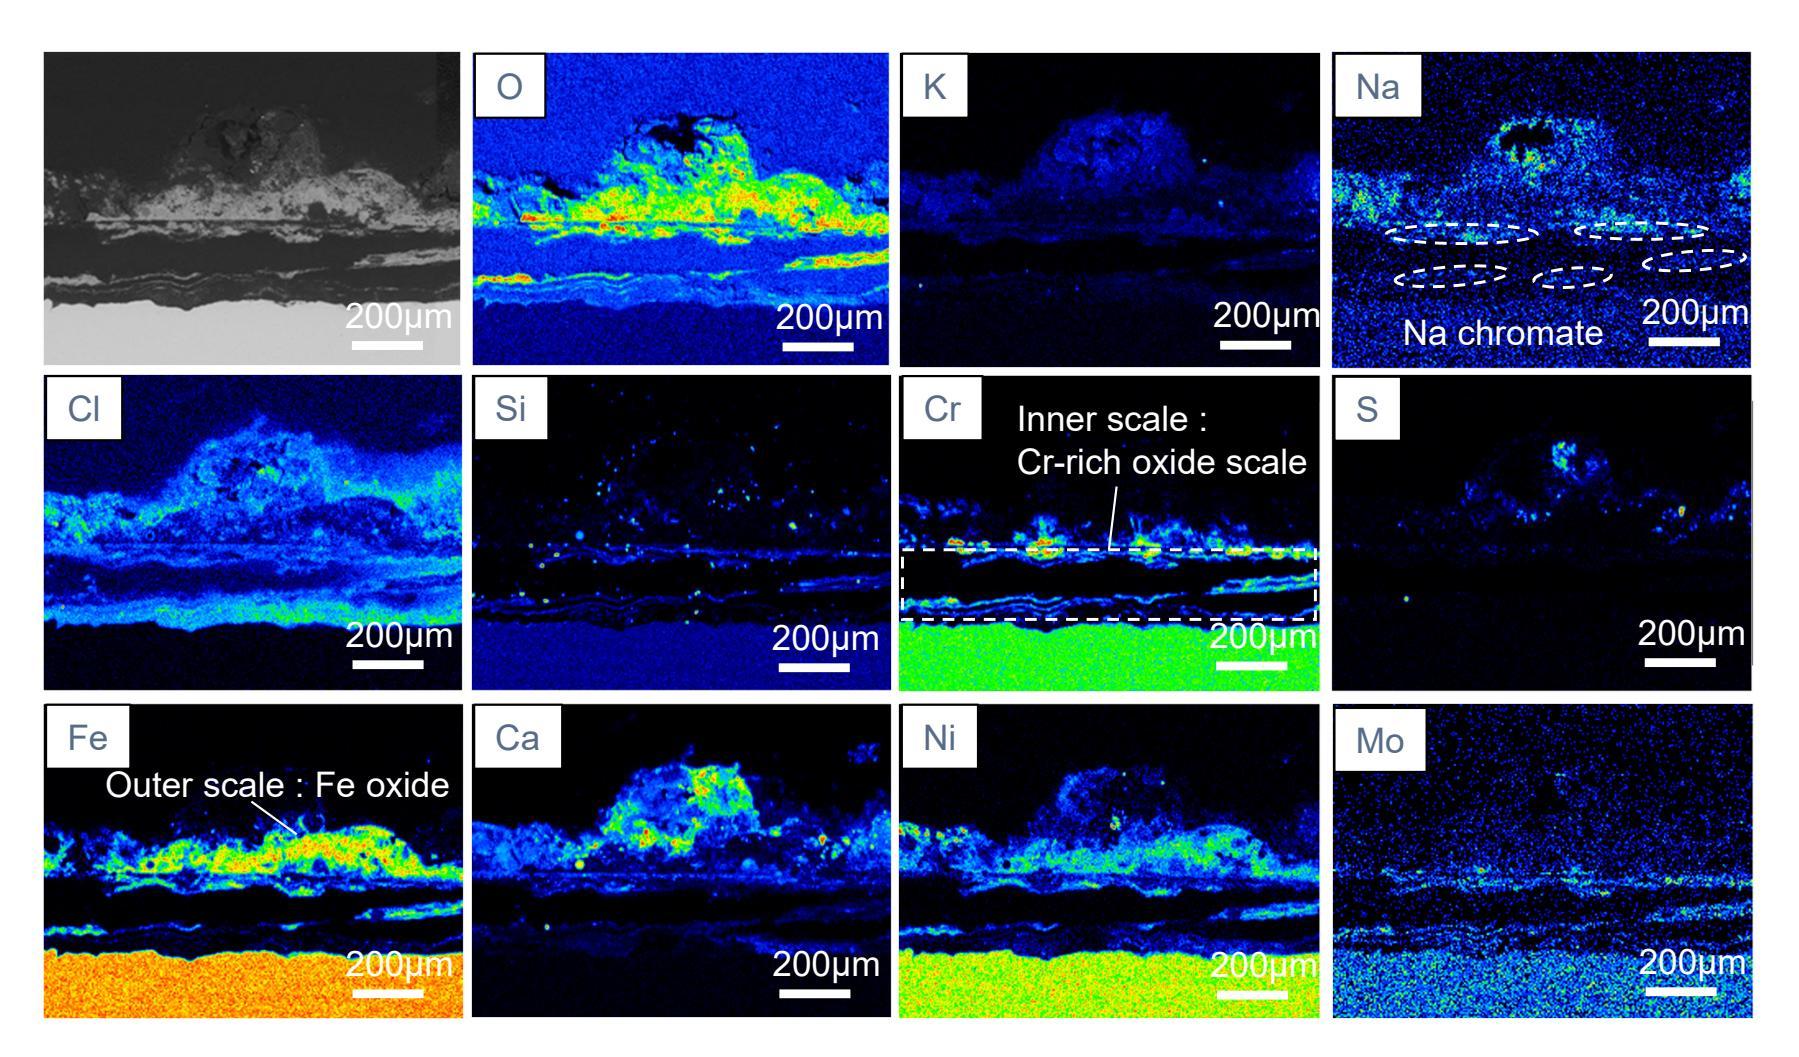
Figure 8 Elemental distribution maps of the cross-section of QSX5 embedded in the tube side ash after corrosion

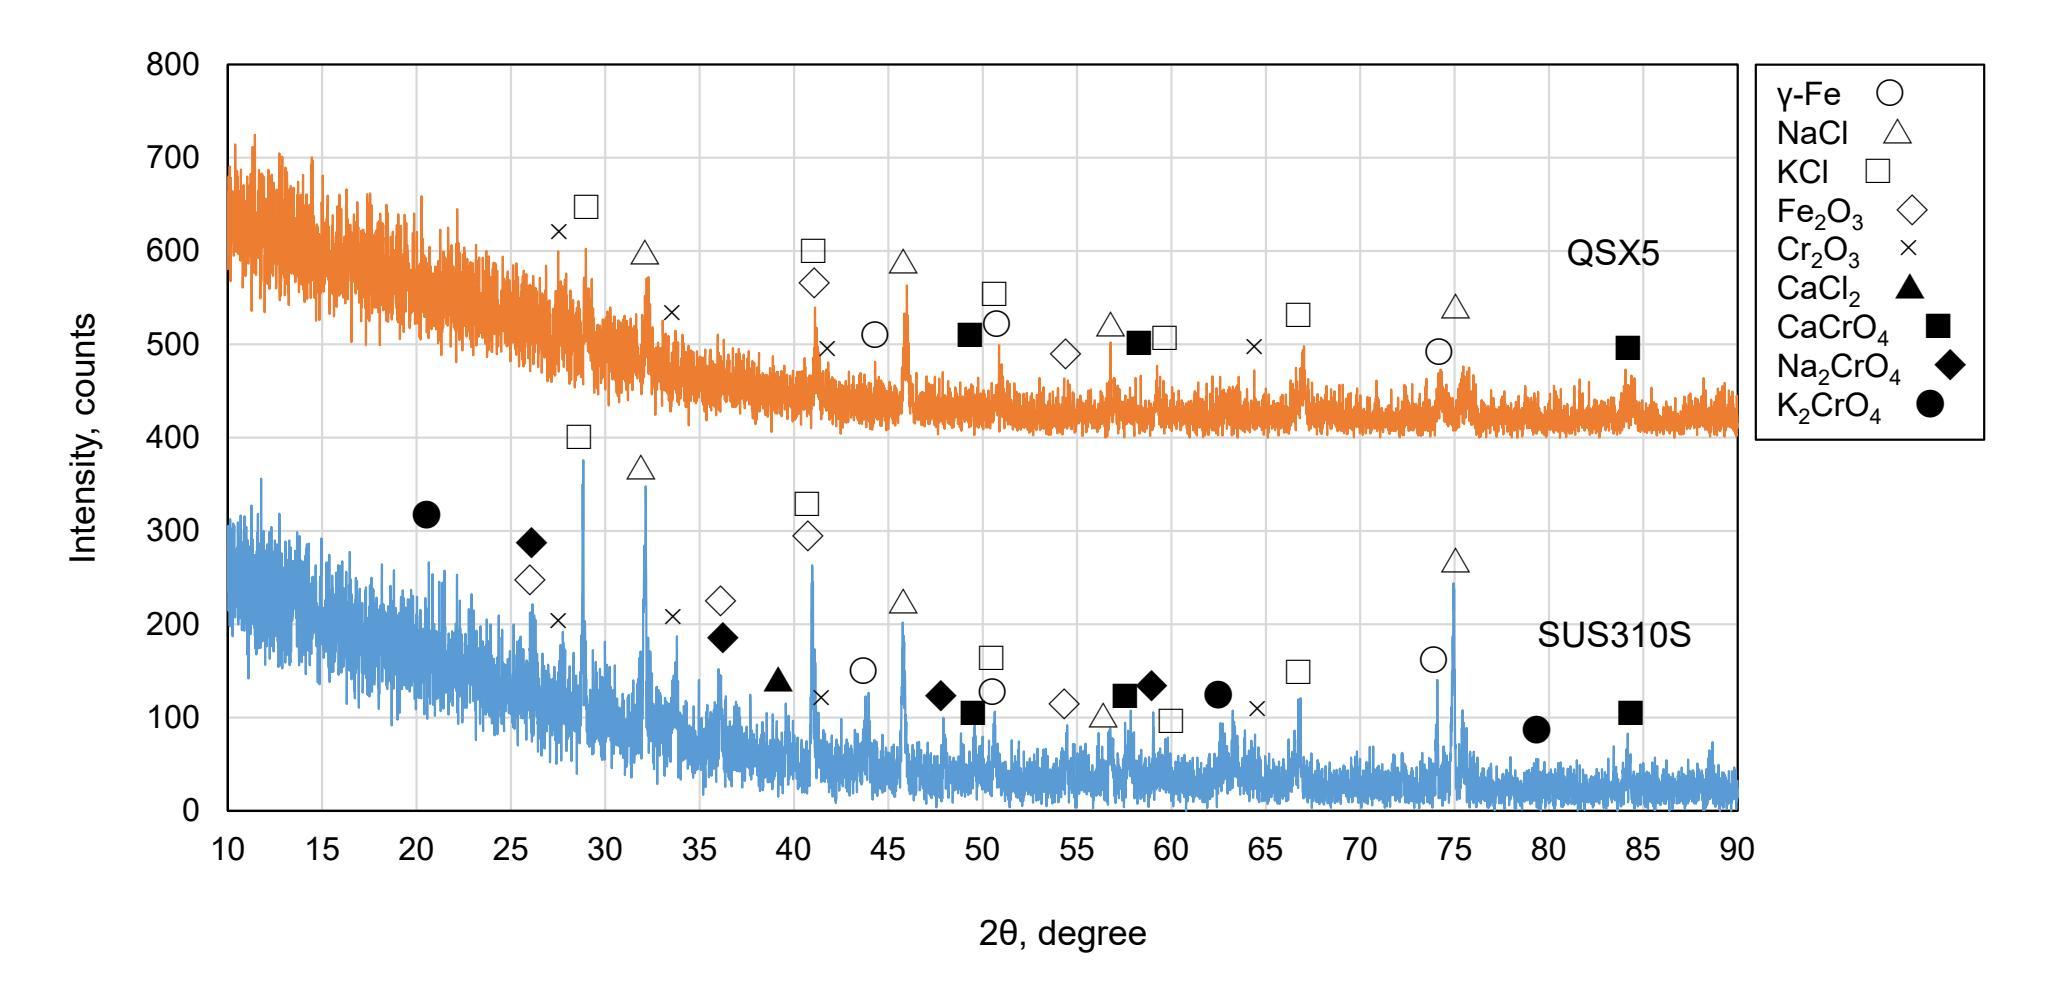
Figure 9 X-ray diffraction profiles of SUS310S and QSX5 after 100h of temperature gradient corrosion

Figure 9 shows X-ray diffraction patterns of the SUS310S and QSX5 specimens after the temperature gradient corrosion test for 100 h. In the case of the SUS310S, γ -Fe from the substrate, Fe₂O₃, and Cr₂O₃ were identified from the main scale component, and Na, and Ca chromates, which were confirmed by EPMA, were also identified but K chromate was not detected. γ -Fe, Fe₂O₃, Cr₂O₃, Ca chromate, and the ash components NaCl, and KCl were also identified in the QSX5 specimen, however, Na and K chromates were not found even though they were detected by EPMA. It is possible that the amounts of those corrosion products formed on the QSX5 specimen were too small to be detected by conventional XRD.

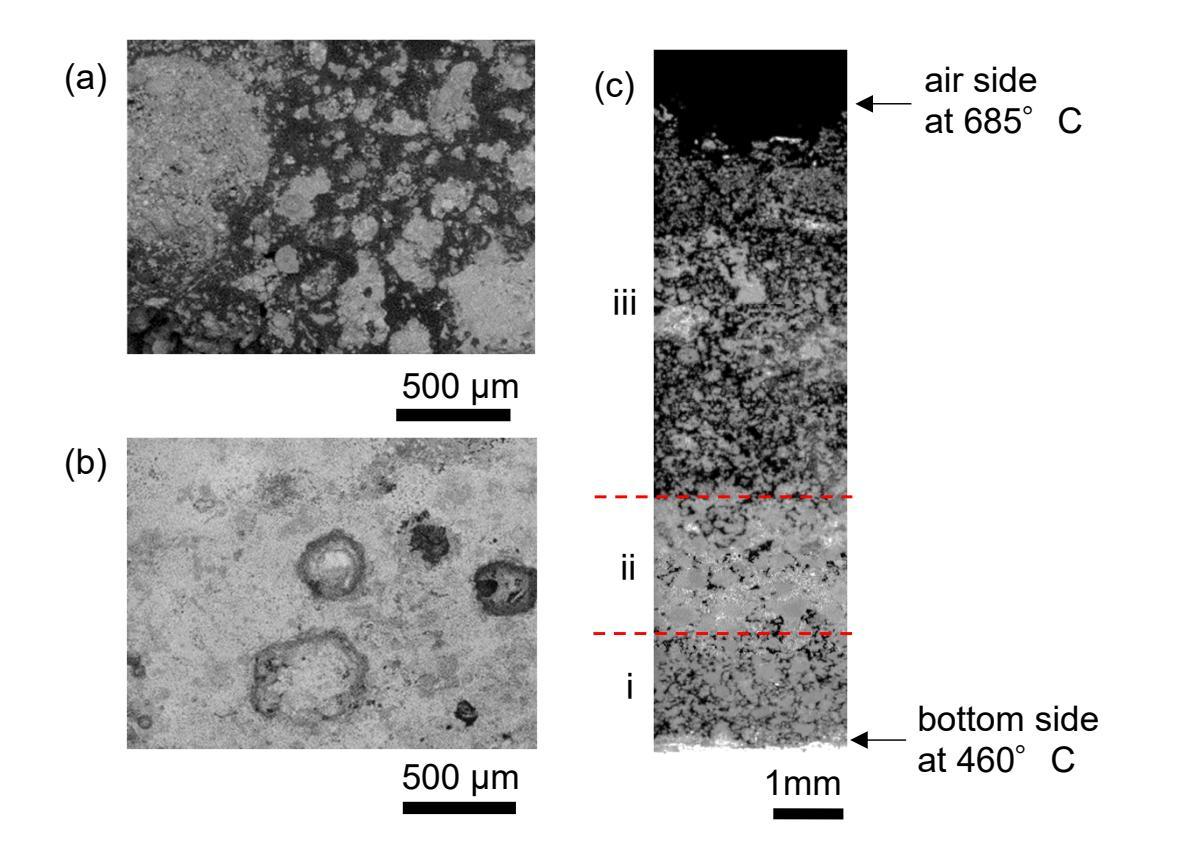
Figure 10 Ash cross-sections:

(a) non-heating,

(b) after heating with lid at 685 ° C in air

(c) after temperature gradient corrosion test

Figure 10 shows cross-sections of the ash. The first (a) shows a non-heated cross-section, the second (b) after being heated

in a crucible with a lid at 685 °C for 2 h, and the third (c) after the temperature gradient corrosion test for 100 h. The ash before heating consisted of different sized particles and components with bright contrast were dispersed in the particles. After heating at 685 °C for 2 h, the ash became dense due to partial melting. As shown in Figure 11, the Cl concentration in the heated ash was increased to about 41%, which is higher than that of that non-heated ash, 25.5%, which might be due to densification of the ash. The ash cross-section after the temperature gradient corrosion test showed a three-layered structure in the depth direction. In region 1 on the specimen side (bottom), the ash contrast was bright and porous, but the ash became dense in region 2, which was similar to heated ash at 685 °C for 2 h, and bright contrast precipitates were present. The ash in the region 3 (atmospheric side) was porous and similar to that of non-heated ash. Figures 11 and 12 show the concentration distributions of Ca, Na, K, and Cl and the temperature distribution of the ash in the depth direction after the temperature gradient corrosion test. The concentration of K, Na, and Cl is highest in region 2. The Cl concentration in regions 2 and 1 was higher than that of non-heated ash. However, the concentrations of Na, K, and Cl in region 3 gradually decreased towards the ash surface. Because the concentration of Ca was almost constant across the ash deposition, most of the alkali salts diffused from the melted region 2 as a vapor in both the surface and bottom directions. The vapor of salts diffused to the ash surface should be lost to the atmosphere during a corrosion test. However, the vapor of alkali salts diffused inwardly to the bottom side, the temperature of which is lower than the melting point, and this might contribute to the acceleration of the steel corrosion rate.

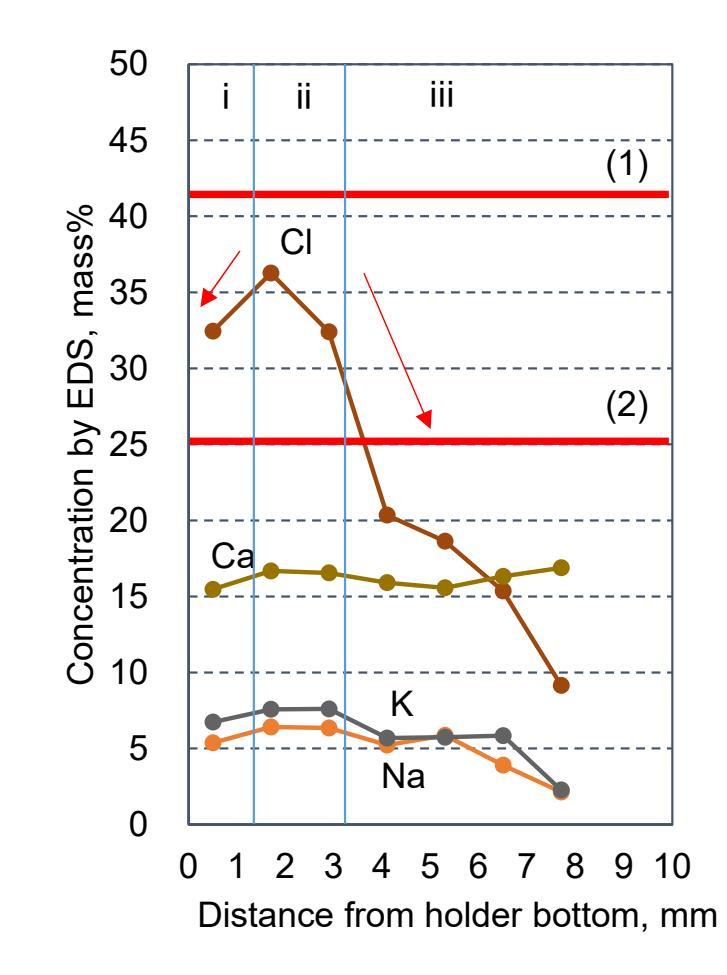
Figure 11 Cross-sectional concentration distribution of ash by EDS after temperature gradient corrosion test

- (1) Cl concentration at 685° C with lid for 2h
- (2) Cl concentration on non-heating

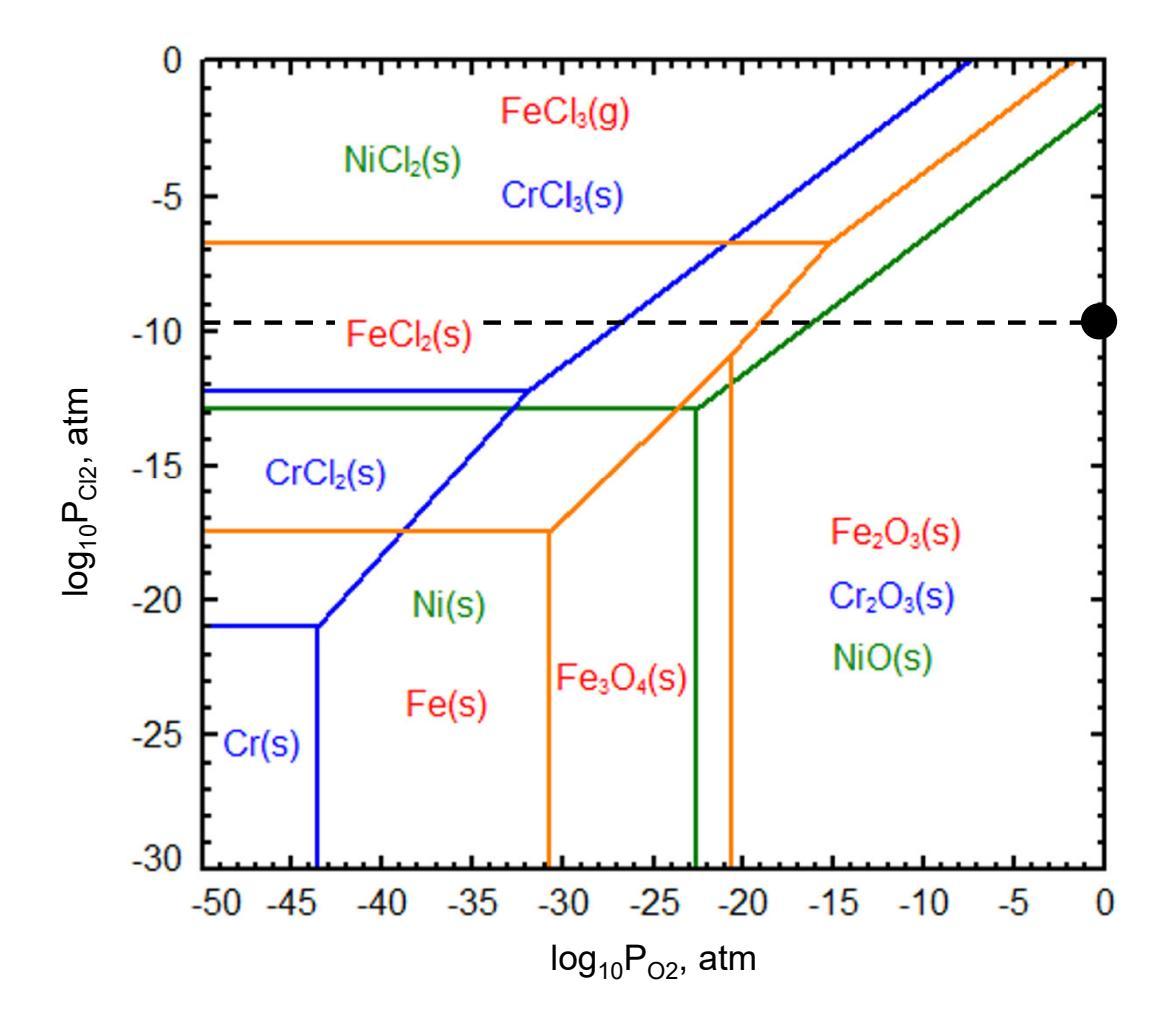
Figure 13 Quasi-stability diagram for the Fe-25Cr-20Ni system at 460°C with $a_{Fe} = 0.62$, $a_{Cr} = 0.28$, $a_{Ni} = 0.11$, $P_{O2} = 0.2$ atm

Figure 13 shows phase stability diagrams of Fe-Cl-O, Cr-Cl-O, and Ni-Cl-O at 460 °C. Fe, Cr, and Ni in Figure 13 were calculated from the activity of those elements in the Fe-25Cr-20Ni alloy using FactSage software. The chloride

region in the figures includes a gas phase having a vapor pressure of 10^{-4} atm or more. The equilibrium chlorine potential when the combustion ash was held at 460 °C in the air is given by Formula (1) from the calculation using the FactSage software.

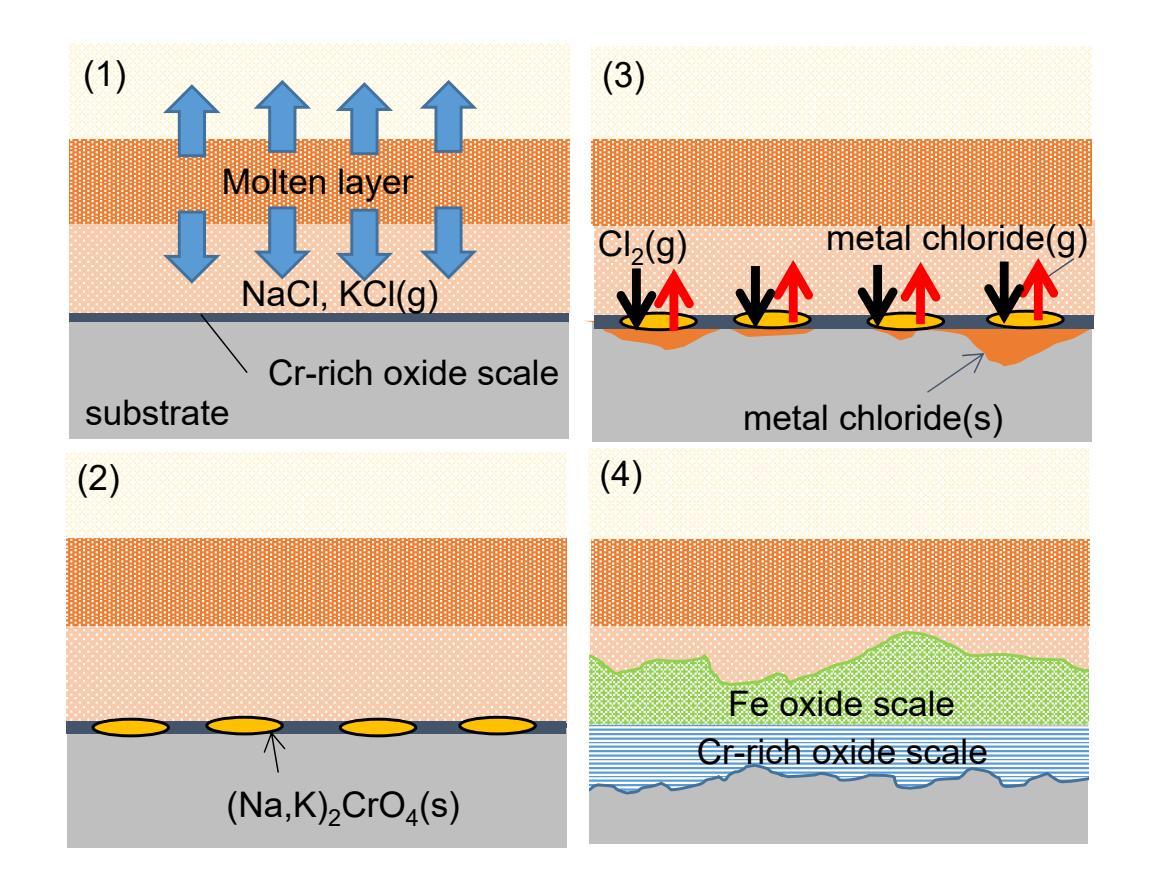
Figure 14 Schematic of corrosion model in the combustion ash containing alkali salt in the air

Figure 14 is a schematic representation of the corrosion behavior of heat-resistant steels in a temperature gradient corrosion test. At the initial corrosion stage, a protective Cr-rich oxide scale is formed on the surface of the specimen, and the melts is formed in the temperature range above the melting point of the ash. The alkali salt vapor diffuses from the molten layer to the surface of the specimen as shown in Figure 14 (1). Alkali salt vapors react with the Cr-rich scale to form Na and K chromates (the breakdown of the protective Cr-rich scale, Figure 14 (2)). The chlorine partial pressure increases due to the chromate formation reaction, and more metal chloride is formed and volatilized at the scale/metal interface (Figure 14 (3)). Once the breakdown areas cover the entire surface of the specimen within a short time, the entire surface becomes covered by a porous Fe oxide and the layer-by-layered inner layer is formed (Figure 14 (4)). Deposite-induced corrosion as this study is described as occurring in two stages: an "incubation stage" in which corrosion is slow and then a "propagation stage" in which corrosion is rapid ^[17]. Therefore, it is presumed that the corrosion rate of heat-resistant steel changes rapidly due to the breakdown of the Cr2O3 scale.
