Title	Fatigue analysis of orthotropic steel-ultra-high-performance fiber-reinforced concrete (UHPFRC) composite deck considering accelerated deterioration and self-healing of fractured ultra-high-performance fiber-reinforced concrete in surface water condition
Author(s)	Ma, Chi Hieu; Deng, Pengru; Matsumoto, Takashi
Citation	Advances in Structural Engineering https://doi.org/10.1177/13694332231207180
Issue Date	2023-10-03
Doc URL	http://hdl.handle.net/2115/90625
Rights	Chi Hieu Ma, Pengru Deng, and Takashi Matsumoto, Fatigue analysis of orthotropic steel-ultra-high-performance fiber-reinforced concrete (UHPFRC) composite deck considering accelerated deterioration and self-healing of fractured ultra-high-performance fiber-reinforced concrete in surface water condition, Advances in Structural Engineering. Copyright © 2023. DOI: https://doi.org/10.1177/13694332231207180
Туре	article (author version)

1	Fatigue analysis of orthotropic steel-UHPFRC composite deck
2	considering accelerated deterioration and self-healing of fractured
3	UHPFRC in surface water condition
4	Chi Hieu Ma <sup>a,*</sup> , Pengru Deng <sup>c</sup> and Takashi Matsumoto <sup>b</sup>
5	<sup>a</sup> Graduate School

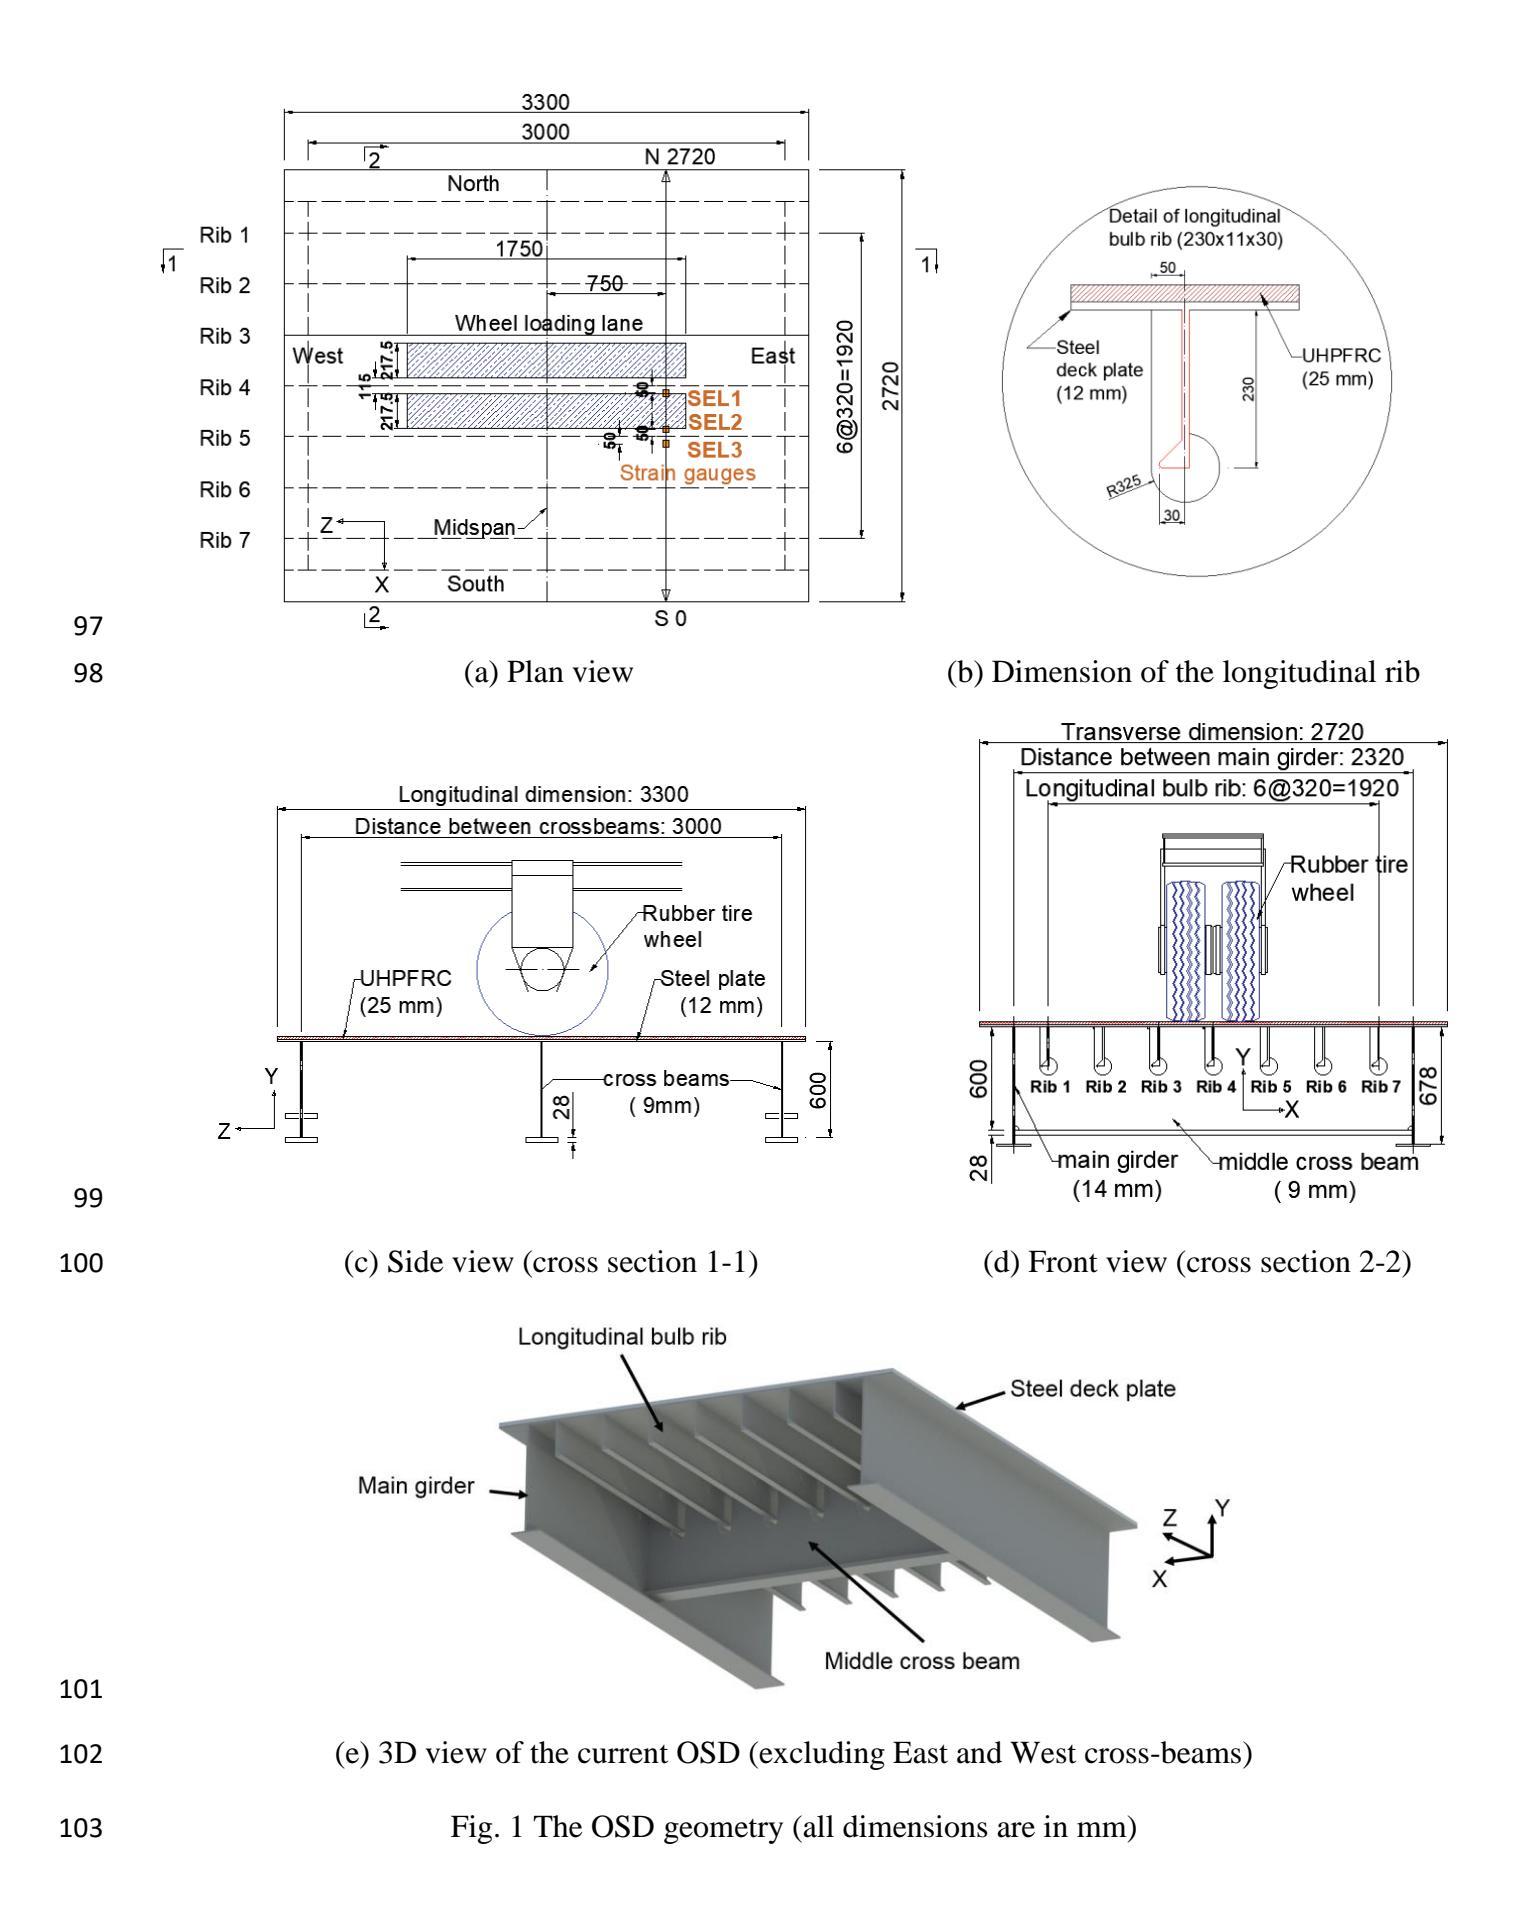
To examine the effectiveness of the UHPFRC overlayer in improving the fatigue life of an OSD, fatigue tests on a full-scale OSD were conducted under wheel loading and environmental conditions in the previous study (Makino et al., 2021). Fig. 1 illustrates the geometry of the investigated composite deck. The dimensions in transverse and longitudinal directions of the OSD were 2720 and 3300 mm, respectively. The bridge deck comprised a 12 mm steel deck plate covered by a UHPFRC layer with a thickness of 25 mm, seven longitudinal ribs, three cross beams and two main girders.

104 The web thicknesses of the main girders and crossbeams were 14 and 9 mm, respectively. The 105 dimensions of the longitudinal bulb ribs were  $230 \times 11 \times 30 \text{ mm}^3$  (Fig. 1(b)).

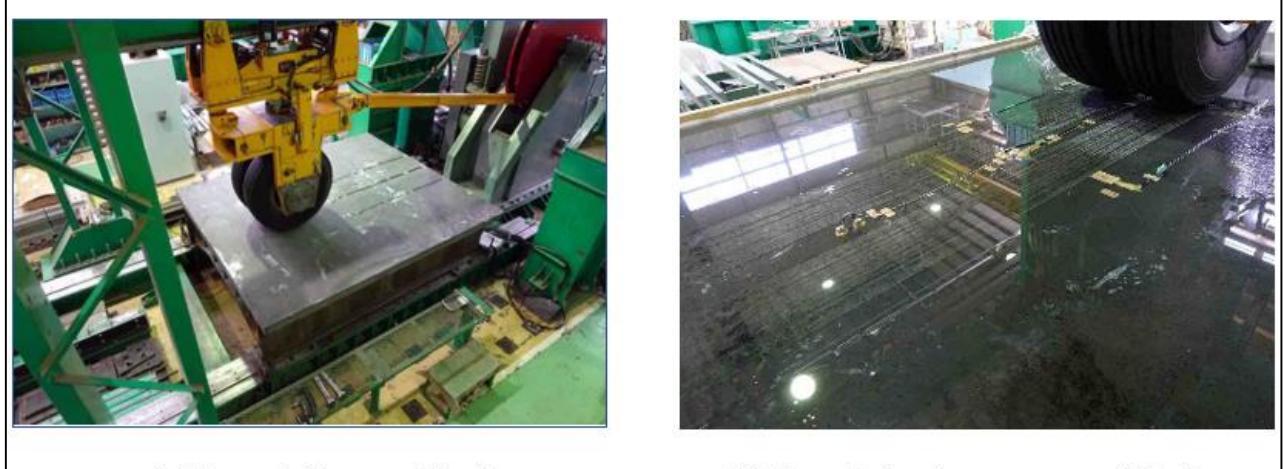
# Fig. 2 Fatigue test of the OSD (Makino et al., 2021)

The loading and environmental conditions adopted during the fatigue test for the composite bridge deck, and the fatigue test images of Stages 1 and 2 are depicted in Fig. 2. In the current study, fatigue analysis was conducted for Stage 2. After Stage 1, which included 1,100,000 cycles subjected to a moving wheel loaded with a rubber tire under dry conditions, the damaged composite deck with evident fine cracks on the top surface of the UHPFRC was subsequently tested for 60,000 cycles

(a) Stage 1 (dry condition)

(b) Stage 2 (surface water condition)

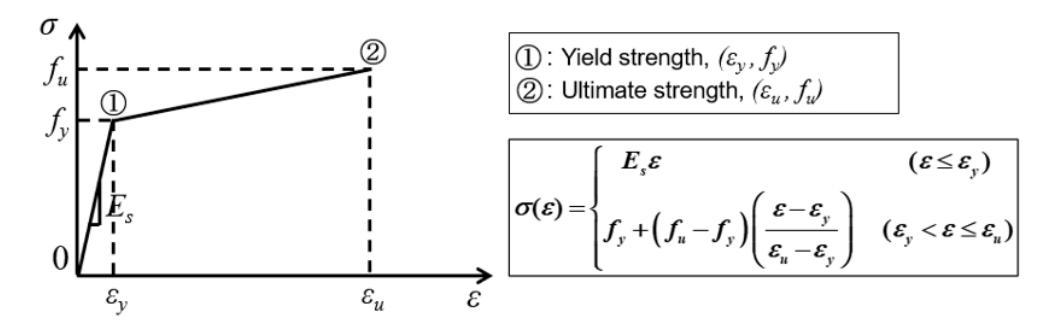
The stress–strain relationship of the steel material, and the primary material properties of the steel members are presented in Fig. 3. Notably, a Poisson's ratio of 0.3 and Young's modulus of 200 GPa are considered in the current model. The von Mises criterion is used as the yield criterion of steel. In the presence of the UHPFRC-strengthening layer, a significant decrease in stress levels was observed from the fatigue sensitive locations of the OSD, and no fatigue cracking was observed from the steel members. The fatigue of steel material was thus not prominent during the tested stages. In the current analysis, the fatigue life of steel members is estimated in Phase 1 (as mentioned in Section 2) to assess the beneficial effect of the self-healing behavior in UHPFRC cracks.

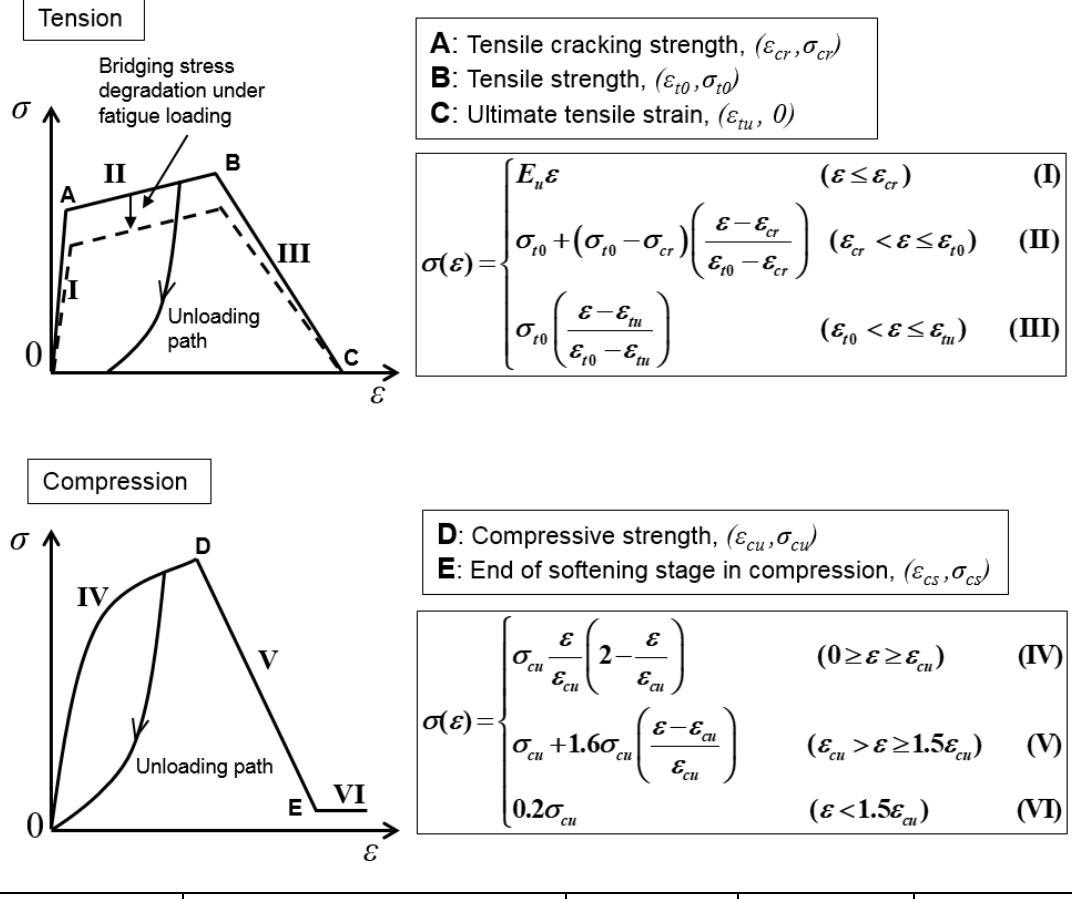
A user subroutine in Marc program is coded to define the constitutive law of UHPFRC. According to JSCE Recommendations (2008), the nonlinear stress–strain relationships of UHPFRC are presented in Fig. 4. The constitutive law of UHPFRC under tension can be defined by a trilinear relation, i.e., (I) elastic, (II) strain-hardening, and (III) strain-softening domains. After the elastic domain, the tensile stress increases with the formation and propagation of microcracks in the second domain, i.e., the strain-hardening domain. Following this, localized macrocracks initiate and develop in the third domain after achieving the tensile strength.

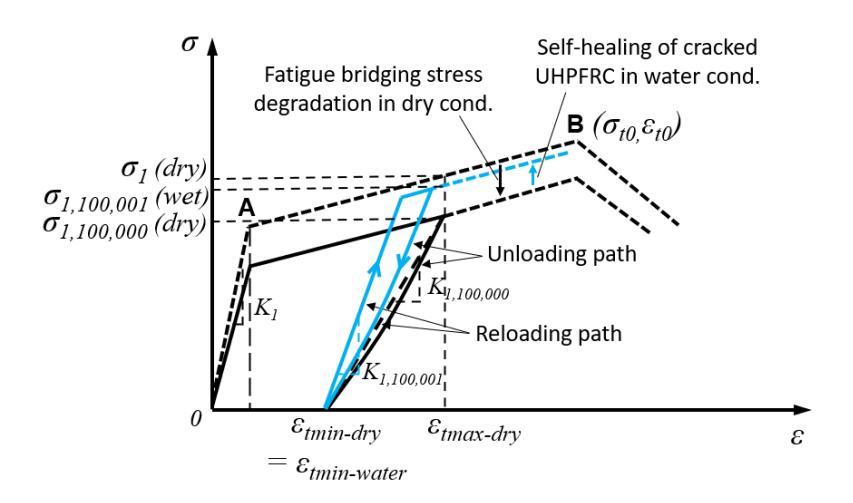
Based on the studies conducted by Herbert and Li (2012, 2013), the mechanical recoveries of tensile strength and reloading stiffness of the UHPFRC surface cracks are considered in the current analysis, from the end stage of the dry condition (1,100,000th cycle) to the beginning stage of the surface water condition (1,100,001st cycle) in Phase 1 (Fig. 5).

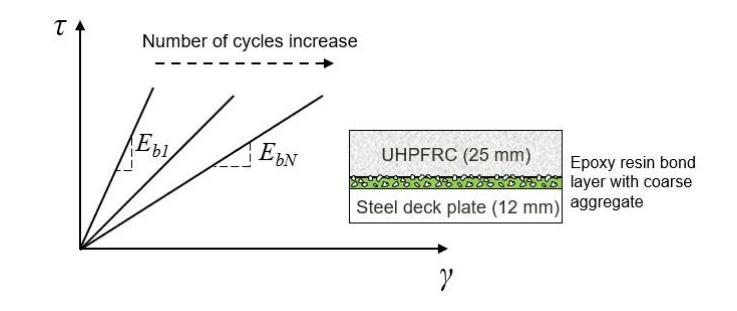
strain relationship is assumed in the current analysis (Fig. 6(a)). The shear elastic stiffness of the bond material, i.e.,  $E_{b1}$ , is 2.66 GPa, is used following properties reported by Mitamura et al. (2011). In fatigue analysis of Stage 1, the interfacial bond stiffness degradation between steel plate and overlayer caused by repetitive moving-wheel load (see Fig. 6(a)) was considered by Ma et al. (2021). According to this study, by comparing the experimental observations (i.e., steel strain and hammer tapping test results) with the analysis results, the bond stiffness degradation speed was determined, as follows:

(a) Bond stiffness degradation model at steel/UHPFRC interface (Ma et al., 2021).

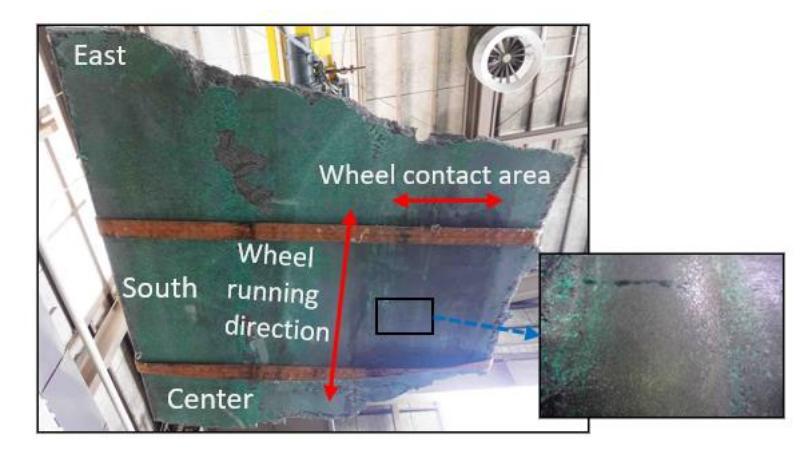
(b) Interfacial bond layer at the end of fatigue test (Makino et al., 2021).

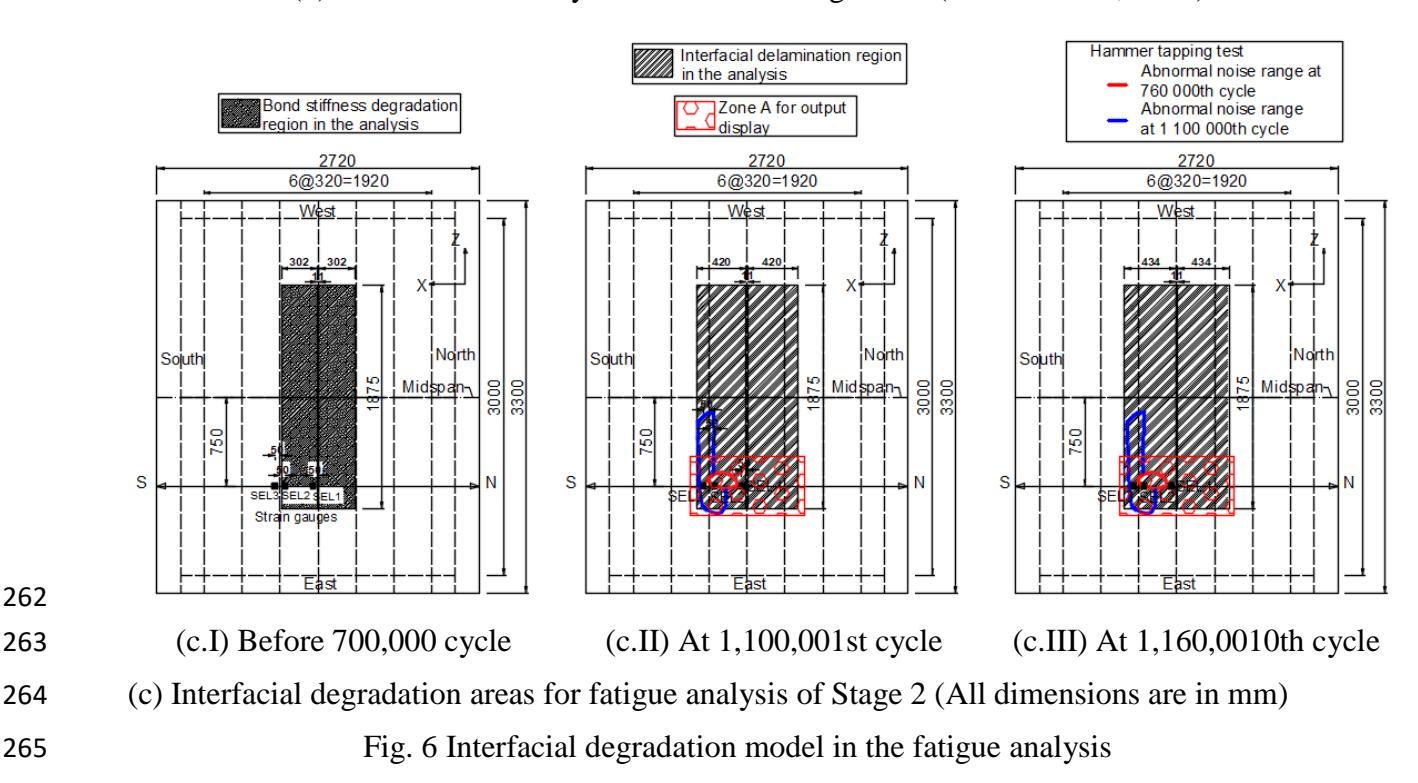
where  $E_{bN}/E_{b1}$  denotes the ratio of the interfacial stiffness from *N*th to 1st cycles. The region being applied the bond stiffness degradation,  $S = 2 \times 302 \times 1875 \text{ mm}^2$ , is shown in Fig. 6(c.I).

Subsequently, the delamination area at the interface was considered for the FEM model from the 243 700,000th cycle when the interfacial bond stiffness under wheel load region was zero (Ma et al., 244 2021). Fig. 6(b) shows the bonding layer at the UHPFRC/steel interface at the end of the experiment. 245 246 The dark region under the wheel contact area, which comprised iron oxide particles obtained from shot-blasting process for the steel plate before applying the UHPFRC overlayer, could be observed 247 after the fatigue test. This denoted the fatigue failure of bonding layer at wheel load region. In addition, 248 249 based on acoustic inspections, i.e., a hammer test, in Stage 1 (see Fig. 6(c)), the abnormal noise range was detected at the 760,000th cycle, indicating the occurrence of interfacial delamination. Thereafter, 250 the delamination area found by the hammer test gradually expanded in the local region above Rib 5. 251 For the current model, the delamination area at the interface chosen at the initiating cycle of Stage 2 252 (1,100,001st) was equal to that at the ending cycle of Stage 1 (1,000,000th), as shown in Fig. 6(c.II). 253 254 Throughout Stage 2, the average expansion speed of 4.67 mm/10,000 cycles along the transverse direction, which was applied to the interfacial debonded area, was selected identical to that of the 255

- previous cycles in Stage 1 (from the 940,000th to the 1,100,000th cycles). The transverse dimension
- of the debonded area are then gradually increased from 840 to 868 mm (Fig. 6(c.III)).

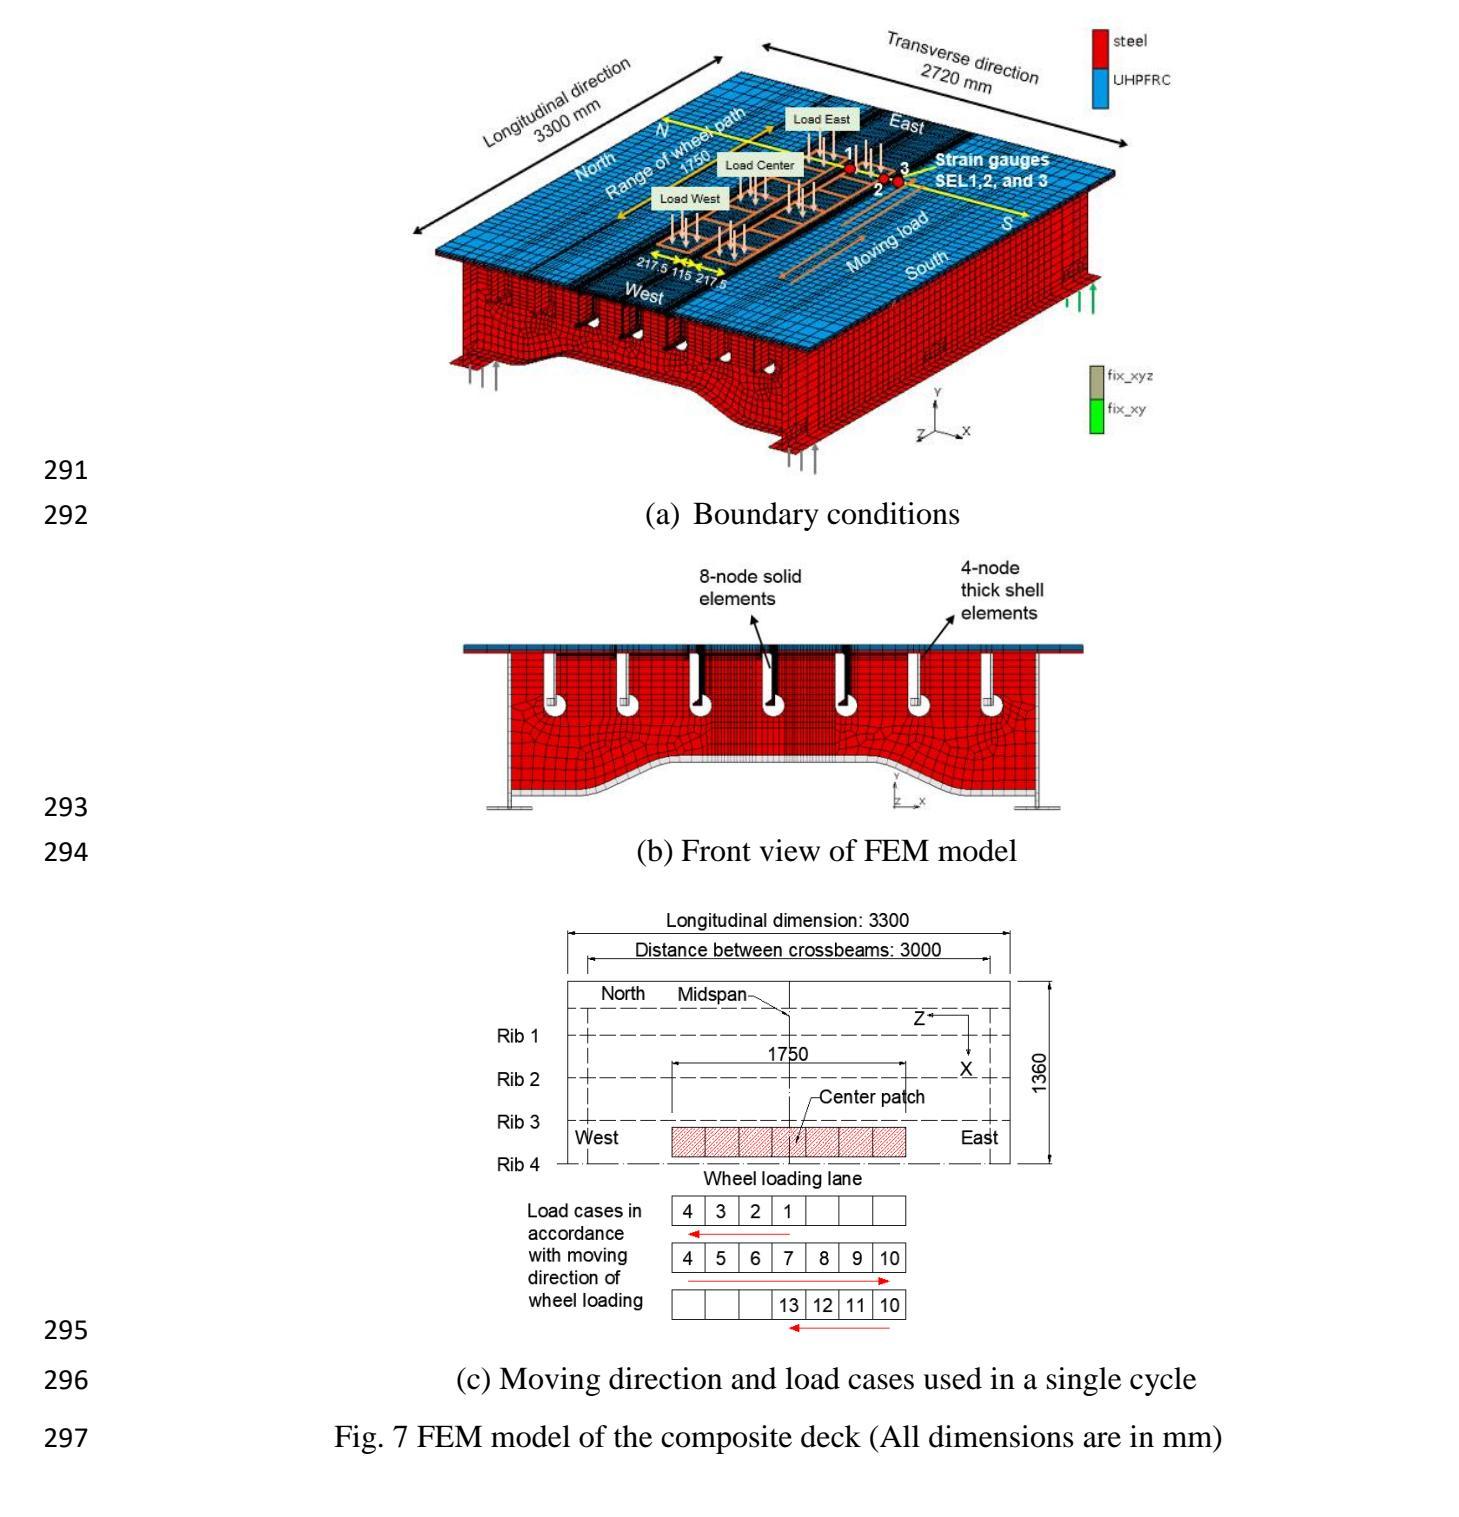
The boundary conditions and mesh pattern in the FEM model of the composite deck are shown in 267 268 Fig. 7(a). Notably, a fine mesh with a minimum transverse size of 2.5 mm was employed for the overlayer and steel plate at regions above the three central longitudinal ribs. The UHPFRC-reinforced 269 layer was vertically segregated into three layers in the current FEM model. In order to minimize 270 271 computational cost, the 4-node thick shell elements are utilized instead of the 8-node solid elements to model the steel members such as cross beams, main girders, and the 4 outer bulb ribs (which are 272 located far away from the critical region at wheel loading lane, as shown in Fig. 7(b)). It was found 273 274 that, in comparison the model using only solid elements, the analysis time of the current model 275 reduced about 40%, while the differences between numerical results at critical locations in steel deck plate of the two FE model are within 1%. The total number of elements used in the current FE model 276 277 are 47,390.

278 Four edges under the main girders were supported with a 3000 mm longitudinal span. Two edges 279 along the west side were restricted in all the three translational directions. The other edges from the 280 east side were constrained against translation along the X and Y directions. The rubber tire wheel with a load of 100 kN was simulated using seven load locations. The size of each load location was 281 282  $2 \times 217.5 \times 250$  mm<sup>2</sup>, with a central gap of 115 mm, i.e., the distance between two tires. The 100-kN wheel-load was distributed over the whole area of load location, in which non-uniform distributions 283 along the longitudinal and transverse directions of contact patch of rubber tire were based on the 284 loading model presented by Ma et al. (2021), which has been reported to provide a better prediction 285 of structural responses in steel deck plate than the standard uniformly-distributed load model. To 286 simulate the interface between UHPFRC and steel plate in FEM model, the UHPFRC bottom layer 287 and the steel-plate top surface are designated as deformable bodies of the contact analysis in 288 MSC/Marc. The Touching contact option is used to model the interfacial delamination region (see 289 290 Fig.6(c)), in which the material penetration is prevented. The remain interfacial region is simulated

300 In the fatigue analysis, the moving direction of wheel loading under the specified load cases in a 301 single cycle is presented in Fig. 7(c). The wheel load is initially applied to the central location until 302 the peak value (100 kN) is reached from load case 1. In load case 2, this location is unloaded with the loading of the adjacent elements at the same increasing rate. Herein, each load case includes 30 303 loading steps with a total running time of 2190s. This procedure is continuously repeated along the 304 305 loading lane, reproducing the movement of the rubber tire wheel. During this process, the bridging 306 stress degradation equation (i.e., Eq. (6)) and unloading behaviors at each integration point of the UHPFRC elements are modified and determined based on the maximum value of tensile strain, which 307 308 is recorded from the previous cycle of the fatigue analysis. The obtained bridging stress degradation value at each node is then applied directly to the nonlinear constitutive law of UHPFRC after cracking 309 310 which is defined in the multi-fixed smeared crack model for each cycle. The current analysis of Stage 2 is performed for 60,000 cycles to reproduce the fatigue test under surface water condition. 311

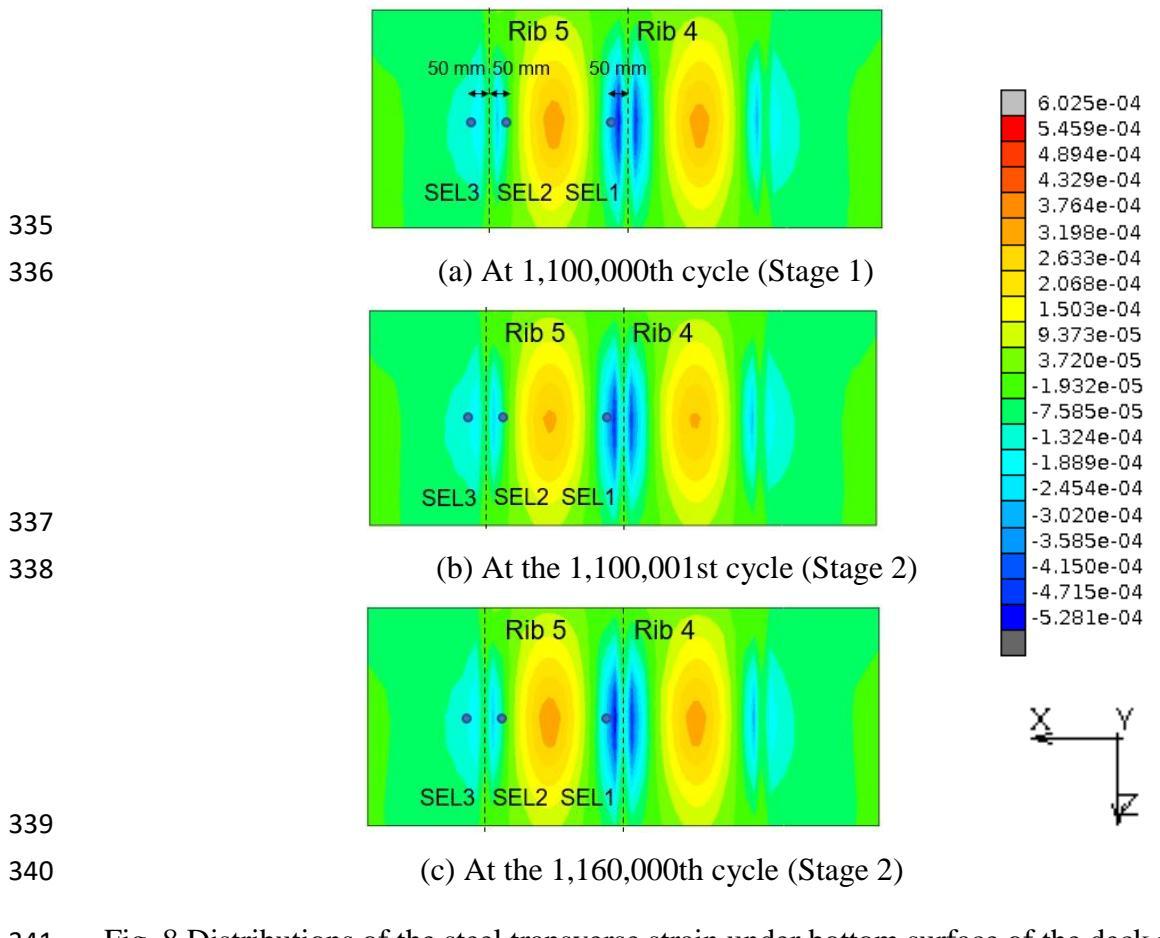
The distributions of the transverse strain under bottom surface of the steel deck plate for different 315 cycles are depicted in Fig. 8. The illustrated results are obtained from zone A (Fig. 6(c.II)) under load 316 317 case 10. Under load case 10, the positive bending at the tire contact region is produced by the wheel load along with the overall downward movement of the steel deck plate. On the other hand, owing to 318 the stiffening effect of the longitudinal Ribs 3,4 and 5, the wheel load induces negative bending at 319 320 these local regions. At the 1,100,001st cycle (Phase 1), owing to an increase in the tensile strength of the fine cracks in the UHPFRC overlayer after autogenous self-healing (Section 3.2.2), the overall 321 stiffness of the composite deck increases after one-night exposure to water. This leads to a decrease 322 in strain levels in the compressive zones at Ribs 3–5 and tensile zones at the wheel contact area of 323 the steel deck plate during this loading cycle. Further, the mechanical recoveries of the cracked 324 325 UHPFRC in Phase 1 can be interpreted based on the opening-closing actions of a single crack (Fig.

Fig. 8 Distributions of the steel transverse strain under bottom surface of the deck plate for different

342 cycles in load case 10 (displayed at zone A).

In contrast to the first cycle of Stage 2, the increase in transverse strain magnitudes can be observed 345 at the 1,160,000th cycle (see Fig. 8(c)), and this is owing to fatigue bridging stress degradation of 346 cracked UHPFRC under moving-wheel loading in Phase 2. After the formation of a tensile crack, 347 348 owing to the continuous reduction in tensile strength resulting from the degradation in the bridging stress between crack surfaces, a stress concentration can be induced in the region of the crack tip. 349 Thereafter, the fatigue crack propagates in the overlayer with a newly formed crack length at the 350 351 crack tip. Consequently, the deformation of the bridge deck is increased, leading to strain 352 redistribution in the UHPFRC and steel plate. Moreover, stiffness reduction of the bridge deck is as

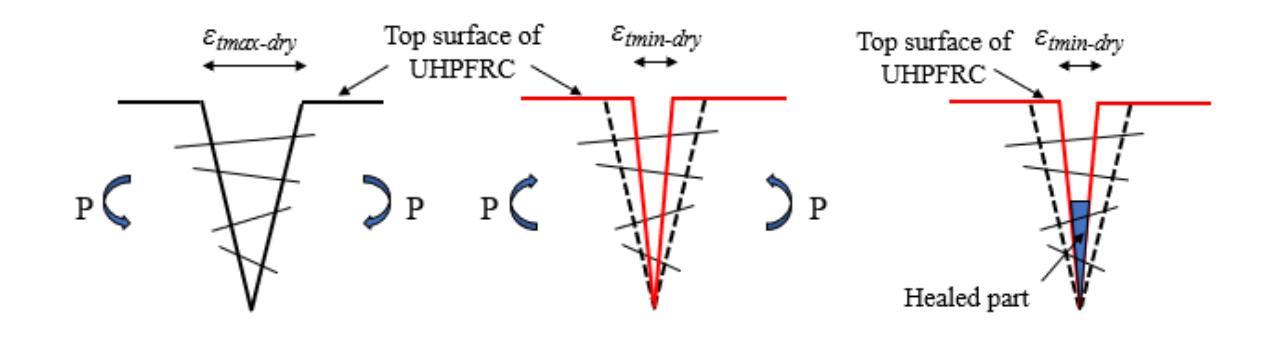
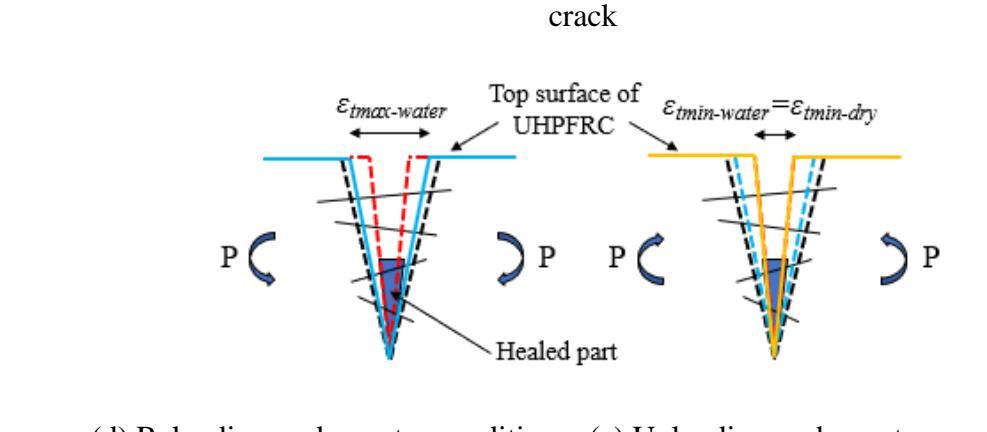
326 9) on the top layer of the overlayer before and after self-healing. It is noted that the UHPFRC tensile cracks at East patch above Ribs 3, 4 and 5 are under the process from opening to closing when the 327 wheel load moves from East to West load patches; and vice versa. In the presence of the healed part 328 329 inside the UHPFRC crack, the stress transfer between pulled-out or ruptured fibers is restored, causing an increase in the bridging stress between the crack surfaces. Thus, the reloaded maximum 330 strain or crack opening displacement decreases after the self-healing of UHPFRC cracks (Fig. 9(d)). 331 332 The autogenous healing process of the UHPFRC cracks is assumed to terminate at the beginning of the 1,100,001st cycle (Fig. 9(c)), and the healed parts undergo cracking and degradation under 333 334 repetitive wheel loading without further self-healing throughout Stage 2. Therefore, the unloading

(a) Loading under dry condition (b) Unloading under dry condition (c) Healed part formed inside

357 (d) Reloading under water condition (e) Unloading under water condition
358 Fig. 9 Opening–closing behaviors of a UHPFRC crack before (a and b) and after (d and e) self-

minimum strain under the water condition ( $\varepsilon_{tmin-water}$ ) is maintained equal to that under the dry condition ( $\varepsilon_{tmin-dry}$ ) (Fig. 9(e)).

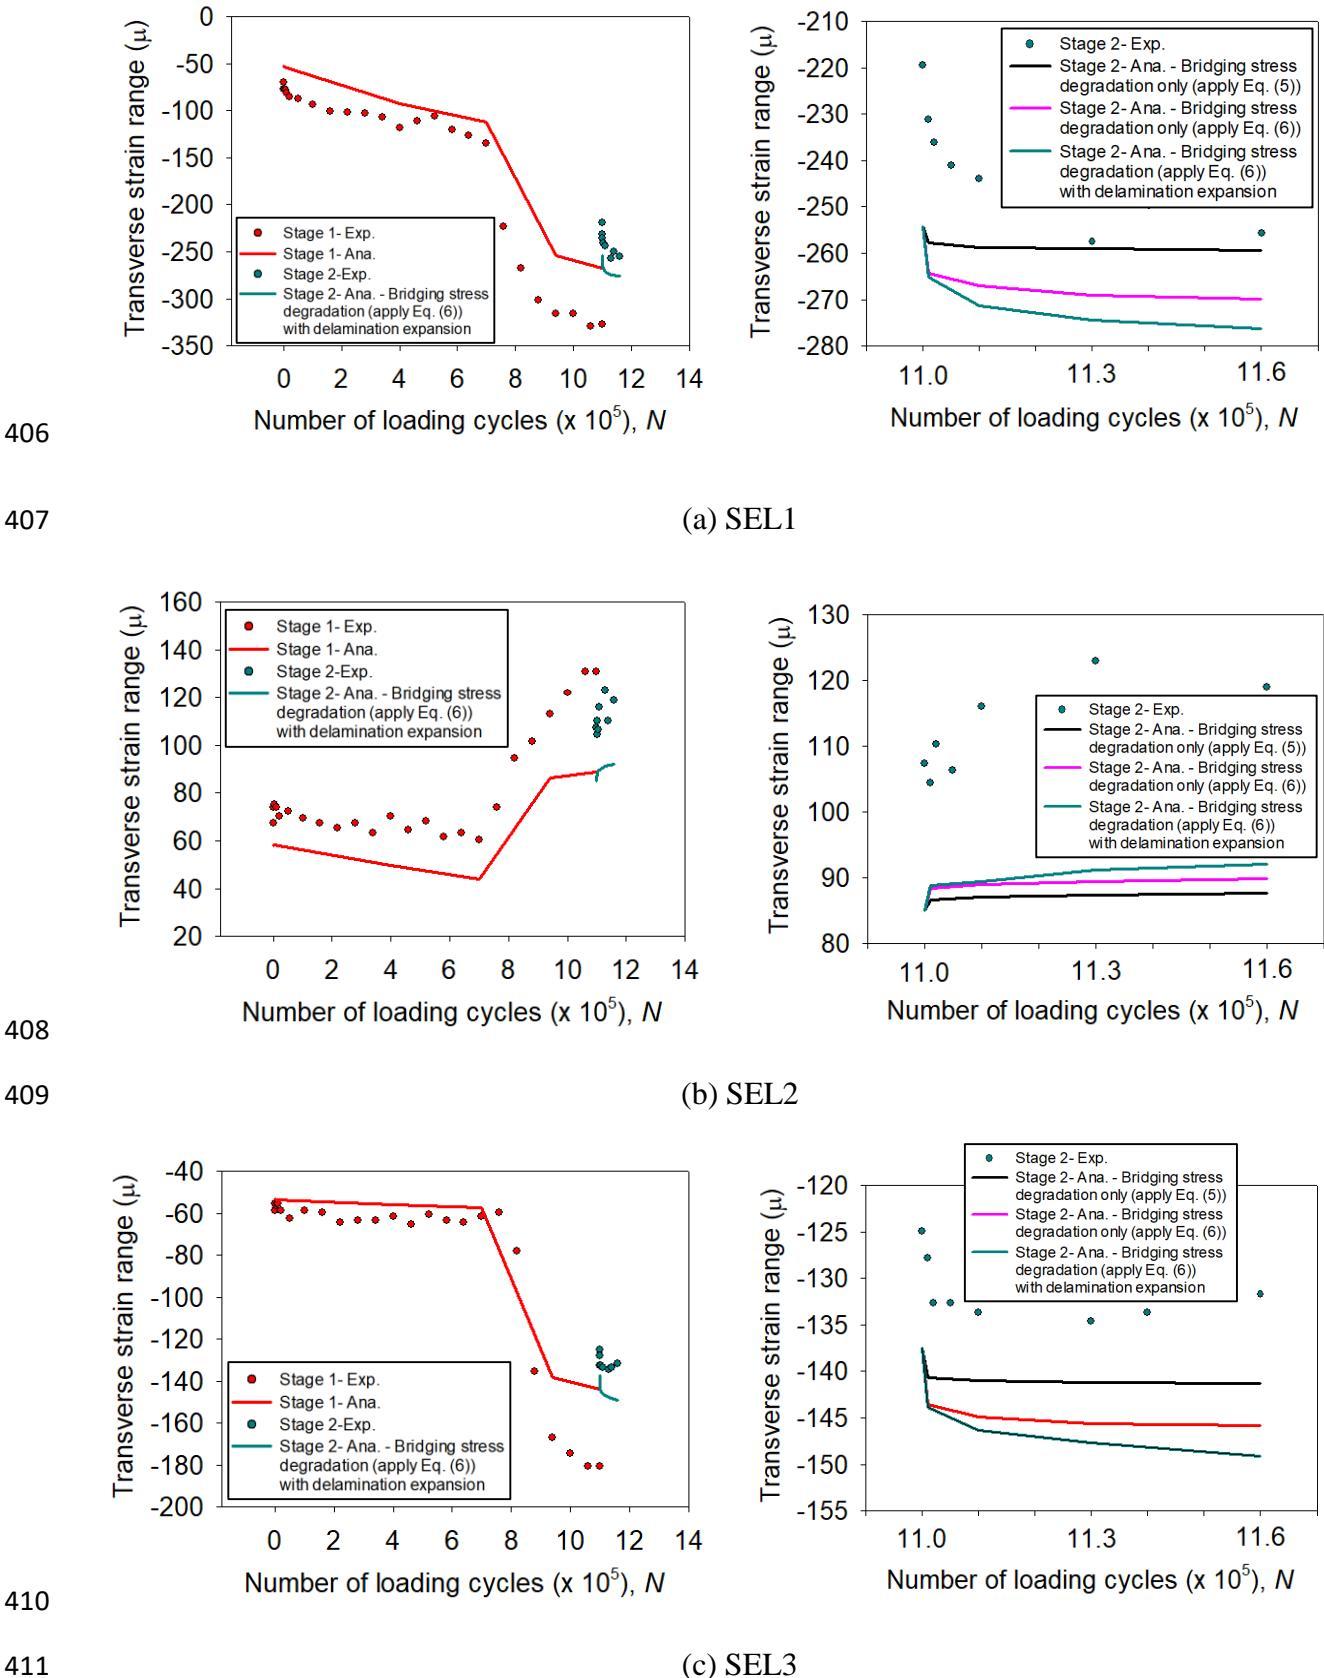
Fig. 10 Transverse strain range vs. the number of cycles at SEL strain gauges

367 In Fig. 10, the transverse strain range evolutions in load case 10 at the locations of the SEL strain gauges (Fig. 1(a)) under steel-plate bottom are plotted in comparison with the experimental data, with 368 the chosen recovery ratios for tensile strength and reloading stiffness of 70%. As reported by Ma et 369 370 al. (2021), in Stage 1, owing to continuous deterioration of the interfacial bond stiffness before the 371 700,000th cycle, the strain range of the steel deck plate gradually decreases with an increase of the number of cycles. Subsequently, a delamination area formed at the UHPFRC/steel interface and 372 373 expands along the transverse direction, leading to considerable variations in the transverse strain 374 range levels of the steel deck plate from 700,000th to 1,100,000th cycles. From Fig. 10, it is apparent that the experimental strain range magnitudes at the SEL strain gauges from the end of Stage 1 375 376 (1,100,000th cycle) to the beginning of Stage 2 (1,100,001st cycle) have decreased after one-night exposure in surface water condition. Possible cause of this behavior is the self-healing of surface 377 cracks in the overlayer, as introduced above. To assess the effect of this mechanism on the structural 378 responses of the composite deck, a parametric study is conducted and presented in the following 379 section. 380

From Fig. 10, it is obvious that the contribution of bridging stress degradation to the increase in the strain range is more dominant during the early stages of the fatigue analysis under the surface water condition based on a comparison between numerical models with and without interfacial delamination expansion. The reason for this is that the expansion of the debonded zone is quite minimal at the beginning cycles of Phase 2. With an increase in the number of cycles, the strain ranges of the steel plate increase, as the UHPFRC–steel composite undergoes continuous degradation when the delamination area is expanded along the transverse direction.

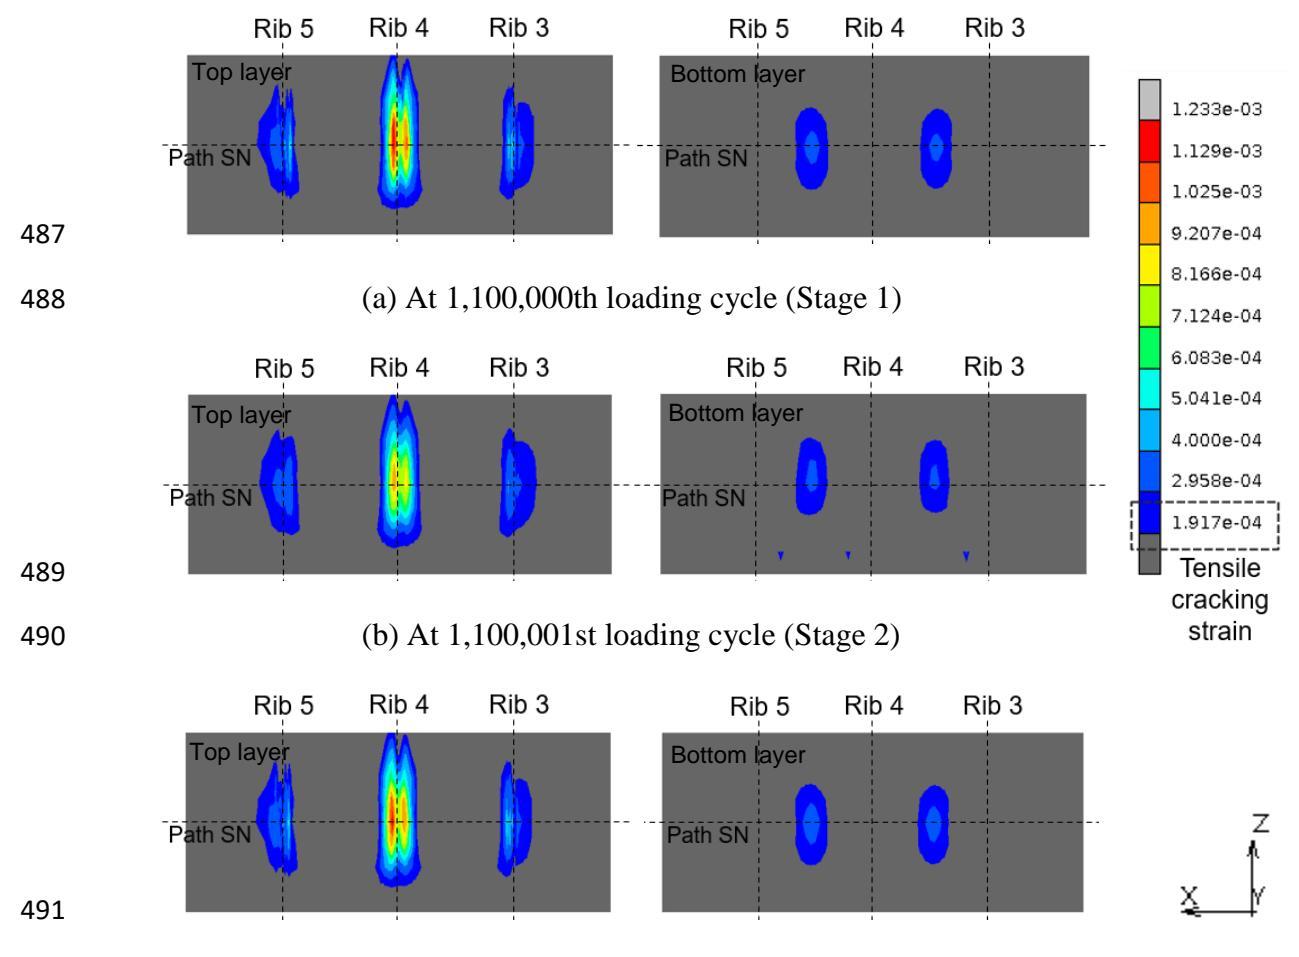
478 The maximum strain distributions for the cracked elements during Stages 1 and 2 at zone A (presented in Fig. 6(c)) are shown in Fig. 13 for the bottom and top layers of the reinforced overlayer, 479 480 respectively. The blue-to-red color band represents the cracked regions on the overlayer surface. For the OSD, an overall downward movement of the steel deck plate is achieved under wheel loading, 481 which induces positive bending at the tire contact region. However, owing to the stiffening effect of 482 the longitudinal rib, negative bending at these local regions is produced via wheel loading. Therefore, 483 cracks emerge on the top surface of the overlayer and propagate at local zones above Ribs 3, 4, and 484 5; whereas tensile cracks at the bottom layer of the UHPFRC overlayer are created at the rubber-tire 485 contact regions. At the beginning cycle of Stage 2, owing to an increase in the tensile strength caused 486

#### (c) At 1,160,000th loading cycle (Stage 2)

# Fig. 13 Distributions of maximum principal strain for cracked areas on top and bottom layers of UHPFRC overlay (displayed at zone A)

by the self-healing of the cracks on the top layer of the UHPFRC, the maximum tensile strain levels from the top and bottom layers of the UHPFRC overlayer, as shown in Fig. 13(b), decrease compared to those under the dry condition (Fig. 13(a)). This is accompanied by a narrower crack region from the bottom layer of the overlayer. On the contrary, the maximum tensile strain level of UHPFRC increases at the end of this stage owing to a significant increase in the bridging stress degradation speed of the healed UHPFRC in stagnant water, as shown in Fig. 13(c).

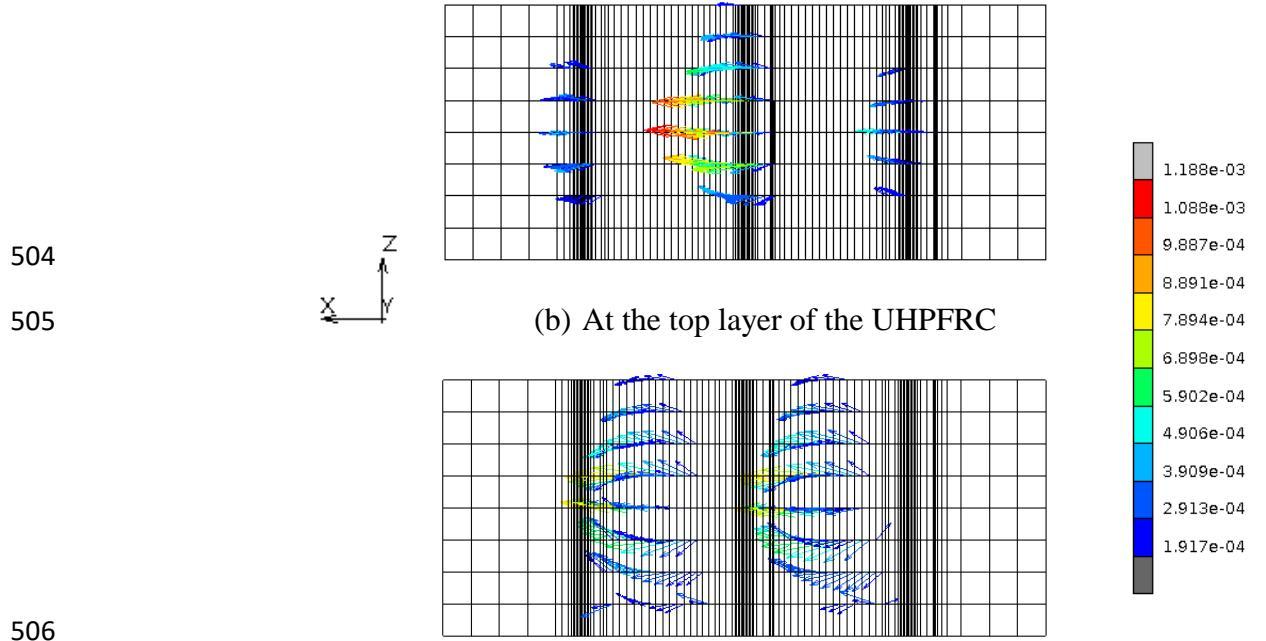
The maximum principal strain directions obtained from the crack elements in the UHPFRC overlayer under load case 10 of the 1,160,000th cycle are depicted in Fig. 14. It is obvious that the maximum principal strain directions obtained from the crack elements on the UHPFRC top surface

#### (b) At the bottom layer of the UHPFRC

Fig. 14 Maximum principal strain directions of UHPFRC cracks at 1,160,000th loading cycle 508 are transverse (Fig. 14(a)). This implies that the UHPFRC cracks initiate and propagate along the 509 longitudinal direction along Ribs 3, 4, and 5. On the other hand, diagonal cracks are observed from 510 the bottom layer of the UHPFRC overlayer, and distributed around the east-load-patch centerline (see 511 Fig. 14(b)). In the current model, it is found that that the second or third cracks in the UHPFRC 512 elements are not formed after the initiation of the first cracks (Fig. 13). This is because the obtained 513 stress levels along the longitudinal and vertical directions from the crack elements in the UHPFRC 514 overlayer are much smaller than those along the transverse direction, which can be attributed to the 515 516 stiffening effect of the longitudinal ribs and relative thin thickness of the applied UHPFRC overlayer.

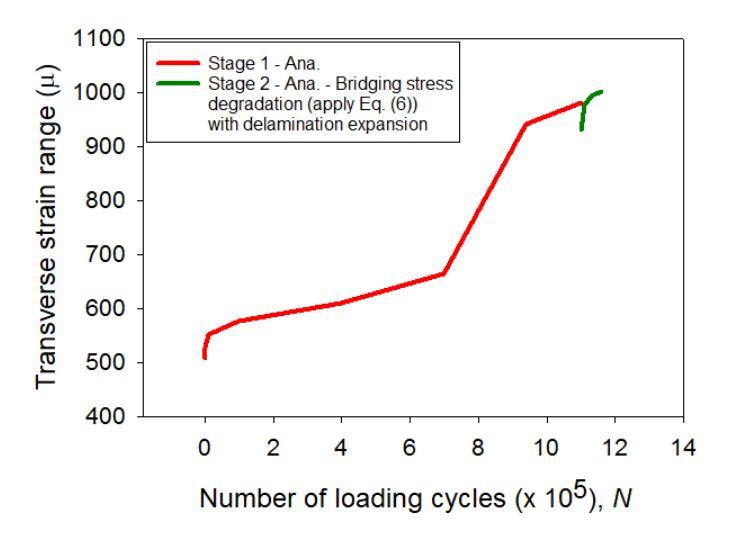
The transverse strain range evolution at the critical location on UHPFRC top surface (i.e., middle point of path SN) is plotted in Fig. 15, with the mechanical recovery ratio of 70%. Since the strain gauges separated from the UHPFRC top surface after 20,000 cycle, the discussion in this section is focused on the numerical results.

Fig. 15 Transverse strain evolution at the middle point of path SN

In Stage 1, the transverse strain range of the UHPFRC overlayer gradually increase until 700,000th cycle, due to the combination of the degradations of cracked bridging stress and interfacial bond stiffness. After that, from 700,000th to 1,100,000th cycles, a considerable increase in strain range results are obtained after the formation and development of the interfacial delamination area.

In Phase 1 of Stage 2, it can be observed that there is a reduction in transverse strain range at the 528 middle point of path SN in UHPFRC overlayer after applying the mechanical recovery ratios of 70% 529 to the UHPFRC surface cracks to reproduce the self-healing behavior. Herein, the reduction 530 percentage is approximately 5.09% (reduced from 981µ to 932µ). Subsequently, under fatigue 531 loading process (Phase 2), by applying the increased speed of crack bridging stress degradation in Eq. 532 (6), the transverse strain results in UHPFRC overlayer continuously increase, especially from the 533 534 initial 5,000 cycles of Phase 2. These results are similar to the observation of the steel strain results represented in Fig. 10. 535
