Title	Fatigue analysis of orthotropic steel-ultra-high-performance fiber-reinforced concrete (UHPFRC) composite deck considering accelerated deterioration and self-healing of fractured ultra-high-performance fiber-reinforced concrete in surface water condition
Author(s)	Ma, Chi Hieu; Deng, Pengru; Matsumoto, Takashi
Citation	Advances in Structural Engineering https://doi.org/10.1177/13694332231207180
Issue Date	2023-10-03
Doc URL	http://hdl.handle.net/2115/90625
Rights	Chi Hieu Ma, Pengru Deng, and Takashi Matsumoto, Fatigue analysis of orthotropic steel-ultra-high-performance fiber-reinforced concrete (UHPFRC) composite deck considering accelerated deterioration and self-healing of fractured ultra-high-performance fiber-reinforced concrete in surface water condition, Advances in Structural Engineering. Copyright © 2023. DOI: https://doi.org/10.1177/13694332231207180
Туре	article (author version)

1	Fatigue analysis of orthotropic steel-UHPFRC composite deck
2	considering accelerated deterioration and self-healing of fractured
3	UHPFRC in surface water condition
4	Chi Hieu Ma <sup>a,*</sup> , Pengru Deng <sup>c</sup> and Takashi Matsumoto <sup>b</sup>
5	<sup>a</sup> Graduate School

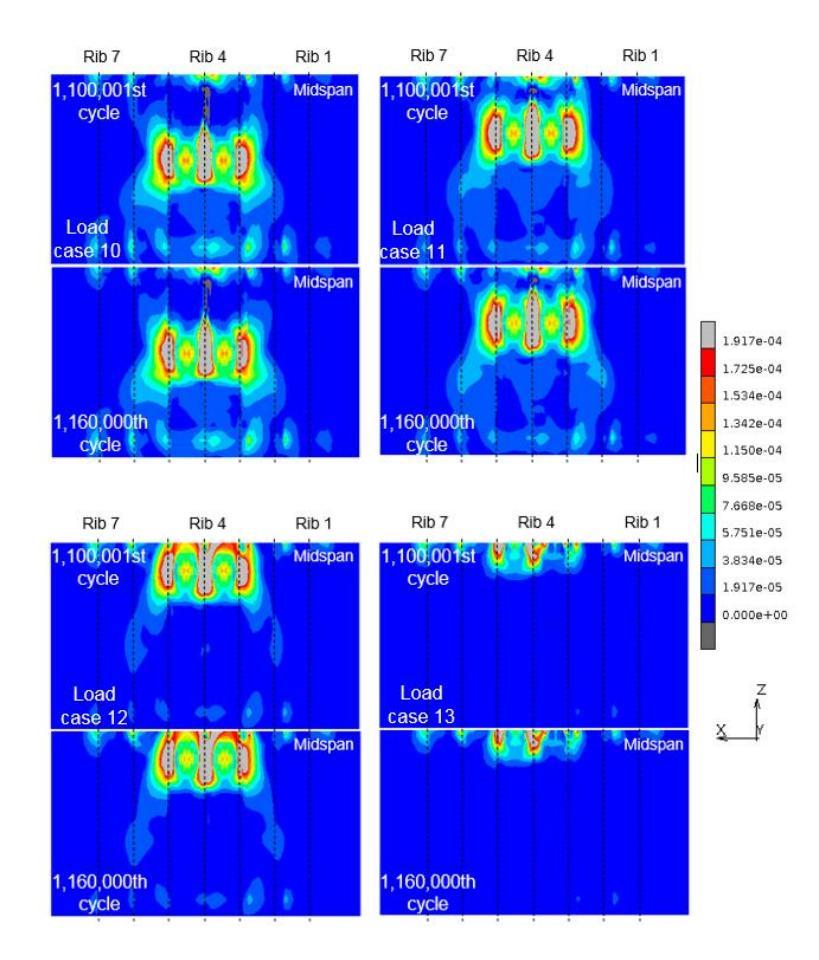
Fig. 16(a) shows the distributions of the maximum principal strain from the UHPFRC top layer subjected to a moving-wheel load during the beginning and ending cycles of Stage 2. In the analysis, a sequence from load case 10 to load case 12 represents the wheel-load moving process from the east 540 patch to the center patch (Fig. 7(c)). The gray color indicates the cracked regions on overlayer surface. According to the analysis, the highest level of the maximum principal strain applied to the top layer 541 of the UHPFRC is reported above the middle rib (Rib 4) in load case 12. In load case 13, the maximum 542 principal strain levels and obtained cracking zone are substantially reduced compared to those in the 543 adjacent load cases, owing to the stiffening effect of the middle crossbeam. At the end of Stage 2 with 544 the presence of stagnant water, multiple fine cracks are not localized into macrocracks. Despite the 545 546 significant increase in the bridging stress degradation speed applied for UHPFRC, the highest level of the maximum principal strain obtained from the reinforced overlayer is still within the strain-547 548 hardening domain of the UHPFRC, i.e., lower than 1750µ, at the end of Stage 2; this can be attributed to the high tensile strength, along with high fatigue durability under dry conditions for the UHPFRC. 549 550 This also agrees with the surface fine cracks (hairline) observed from the experimental crack pattern 551 shown in Fig. 16(b). Herein, it can be seen that the surface cracks occurred at the contact region of 552 rubber tires, while no crack at this region is obtained from the analysis (Fig.16(a)). Moreover, the through-thickness cracks as well as cracks under bottom surface which were obtained in the analysis 553 554 (Fig. 13) was not observed in the experiment. The possible reason for this issue may be due to the non-uniform distribution of the steel fibers in the UHPFRC overlay. As reported from the bending 555 556 test of UHPFRC beams (Sakai et al., 2022), the fiber contents near the top surface of the specimens are lower than those from the bottom parts, since the fiber may sink in the matrix due to the high 557 558 flowability of UHPFRC. Referring to for the current composite deck, the mechanical properties (i.e., 559 elastic modulus, cracking strength, tensile strength...) from the bottom layer of UHPFRC overlayer may be higher than those from the middle and top layers. Hence, further investigations of the 560 composite bridge deck are needed to examine the effect of the non-uniformity of fiber distribution on 561 562 the cracking behavior of the UHPFRC overlayer.

566 (a) Distributions of maximum principal strain on the UHPFRC top layer obtained from the

fatigue analysis (Gray color: the crack region)

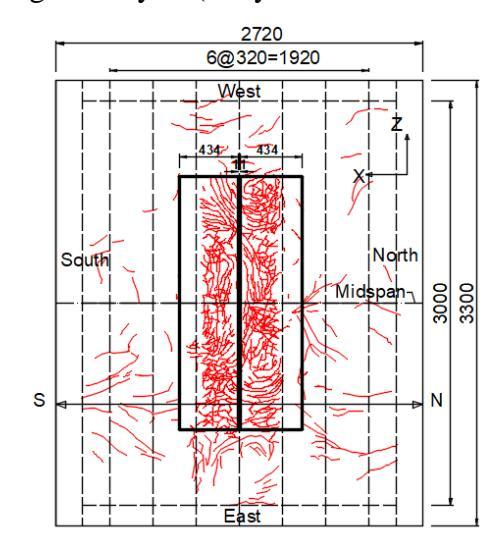
569 (b) Experimental crack pattern on UHPFRC top surface
570 Fig. 16 Crack region obtained from: (a) Fatigue analysis; (b) Experiment.
