RESPONSES OF MACROINVERTEBRATE COMMUNITIES TO RIVER RESTORATION
IN A CHANNELIZED SEGMENT OF THE SHIBETSU RIVER, NORTHERN JAPAN

The effects of restoration of channel meandering and the installation of groynes on physical variables and river-dwelling macroinvertebrates were examined in a lowland river, the Shibetsu River in northern Japan. The lowland segment of the Shibetsu River, which previously meandered, had been straightened by channelization and groynes had been installed in some portions of the channelized reach. In 2002, the channelization works were partly reversed to improve the degraded river ecosystem.

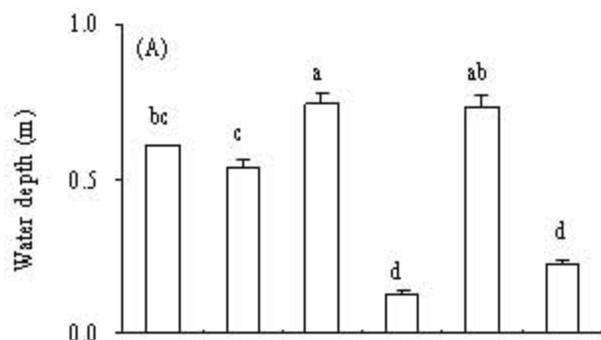
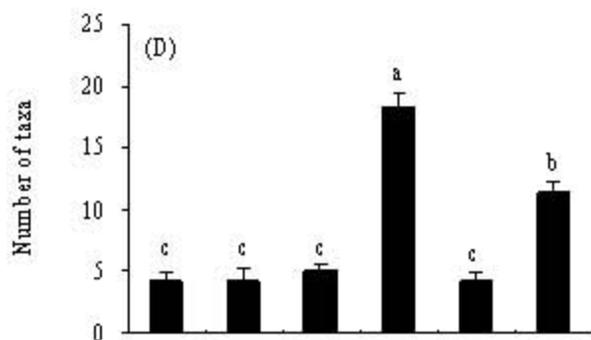
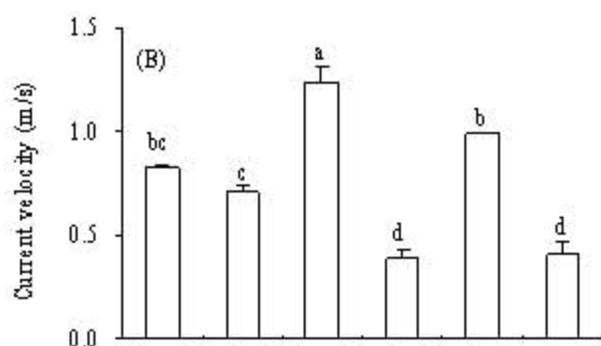
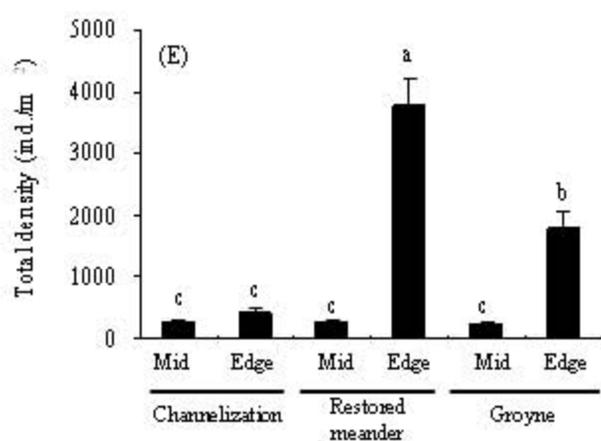
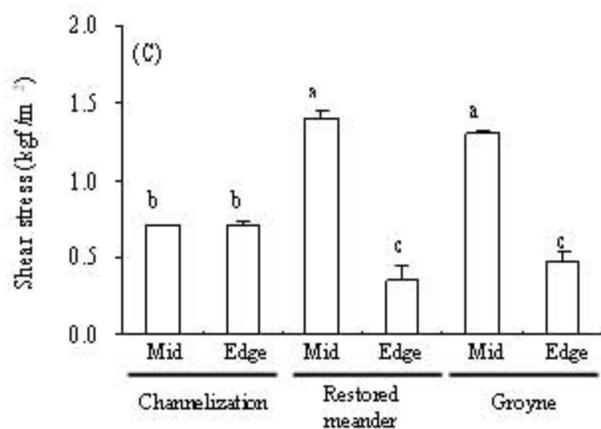
Figure 2. Physical environment (water depth (A), current velocity (B), shear stress (C)) and macroinvertebrate community structure (taxon richness (D) and total density (E)) in six habitat types in June 2003. Vertical bars indicate 1 S.E. Different letters denote significant differences (Holm test, $P < 0.05$).

All physical environmental variables were significantly different among the habitat types in June (water depth, $F_{5,42} = 54.2$, $P < 0.0001$; mean velocity, $F_{5,42} = 52.4$, $P < 0.0001$; shear stress, $F_{5,42} = 48.4$, $P < 0.0001$) and November (water depth, $F_{5,42} = 149.4$, $P < 0.0001$; mean velocity, $F_{5,42} = 73.0$, $P < 0.0001$; shear stress, $F_{5,42} = 167.1$, $P < 0.0001$). In the restored meander and the groyne reaches, water depth was significantly higher in mid-channel habitats, whereas it was lower in edge habitats (Figures 2A, 3A). Similarly, mean velocity and shear stress contrasted between mid-channel and edge habitats in the restored meander and groyne reaches (Figures 2B, C, 3B, C). There was no difference between edge and mid-channel habitats in the channelization reach in June. However, mean velocity and shear stress in November were different between the edge and middle of the channelized reach.

the restored meander reach had a significantly higher total density and taxon richness than other habitat types, followed by the density and richness of the edge in the groyne reach in June (Figures 2D, E) and November (Figures 3D, E). Mid-channel habitat had a low density and richness in all reaches. Macroinvertebrate density and richness did not differ between the edge and mid-channel habitats for the channelization reach in June, but in November, both were significantly greater at the edge rather than in the mid-channel habitat.

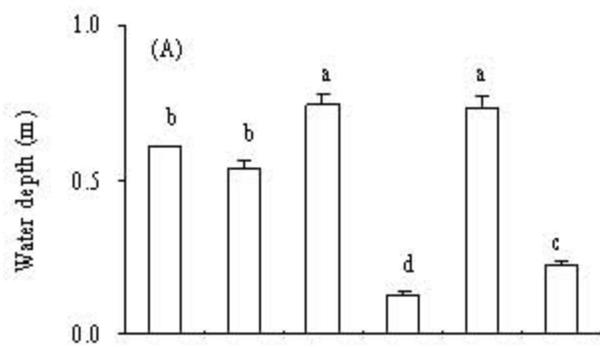
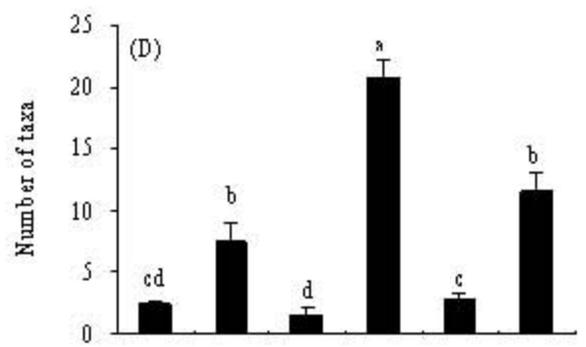
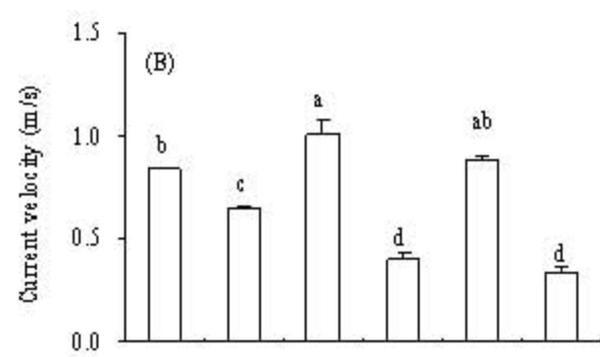
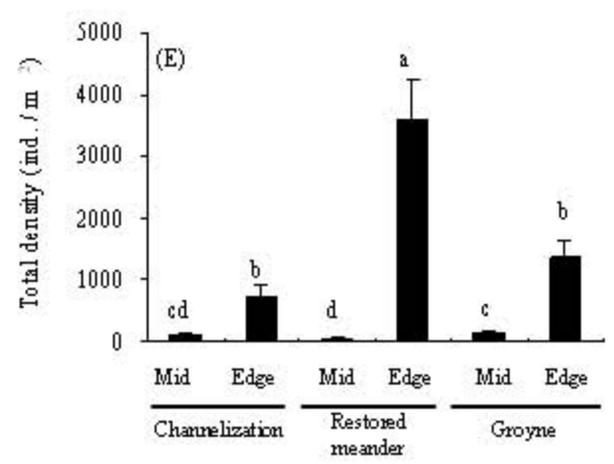
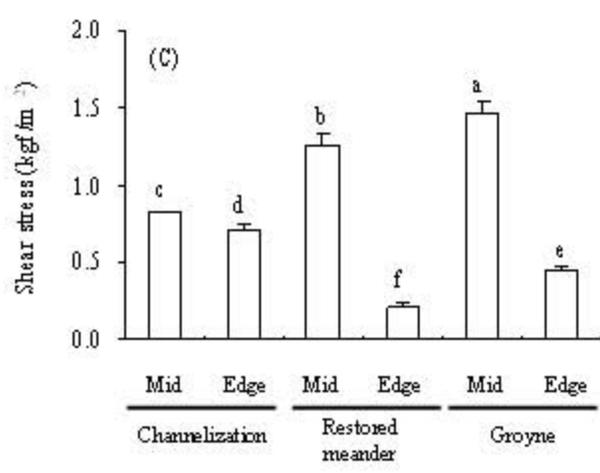
Figure 3. Physical environment (water depth (A), current velocity (B), shear stress (C)) and macroinvertebrate community structure (taxon richness (D) and total density (E)) of six habitats in November 2003. Vertical bars indicate 1 S.E. Different letters denote significant differences (Holm test, $P < 0.05$).

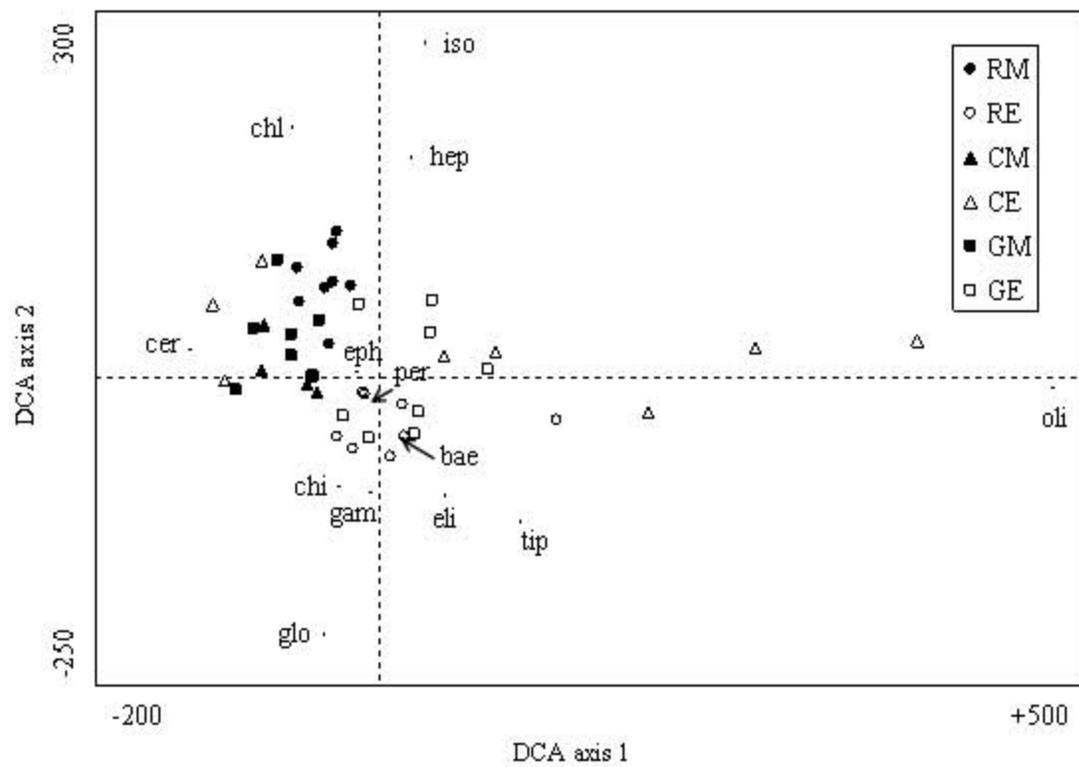
Figure 4. DCA ordination of macroinvertebrate communities from different habitat types in the Shibetsu River, June 2003. RM = restored meander mid, RE = restored meander edge, CM = channelization mid, CE = channelization edge, GM = groyne mid, GE = groyne edge. The location of each taxon is marked with ●, and taxa codes are: ani = Anisogammaridae, bae = Baetidae, cer = Ceratopogonidae, chi = Chironomidae, chl = Chloroperlidae, eli = Elmidae, eph = Ephemerellidae, glo = Glossosomatidae, hep = Heptageniidae, iso = Isonychiidae, oli = Oligochaeta, per = Perlodidae and tip = Tipulidae.

In June, the first two axes of the DCA ordination accounted for most of the variation in the family data, with eigenvalues of 0.286 and 0.155 for axis 1 and 2, respectively. The total inertia (total variation in the data) was 1.035 and the first two axes explained 43% of this variation. The macroinvertebrate community in the groyne edge habitat overlapped the restored meander edge habitat, which was clearly separated from the channelization edge and mid-channel habitats in the three reaches (Figure 4). In comparison to the other habitats, samples from the restored meander edge habitat had lower scores on DCA axis 2. The trichopteran family Glossosomatidae had the lowest score on DCA axis 2, and more than 99% individuals of this family were *Padunia forcipata*.

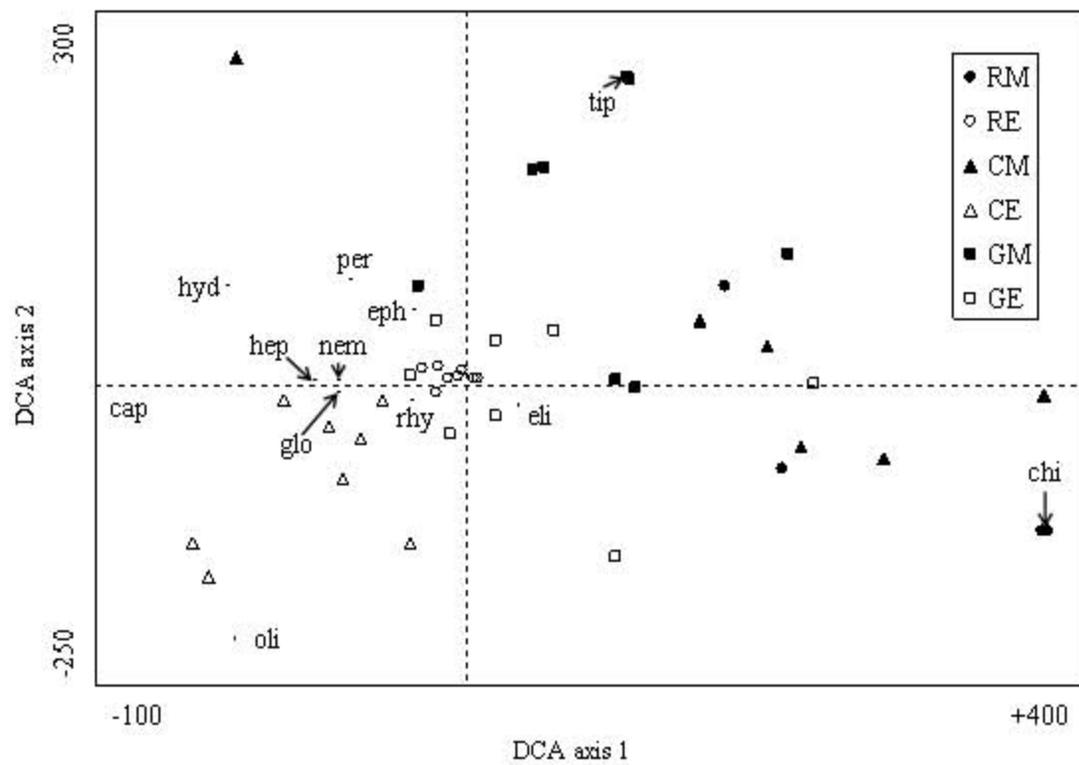
Figure 5. DCA ordination of macroinvertebrate communities from different habitat types in the Shibetsu River, November 2003. Abbreviations for habitat types are given in Figure 4. The location of each taxon is marked with ●, and taxa codes are: cap = Capniidae, chi = Chironomidae, eli = Elmidae, eph = Ephemerellidae, glo = Glossosomatidae, hep = Heptageniidae, hyd = Hydropsychidae, nem = Nemouridae, oli = Oligochaeta, per = Perlodidae, rhy = Rhyacophilidae and tip = Tipulidae.

In November, the first two axes of the DCA ordination accounted for most of the variation in the family data, with eigenvalues of 0.185 and 0.112 for axis 1 and 2, respectively. The total inertia was 0.679 and the first two axes explained 44% of this variation. The macroinvertebrate community in the groyne edge habitat overlapped the restored meander edge habitat, which was clearly separated from the channelization edge and mid-channel habitats in the three reaches (Figure 5). In contrast to June, the channelization edge habitat was separated from the other habitats.
