A challenge to dam improvement for the protection of both salmon and human livelihood in Shiretoko, Japan's third Natural Heritage Site

Futoshi Nakamura¹ and Eishige Komiyama²

Article type: Report

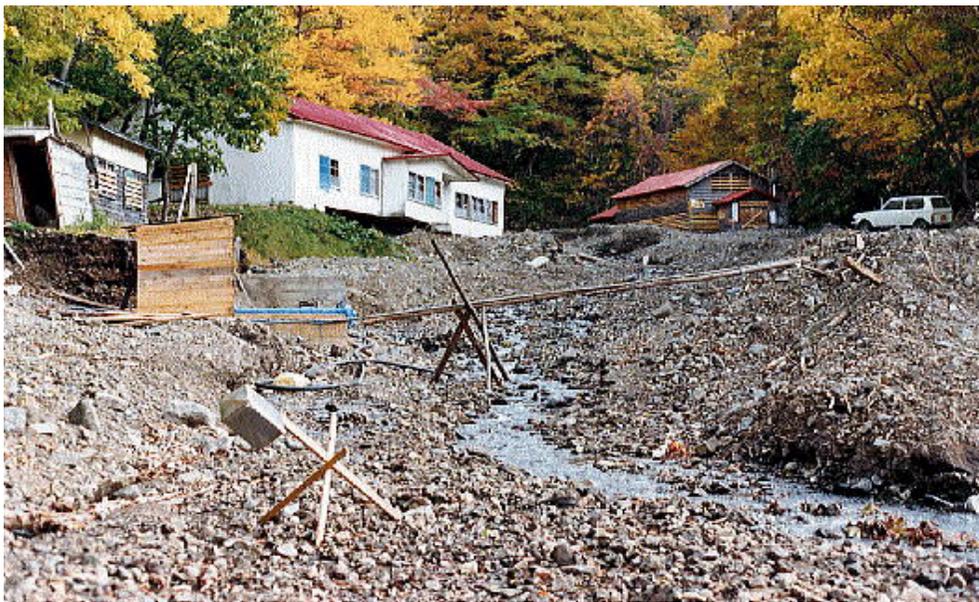
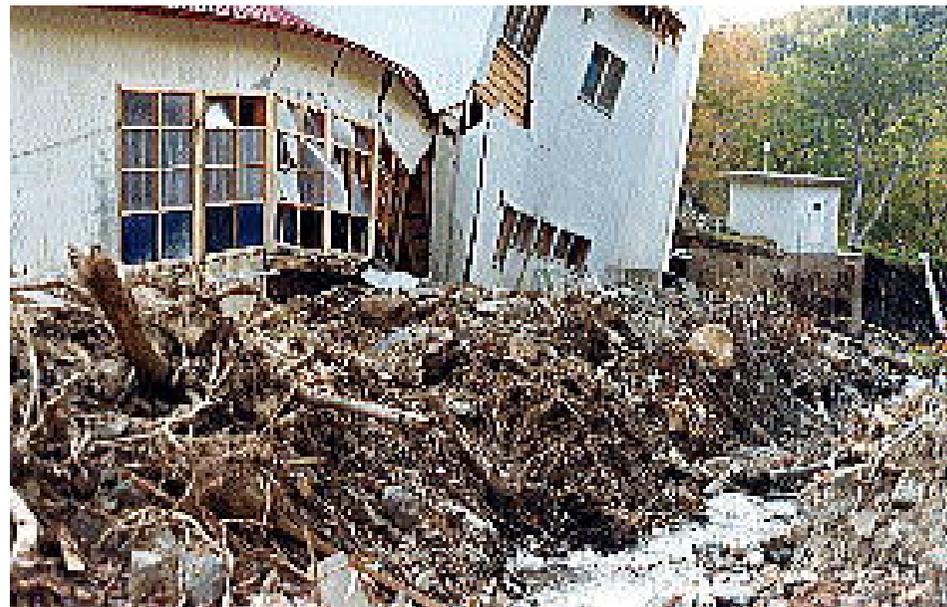
Fig. 5 Debris flow damage from the Iwaubetsu Stream in August 1981.

The total channel length of Iwaubetsu Stream is 10.5 km, and the watershed area is 41.0 km². A town road has been laid along the mainstem. Other human developments along the stream are the town road to Shiretoko-goko Lakes and a bridge in the lower reaches, Iwaubetsu Hot Spring Resort in the middle and a trail to Mt. Rausu in the upper reaches. There is a salmon hatchery in the furthest-downstream watershed. The 1979 and 1981 typhoons triggered debris flow and swept away a part of the town road to the hot spring (Fig. 5).

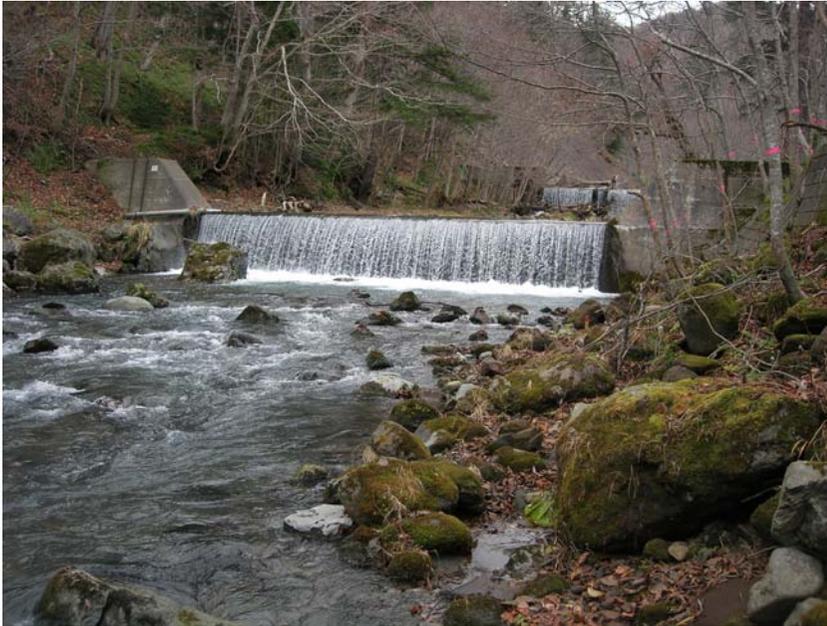
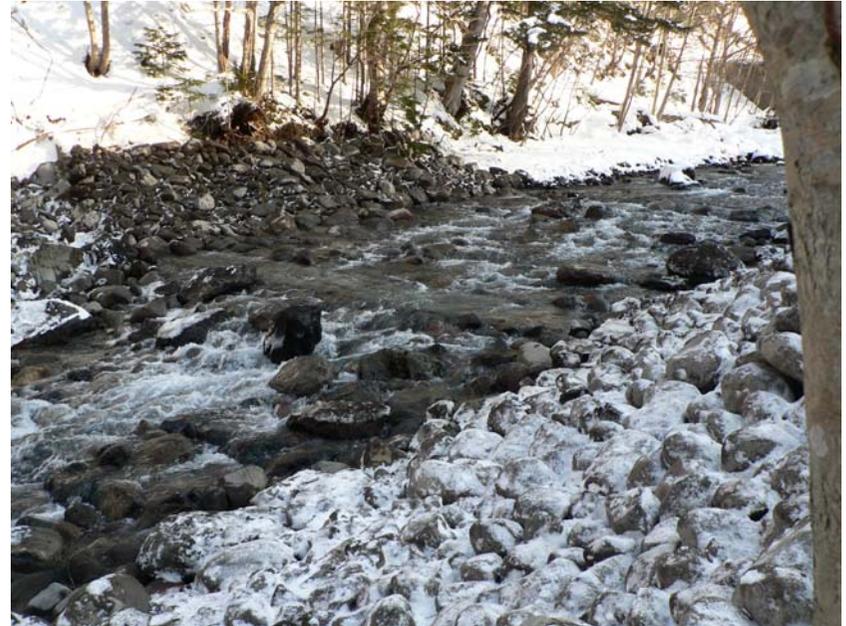
Fig. 6 Dam modification in Iwaubetsu Stream: before and after improvement.

The channel slope was manufactured experimentally from natural rocks to meet three conditions: unimpeded upstream migration, a restored view worthy of a world natural heritage site, and retention of the original erosion control function. The height of the dam was cut down by 1 m, and the channels above and below the dam were sloped with natural rocks. Rocks were fixed with wires. A field test using pink salmon confirmed passage over the modified dam.

The RCWG decided to cut down the bulkhead of the dam by 1m. The channels above and below the dam were sloped with natural rocks. Rocks were fixed with wires using a stone assembling technique, in an irregular arrangement to create a natural appearance. The bed slope was designed to not impede upstream migration, to restore a view worthy of a world natural heritage site, and to retain the original erosion control function (Fig. 6).

In September 2007 a monitoring survey was carried out for this dam. Downstream of the modified dam, a small dam built by the Town of Shari blocks the salmon run; therefore, we could not monitor the natural migration of salmonids (the Town's dam was improved later).

Instead, we released pink salmon below the modified dam, and evaluated their upstream migration over the dam. A pair of breeding salmon was allowed to swim above the dam to release pheromones downstream, which attracted the individuals below the dam.

The fish passage study confirmed that eight out of 15 released fish (53%) and 11 out of 15 released fish (73%) migrated above the dam in the first and second trials, respectively. In the first trial, the fish were tagged, which may encumber their behavior and result in a lower percentage of dam passage. Based upon the field observations, the failure of some salmon to pass the dam was not due to structural problems of the modified dam. Instead, some of the released male and female salmon tried to pair up downstream of the modified dam, and other individuals did not attempt to run upstream but swam downstream immediately after release. In spite of these problems in our releasing experiments, we believe that the modification facilitates the upstream run and extends spawning habitat.

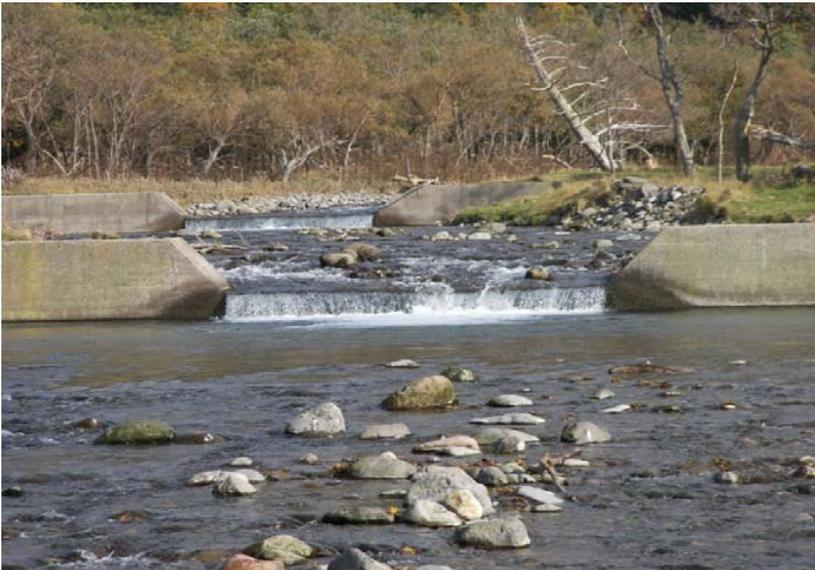
Fig. 7 Dam modification in Rusha Stream: before and after improvement.

To remove the obstacle posed by the currents and the vertical drop, a 'slit' was created

by cutting down the center of the crest, and a ‘notch’ was created by carving only the downstream edge of the crest on both the right and left bank sides. A field survey after modification found that the number of chum salmon redds increased.

One of the problems created by these low dams is the occurrence of detached flows out of the concrete structure. The only way for fish to pass the detached flows and the elevation gap is by jumping from the downstream pool. Jumping is an energy-consuming activity, and the success rate is low. In order to improve this situation, the center of the crest was cut down to create a rectangular opening or 'slit', and the downstream edge of the crest was carved into a 'notch' on both the right and left bank sides. These improvements altered the detached flows previously observed, producing attached flows on the carved surfaces (Fig. 7).

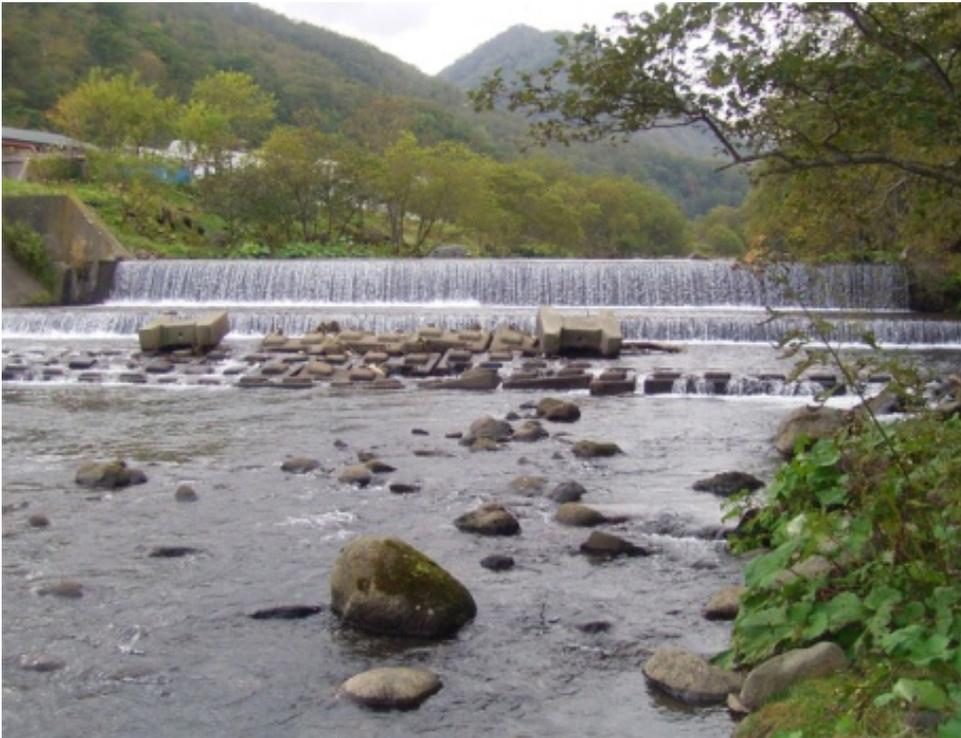
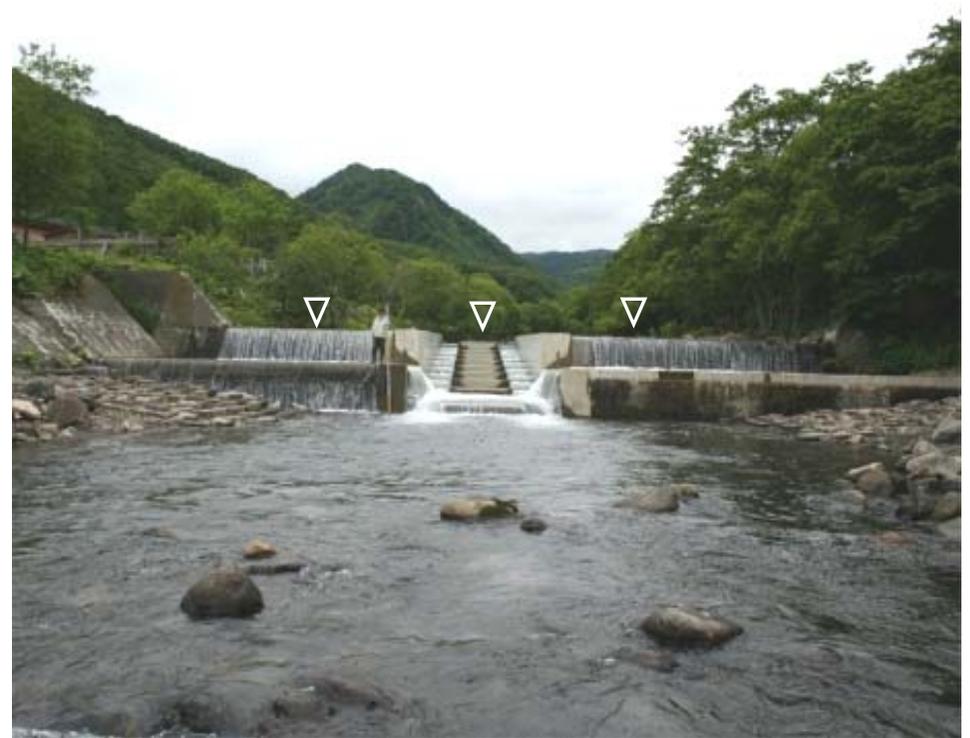
Fig. 10 Dam modification in Rausu Stream: before and after improvement.

A slit was created at the center of the dam, and a fish ladder was built extending from the slit to upstream of the dam. Fish are able to find an entrance of the ladder easily if fish ladder extends upstream from the dam. Water drains not only into the fish ladder at the center but also through spillways on both sides as indicated by “▽”.

Of these, we modified 18 weir dams by installing slits and fish ladders: five in 2005, six in 2006, five in 2007 and two in 2008 (Fig. 9). The slit in each dam was created at the center of the dam, and a fish ladder was built from the slit to upstream of the dam. Fish may lose their way if the fish ladder extends downstream from the dam, but they can easily find the entrance if the fish ladder extends upstream as in the modification design used in Rausu Stream (Fig. 10). One problem with this style of fish ladder is that a large amount of stream water concentrates in the fishway, and the water velocity in the ladder may exceed the appropriate level for upstream migration of fish. In order to prevent this situation, stream water was split upstream of the dam by the sidewalls of the fish ladder (Fig. 11).

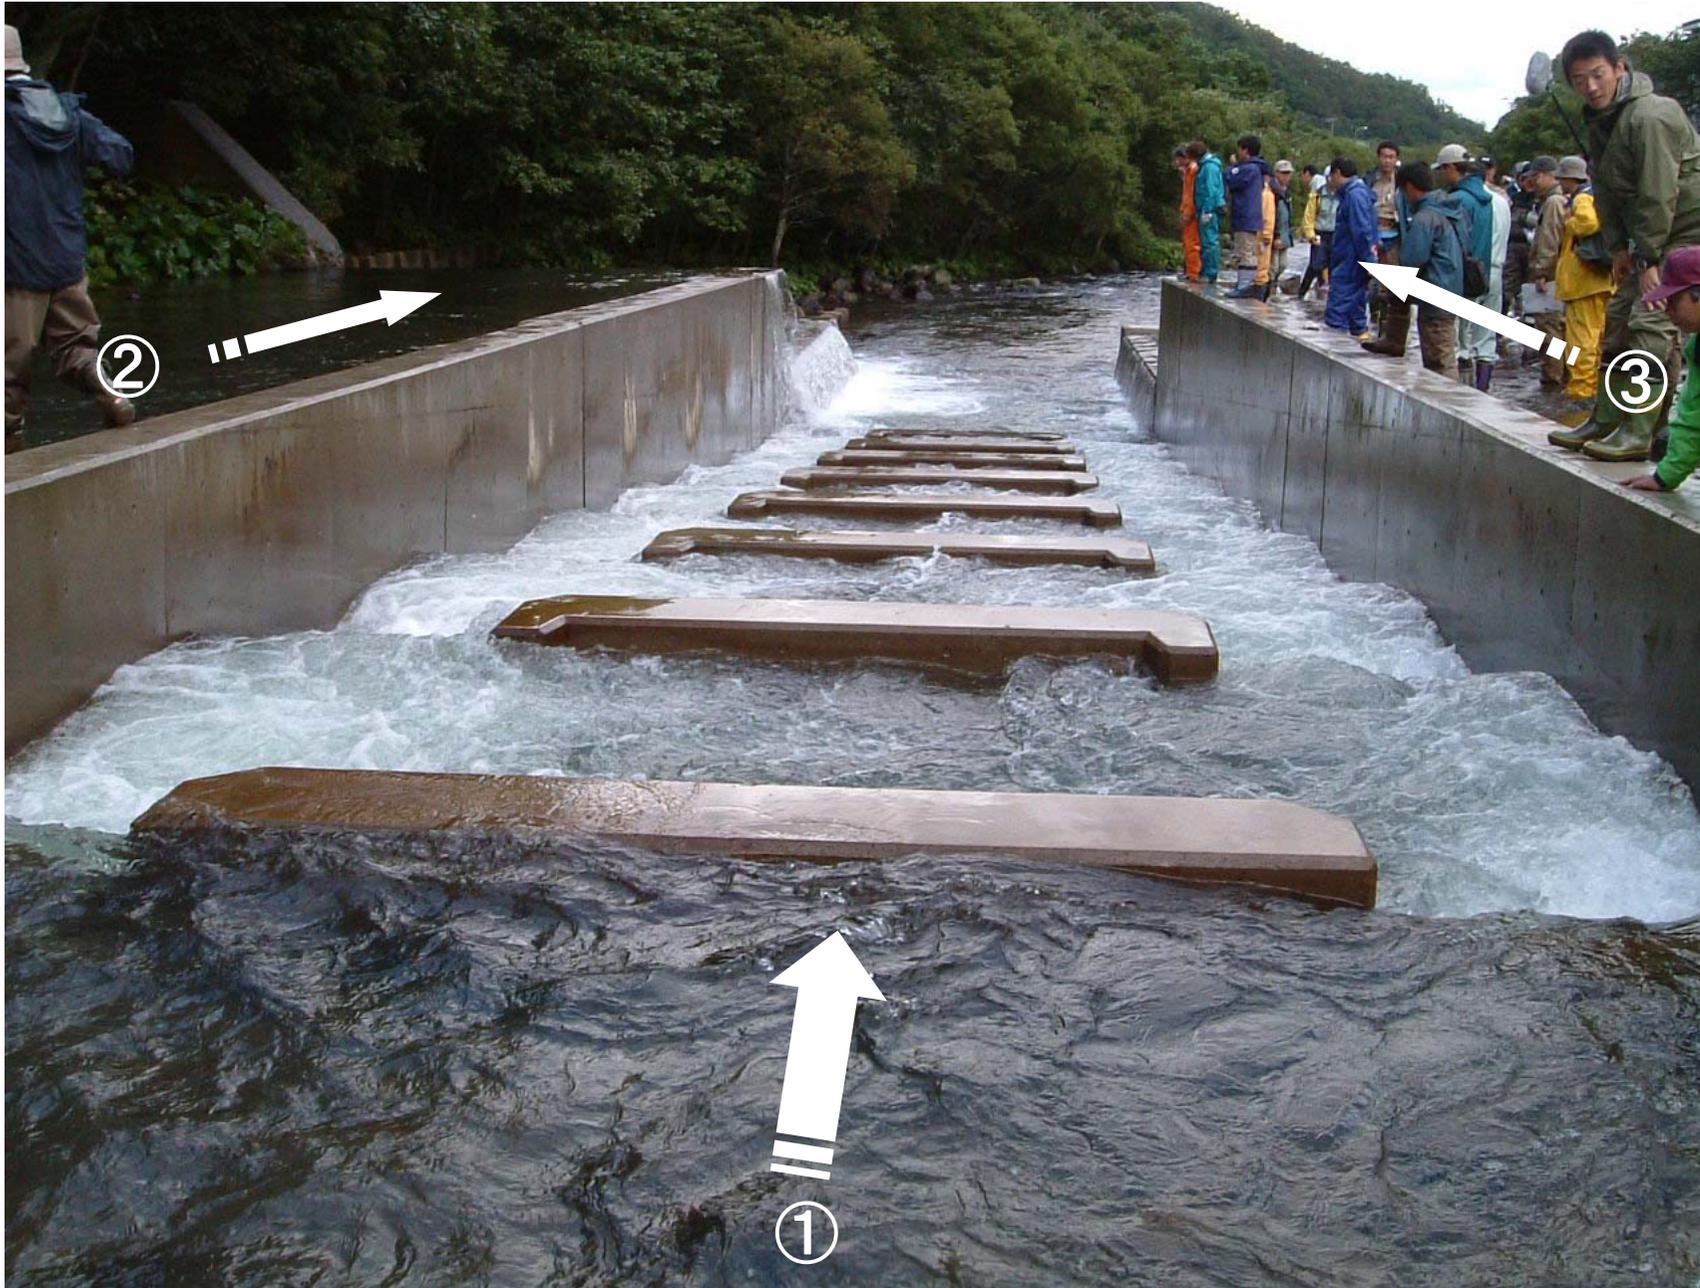
Fig. 11 Upstream conditions of dam modification in Rausu Stream.

In order to avoid all stream water draining into the fish ladder, the stream flow is diverted (① - ③ in the picture) upstream of the dam by the concrete sidewalls of the fish ladder, which are aligned parallel to the stream flow. Arrows in the picture indicate flow direction.
