| Citation | Proceedings of the Thirteenth East Asia-Pacific Conference on Structural Engineering and Construction (EASEC-13), September 11-13, 2013, Sapporo, Japan, C-3-6., C-3-6 |

# THE REGULATIONS FOR REPAIR WORK ON LANDMARKED BUILDINGS

## - IN THE CASES OF 1930S' HIGH-RISE HOUSING IN NEW YORK CITY

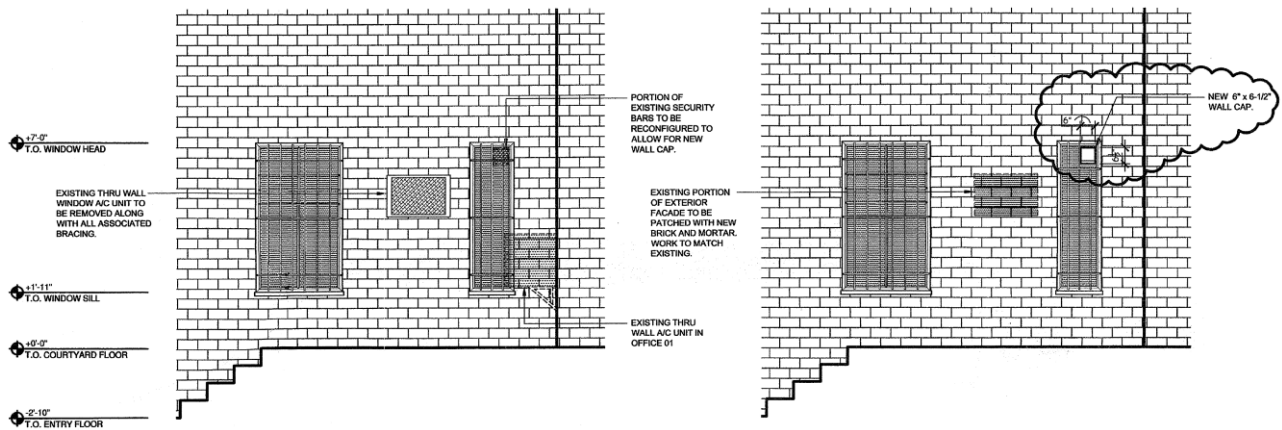
**Figure 1: San Remo's wall cap installed in an existing window opening [8]**  
**Left : Existing east façade elevation. Right : Proposed east façade elevation.**

Table 3 showed the permit records of San Remo (1987 - 2009), Eldorado (1985 - 2009) and Ritz Tower (2002 - 2009) from Landmarks Preservation Commission. A great deal of repair contents is (A)Air Conditioners, (E)Masonry & Wall Surfaces and (H)Windows. For example, in the case of San Remo, architect Dan Allen checked “Guidelines and Material Checklists for Performing work on landmarked buildings” of the Air Conditioners, Wall Surfaces and Windows to fill in the CNE apply form 19 Jan, 2005. Then commissioners checked the photos, drawings, color sample, conditions statement, document of the original design details for repair work according to the upper law “administrative Code of the City of New York” and “Title 63 of the Rules of the City of New York”[7] , approved the job from 2005 to 2009. Figure 1 shows wall cap (Cloud marking) installed

in an existing window opening at the cellar. The work was approved by Section2-11, “Title 63 of the Rules of the City of New York”.

| Building name | Issue date | Permit type | Depend on what Rules | Repair work content |
|---|---|---|---|--|
| | | | (T-63) Section2-11 | Location : At the cellar<br>(H-10) Wall cap is installed in an existing window opening. (Figure 1) |
