STUDY ON FALL PROTECTION FOR ASSEMBLING AND DISMANTLING WORKS OF SYSTEM SCAFFOLDS

K. OHDO*, S. TAKANASHI, Y. HINO, and H. TAKAHASHI

Construction Safety Research Group, National Institute of Occupational Safety and Health, Japan

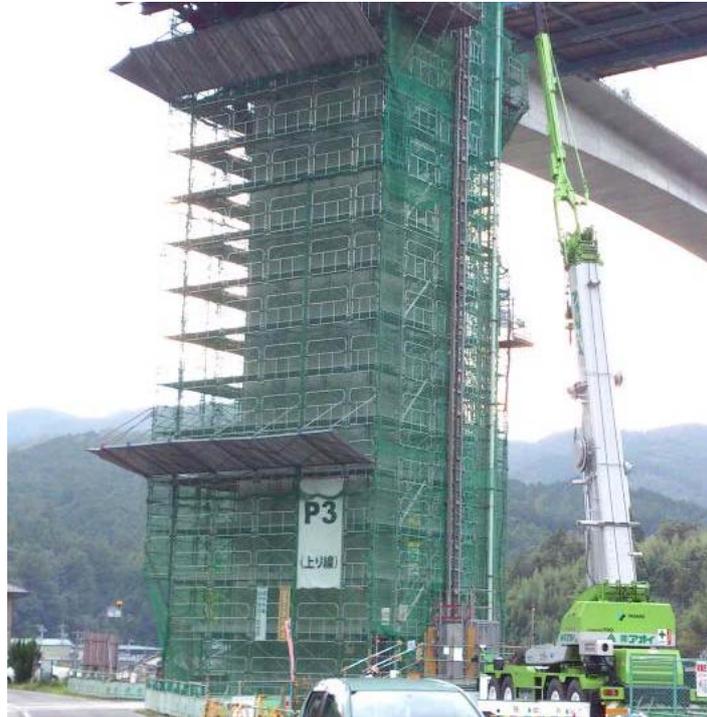
Figure 1: Prefabricated scaffolds assembled by Advanced Guardrail Installation Method.

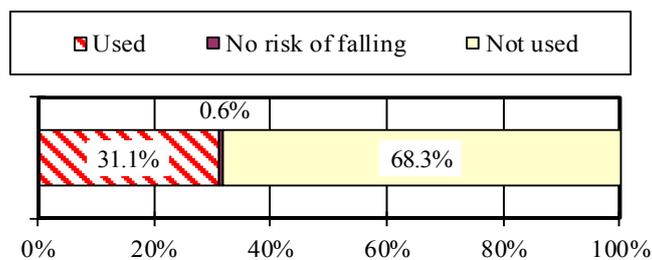
However, it was discovered that this method is not widely used. The MHLW investigated the use rate of this method on 4,892 construction sites. The result is shown in Figure 2. Only 31% of construction sites used this method, and it was found that the use of the method was not widespread, especially for system scaffolds due to a low working property of the methods. Therefore, in this study, other assembling and dismantling method for system scaffolds were examined for the safety work. Finally, the assembling work of the system scaffolds was performed to examine whether the method was practicable.

Figure 2: The use rate of Advanced Guardrail Installation Method.

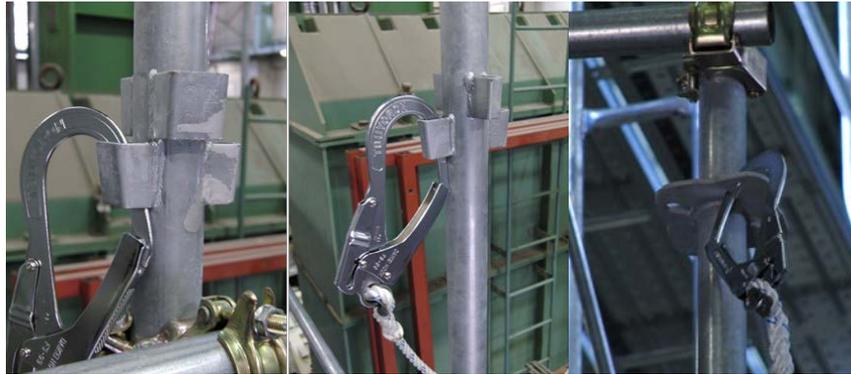
In this study, typical system scaffolds by wedge connections in Japan were selected to examine the safety assembling and dismantling method for prevention the fall from the scaffolds. Then, it was decided that wedge pockets were used for connecting the hook of the safety harness to the scaffolds for fall prevention. Three types of the system scaffolds in Japan were selected in this study. Figure 3 show the typical wedge pockets of the selected system scaffolds and the hook of the safety harness connected to the wedge pockets.

Figure 3: Typical wedge pockets and the hook of the safety harness (Left: Type A, Center: Type B , Right: Type C).

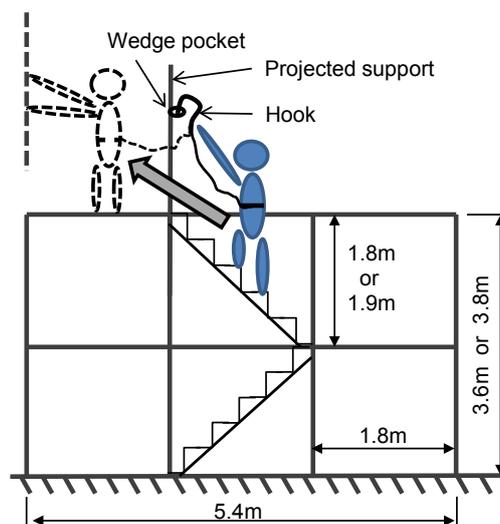
When workers use the safety harness on the scaffolds, the horizontal stability of the scaffolds must be confirmed. In Japan, the ties, which connect the scaffolds to the building wall, shall be installed within 5m (vertical) \times 5.5m (horizontal) to keep the horizontal stability of the scaffolds by Occupational Safety and Health Regulation (Ministry of Health, Labour and Welfare, Japan 1972). For the case of typical system scaffolds selected in this study, the height of 1 story is 1.8m or 1.9m, and the width of 1 bay is 1.8m. From these reasons, the ties are assumed to be installed within 2 stories (3.6m or 3.8m) \times 3 bays (5.4m) for the selected scaffolds. Therefore, the height and width of the scaffolds were decided to be this maximum tie spacing, as shown in Figure 4.

Figure 4: 2 stories and 3 bays scaffolds.

In the experiment, the safety of the fall protection by the safety harness during the assembling or dismantling works above the 2nd story of the scaffolds was examined. A support with wedge pockets was projected above the 2nd story as shown in Figure 4, because it is recommended that the hook should be connected above the ring of lanyard to reduce the damage of falling workers (National Institute of Industrial Safety 2004). Then, the strength of the wedge pocket projected above the 2nd story of the scaffolds must be also confirmed.

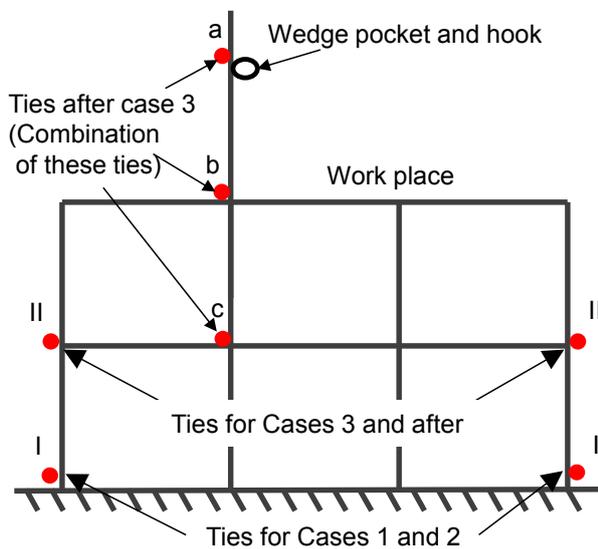
The horizontal stability of the scaffolds and the strength of the wedge pocket were confirmed by fall experiments using a human dummy. Figures 5-6 show the structure of the scaffolds in the experiments, and Table 1 shows the experimental cases. Configurations of ties were changed to confirm the stability of the scaffolds and the strength of the wedge pocket in various conditions, as shown in Figures 5-6 and Table 1. The experiment in Figure 6 was performed for confirming the strength of the guardrail.

Figure 5: Configurations of ties.

Table 2 shows the results of the experiment. In the cases 1 and 2, the ties were installed at the points of I in Figure 5, which is 2 stories down from the work place. The horizontal displacement of the scaffolds exceeded 300mm, when the human dummy was dropped in these cases. Then, it seemed that the scaffolds were unstable by the video observation of the experiments.

In the case 3, the ties were installed at the points of II in Figure 5, which is 1 story down from the work place, and the horizontal displacement of the scaffolds was also observed after the experiment. From the result of the experiment, it was found that the horizontal displacement did not exceeded 300mm, and it seemed that the scaffolds were stable by the video observation. Therefore, in the experiments after the case 3, the ties were installed at the points of II, as shown in Figure 5.

In the cases that the ties were installed at the points of a and b in Figure 5, it was assumed that the impact load concentrated on the wedge pocket by the fall of the human dummy. In the cases that the ties were installed at the point of c in Figure 5, it was assumed that the moment concentrated on the bottom of the projected support by the fall of the human dummy. The experiments were carried out in consideration of these configurations of ties to confirm the strength of the scaffolds' members.

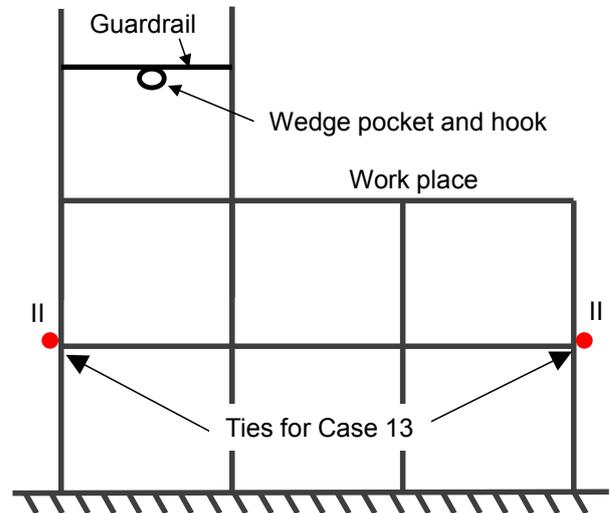
Figure 6: Configurations of ties (Case 13).

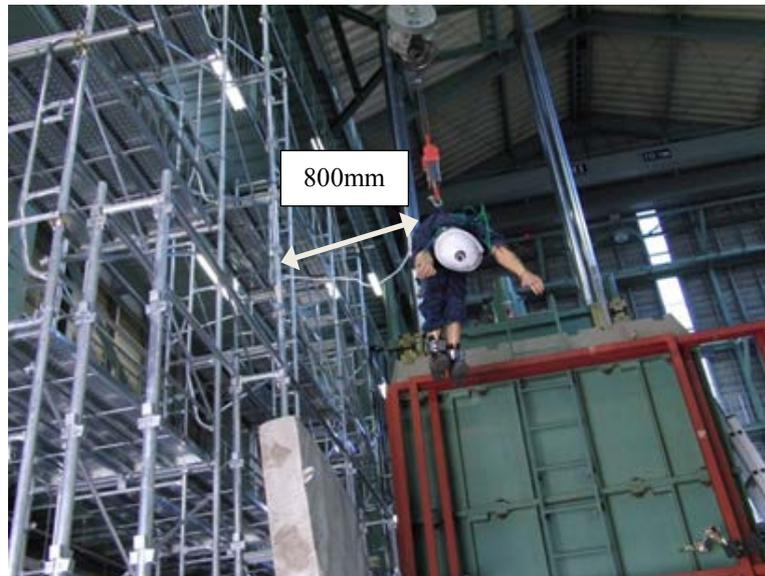
In the experiment, the human dummy, of which weight was 980N was dropped from the same height of the hook of the harness, and the distance between the hook and the human dummy was set to be 800mm as shown in Figure 7. This experimental method was the same way as the fall test by Advanced and Secured Handrail (Japanese Industrial Standards 2006). After the experiments, it was observed the horizontal displacement of the scaffolds and the damage of the wedge pocket, support, guardrail and the hook.

Figure 7: Experimental method for drop of human dummy.

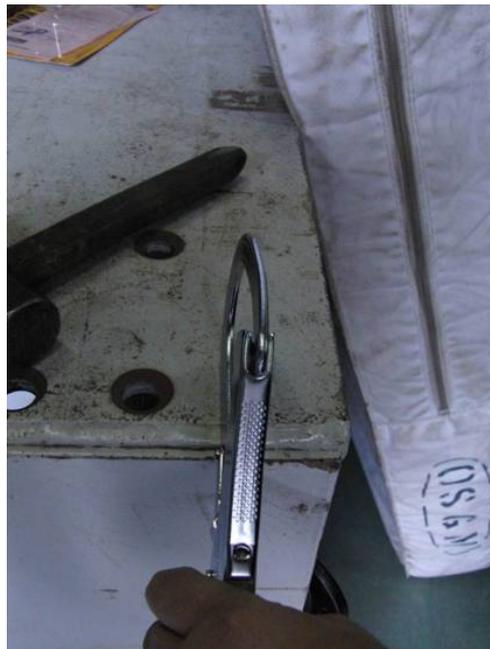
Figure 8: Slight curved hook by the fall experiment.

In a series of these experiments, there were no damage or only a slight damage in the wedge pocket, support, guardrail or the hook, as shown in Table 2 and Figure 8. Therefore, in the case when the ties were installed within 1 story from the work place, it was confirmed that the assembling and dismantling works of the system scaffolds could be performed safe, concerning the stability of the scaffolds and the strength of the scaffolds' members.

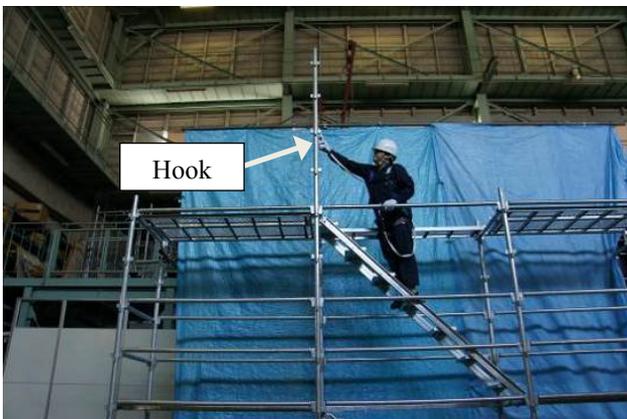
Figure 9: The worker who tried climbing the stairs to the next platform.

First, the worker tried climbing the stairs to the next platform. Then, the hook of the harness could be hung to the wedge pocket with previously projected support, as shown in Figure 9, because it is recommended that the hook should be hung above the ring of lanyard (above the waist) to reduce the damage of falling workers by the Recommendations for Use of Safety Belts (National Institute of Industrial Safety 2004). After climbing to the next platform, the worker tried setting other supports, as shown in Figure 10. Then, the worker could be performed with using the harness.

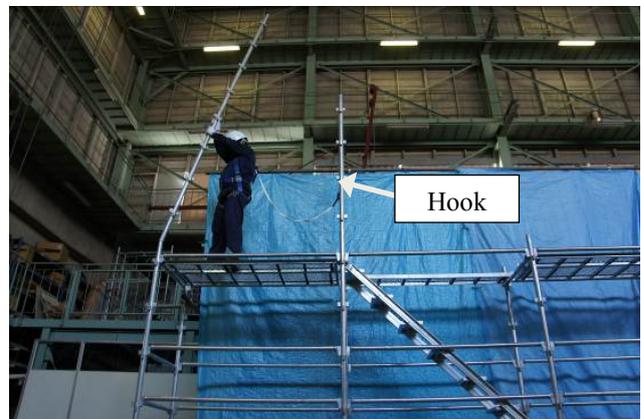
Figure 10: The worker who tried setting other supports.

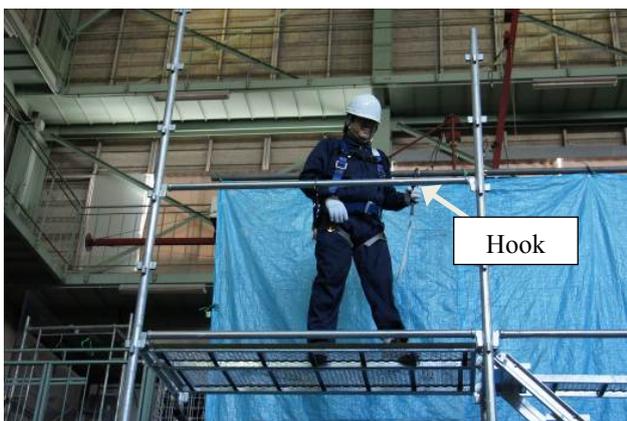
Figure 11: The worker who tried setting the guardrail between the supports.

Next, the worker tried setting the guardrail between the supports, and then the worker could hang the hook of the harness to the guardrail, as shown in Figure 11. After this work stage, the worker could assemble the scaffolds on the next platform with hanging the hook of the harness to the guardrails at all times, as shown in Figure 12. The dismantling work of the scaffolds could be also performed in the reverse order of the assembling work.

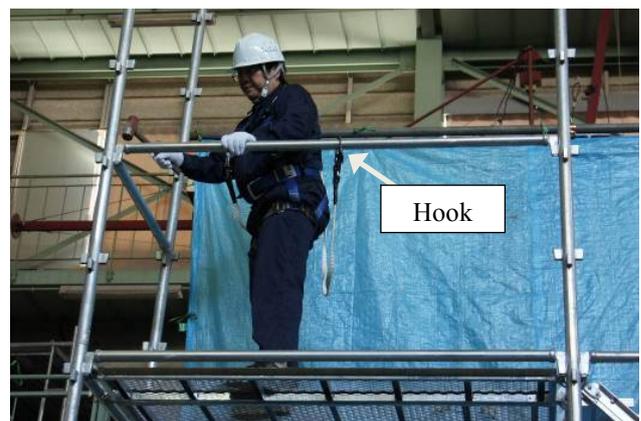
Figure 12: The worker who tried setting other members with hanging the hook of the harness to the guardrail.
