Doctoral Dissertation

**Development of Microwave Non-destructive
Inspection Equipment for Outer Wall Tiles**

Course of Systems Science and Informatics
Graduate School of Information Science and Technology
Hokkaido University

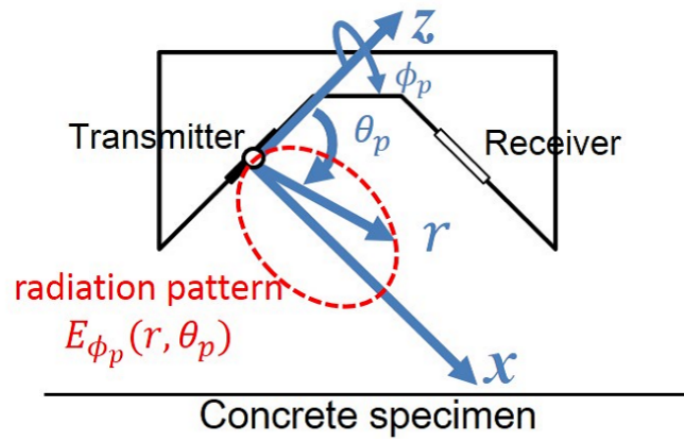
Figure 2.4: Calculation of the radiation pattern using the cavity model

(a) Overview of the cavity model

(b) Radiation pattern of the micro-strip antenna

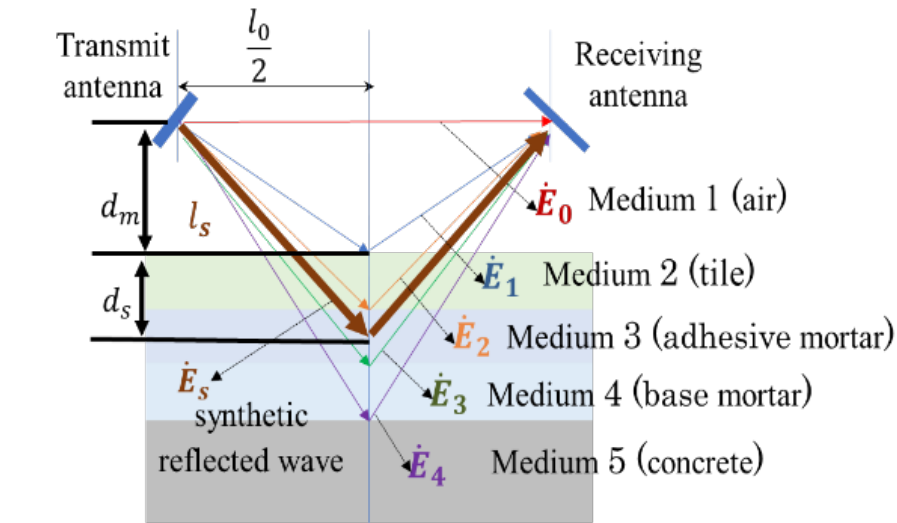
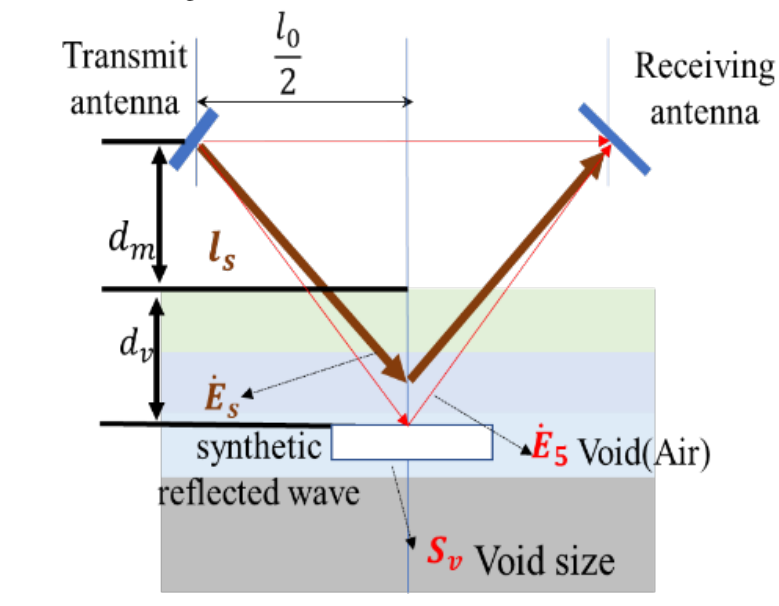
Figure 2.8: Existing electromagnetic wave reflection transmission model

(a) Electromagnetic wave (EMW) reflection from non-detective tiles.

(b) EMW reflection from defective tiles.

In this section, the effect of void size on the reflected wave E_5 is described. Fig 2.8b displays the reflected waves from the various void sizes, S_v . In this case, the unreflected waves were ignored. The value of the waves reflected from the voids E_5 can be calculated as $E_5 = E_5 \sin(\omega t + kl_5)$, and the total of the waves reflected from E_5 depends on the value of $\alpha(S_v)$. A direct relationship exists between α and S_v , a condition $0 < \alpha < 1$ exists because, if α is zero, no void exists. In addition, if $\alpha > 1$, then it represents an object with unlimited void size according to the antenna wave coverage area, as displayed in Fig 2.9.

When considering the case in which an actual void exists, as displayed in Fig.2.8b, the total reflected wave from the defective specimen E_v can be calculated by adding the wave reflected from the void's reflected waves E_5 and the total reflected waves from the E_T as displayed in Eq2.18. Furthermore, the effect of void space $\alpha(S_v)$ was also included in the model. The waves that were not reflected from the voids were not considered in this model.

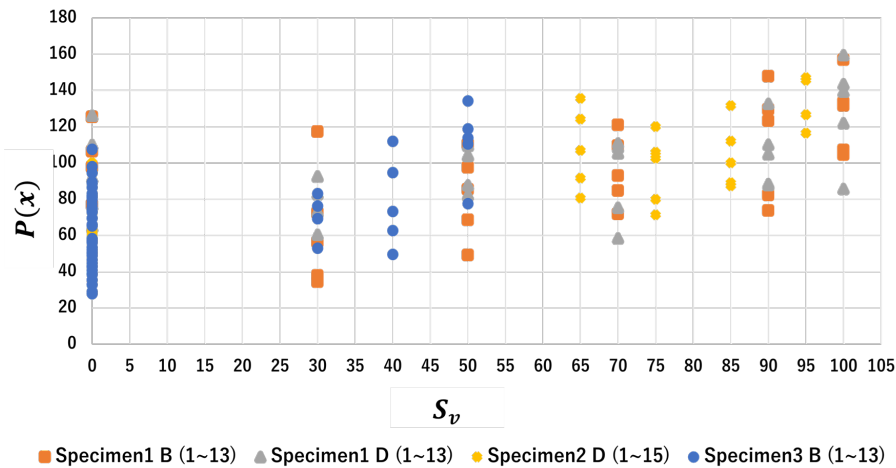
Figure 3.6: Result for the void size and results obtained with MLS

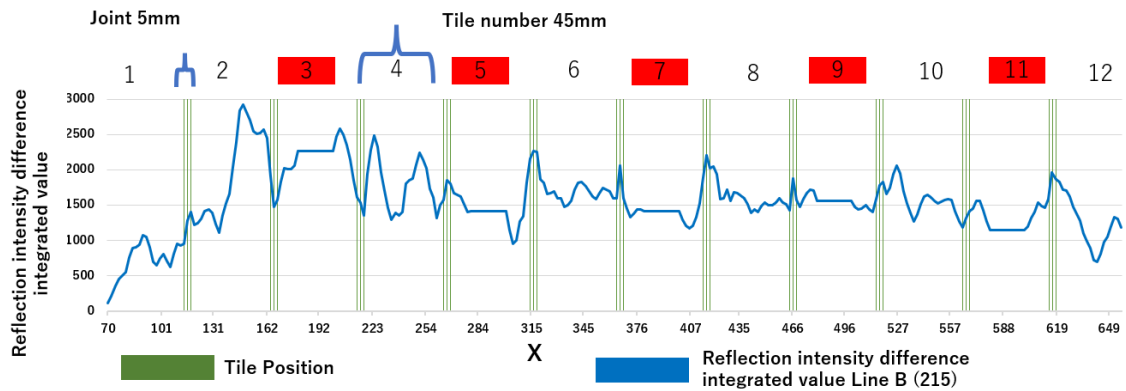
Figure 3.8: Distribution of $P(x)$

(a) Distribution at Y=215mm (Line B 225).

(b) Distribution at Y=225mm (Line B 215).

(c) Distribution at Y=415mm (Line D 425).

(d) Distribution at Y=425mm (Line D 415).

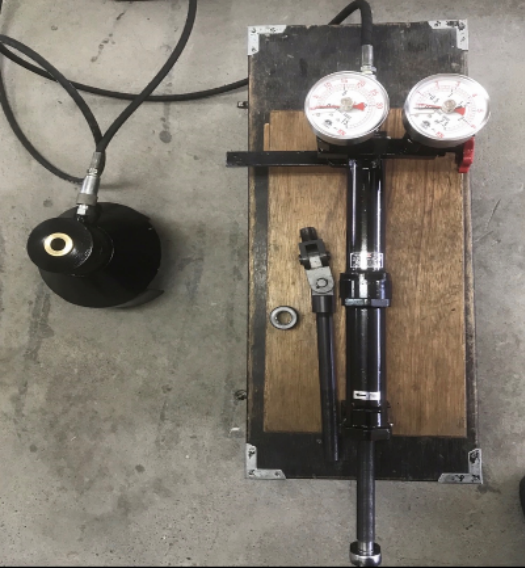
Figure 3.10: Research type adhesion tester.

The adhesion strength measurement was demonstrated using a manual construction research type adhesion tester (LPT-3000 Ox Jack Co., Ltd.). The design research type adhesion tester is shown in 3.9. Before using the tester, a hammering test was demonstrated to determine whether there was void or not. Fig.3.10 shows the parts of the tester. It consists of an analog load cell, a pump handle, and an attachment. When turning the pump handle clockwise, the attachment rises, and pulls the tile until it is removed (Fig.3.11). At the same moment the tile is removed, the power consumed to remove the tile measured by the analog load cell and recorded. The recorded data is shown in

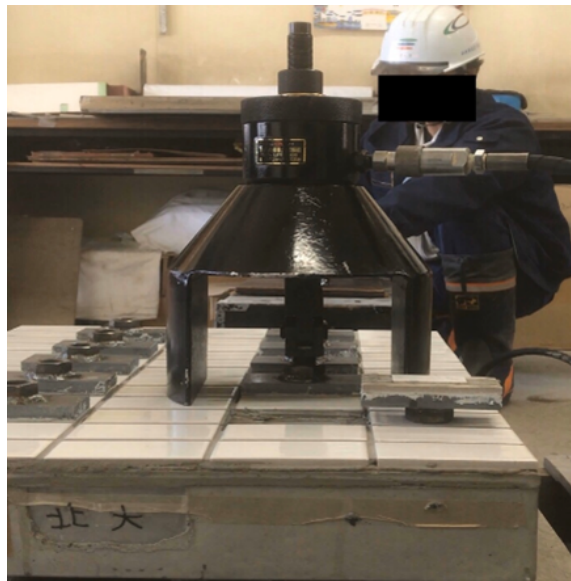
Figure 3.11: Removing the tile.
