Effect of Temperature Gradient in Ash on High-Temperature Corrosion of Super-Heater Material in a Waste Power Generation Boiler

T. Furugaki, H. Takahashi, S. Hayashi

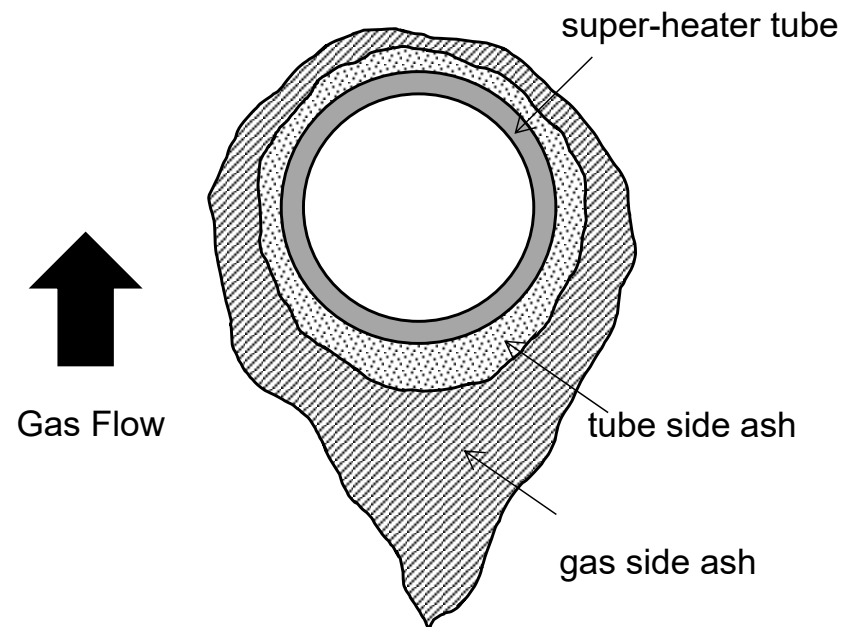
Figure 1 Schematic cross-section of combustion ash deposited on super-heater tube

In this study, combustion ash deposited on the surface of super-heater tubes in an actual waste incineration boiler was used in the corrosion tests. Figure 1 shows a schematic cross-section of the combustion ash deposited on a super-heater tube, and Table 2 shows the composition of the combustion ash sampled at different depths of the deposit by XRF (X-ray fluorescence). The alkali chloride content in the tube side ash was much higher at 31.3 mass% in comparison to the gas side ash at 11.4 mass%. Conversely, the oxide content in the gas side ash was higher than that in the tube side ash. Of these ash samples, the tube side ash, which was rich in alkali salts and highly corrosive, was used for the corrosion tests. The melting point of the tube side ash was confirmed by TG-DTA to be 519°C.

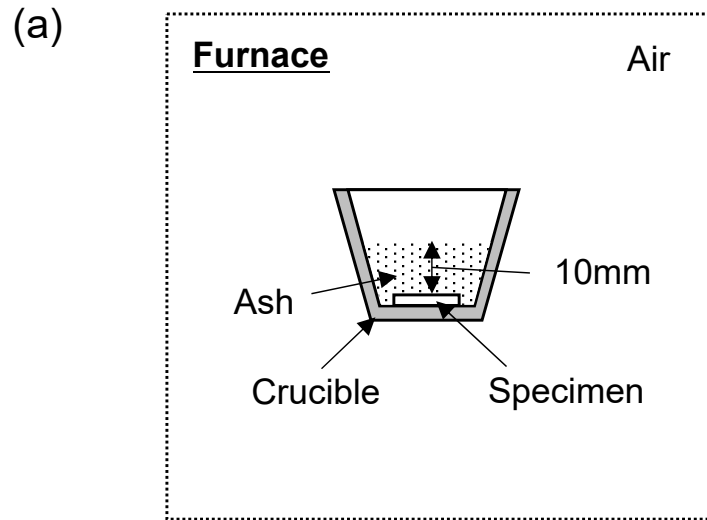
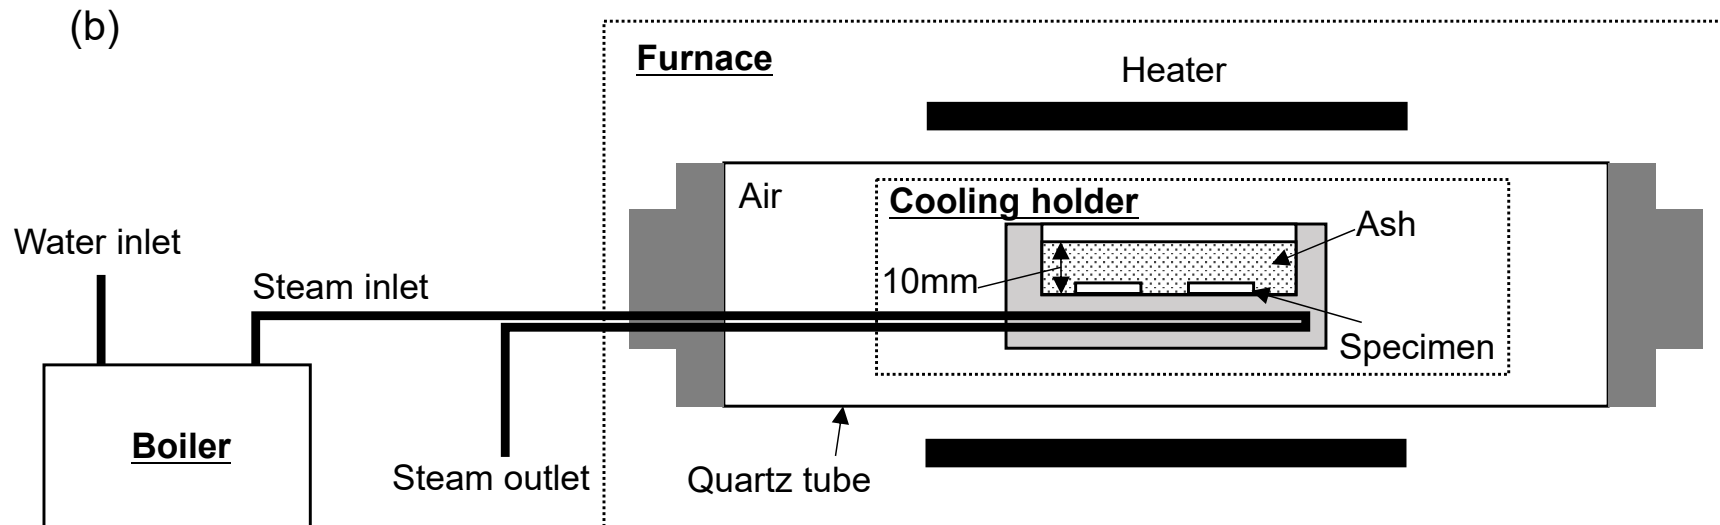
Figure 2 Schematic of corrosion equipment: (a) isothermal corrosion test, (b) temperature gradient corrosion test

Corrosion tests were performed in a furnace in air for 100 h. Tests were conducted either isothermally, where the atmosphere and specimens were set to the same temperature, or non-isothermally, i.e., the temperature of the atmosphere was set higher than that of the specimens. The isothermal corrosion tests were performed in a box furnace at 460 °C, as illustrated in Figure 2(a). The specimens were embedded in the ash at a depth of 10 mm from the ash surface in an Al₂O₃ crucible. The non-isothermal corrosion tests were performed in an open horizontal tube furnace, as illustrated in Figure 2(b). The specimens were embedded in the ash at a depth of 10 mm from the ash surface in the specimen holder and cooled by

feeding steam into the specimen holder. During corrosion tests, the temperature of the atmosphere was set to 685 °C and that of the specimens was set to 460 °C. The temperature was monitored by thermocouples inserted in the reaction tube and the specimen holder.

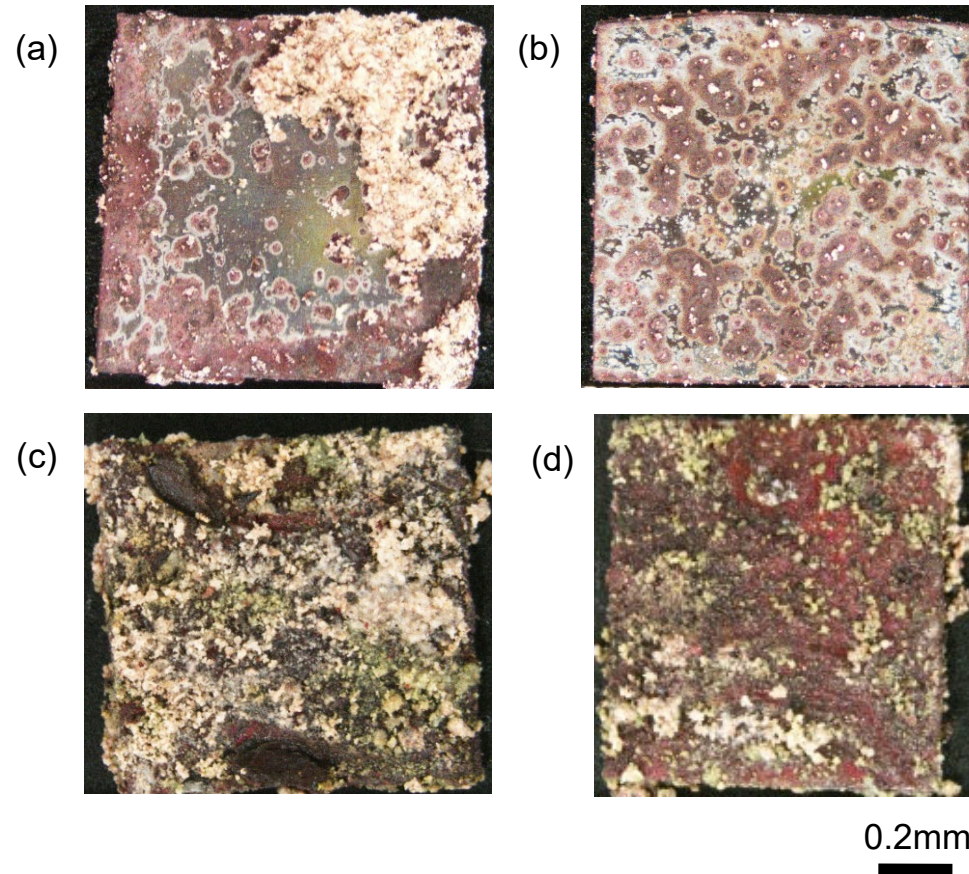
Figure 3 Surface observations of specimen after corrosion for 100 h:
(a) SUS310S after isothermal corrosion test, (b) QSX5 after isothermal corrosion test,
(c) SUS310S after temperature gradient corrosion test, (d) QSX5 after temperature gradient corrosion test

Figure 3 shows the surface appearance of the specimens after undergoing corrosion for 100 h. After the isothermal corrosion test, localized areas of the specimen surface changed to a bright brown color, and the metallic regions with interference color remained in other areas. In addition, the bright brown corroded areas appear to extend around those places where ash had accumulated. On the other hand, after the temperature gradient corrosion test, the corroded areas extended over the entire surface of the specimens with the corrosion products appearing as a dark brown color. Yellow and green colored reaction products can also be locally observed on the dark brown colored corrosion products combined with the white ash. These corrosion products are presumed to be Fe-rich oxides and Ca chromate, as described below.

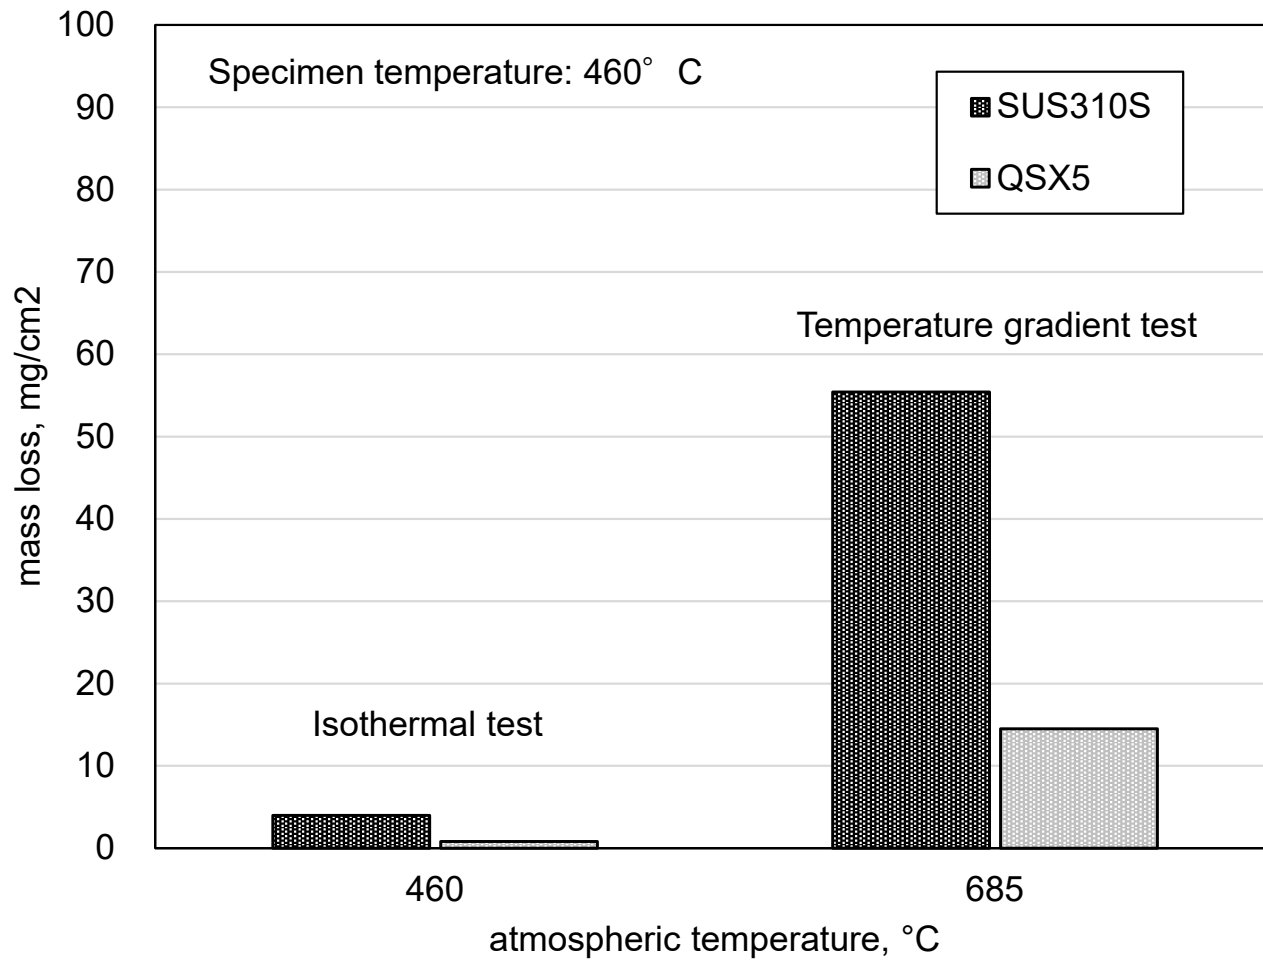
Figure 4 Mass loss after corrosion for 100 h

Figure 4 shows the mass loss of specimens after undergoing corrosion for 100 h. The corrosion mass loss of both steels was small in the isothermal corrosion test, but the mass loss of SUS310S tended to be greater than that of QSX5. However, in the temperature gradient corrosion test, it is obvious that the corrosion mass loss of SUS310S was much greater than that of QSX5, and the corrosion mass loss of both steels was more than 10 times greater than that which occurred during the isothermal corrosion test. This finding indicates that the temperature gradient in the ash accelerates the corrosion rate even though the specimen temperature is the same.

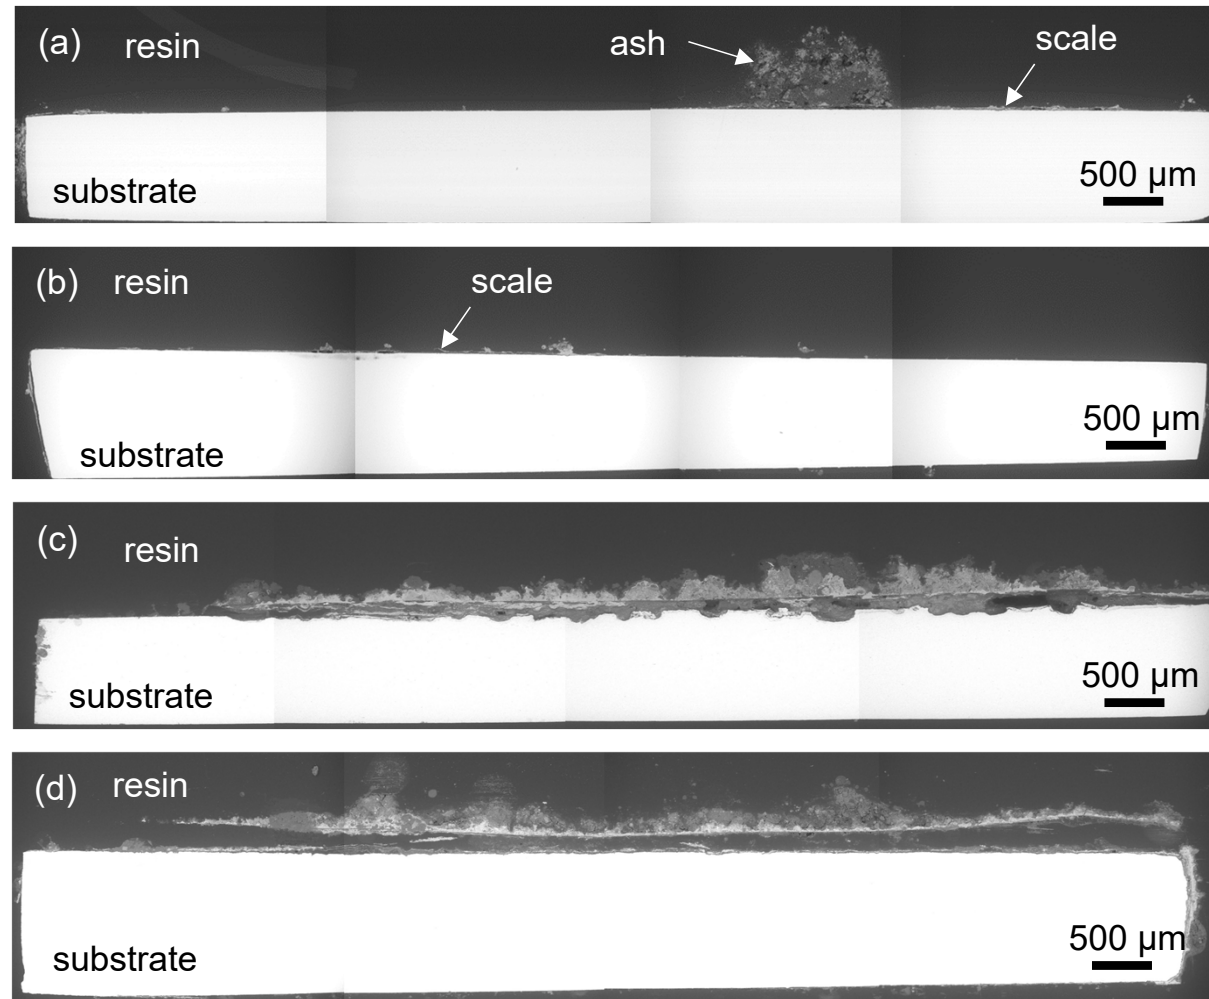
Figure 5 Cross-sections after corrosion for 100 h:

(a) SUS310S after isothermal corrosion test, (b) Q5X5 after isothermal corrosion test,

(c) SUS310S after temperature gradient corrosion test, (d) Q5X5 after temperature gradient corrosion test

Figure 5 shows the cross-sections of the specimens after corrosion for 100 h. A thin oxide scale formed on part of the specimen surface, but no penetration of corrosion products into the specimen can be observed following the isothermal corrosion test as shown in Figures 5(a), (b). However, almost the entire surface of both specimens became covered by a thick oxide scale following the temperature gradient corrosion test. Significant inward attack by can be observed in SUS310S and the surface of the specimen became very rough due to local penetration of corrosion products, as shown in Figure 5(c). However, such penetration of corrosion products was not clearly evident on the QSX5 specimen as shown in Fig. 5(d). This finding suggests that QSX5 has higher resistance to corrosion than SUS310S under the corrosion conditions present in this test.

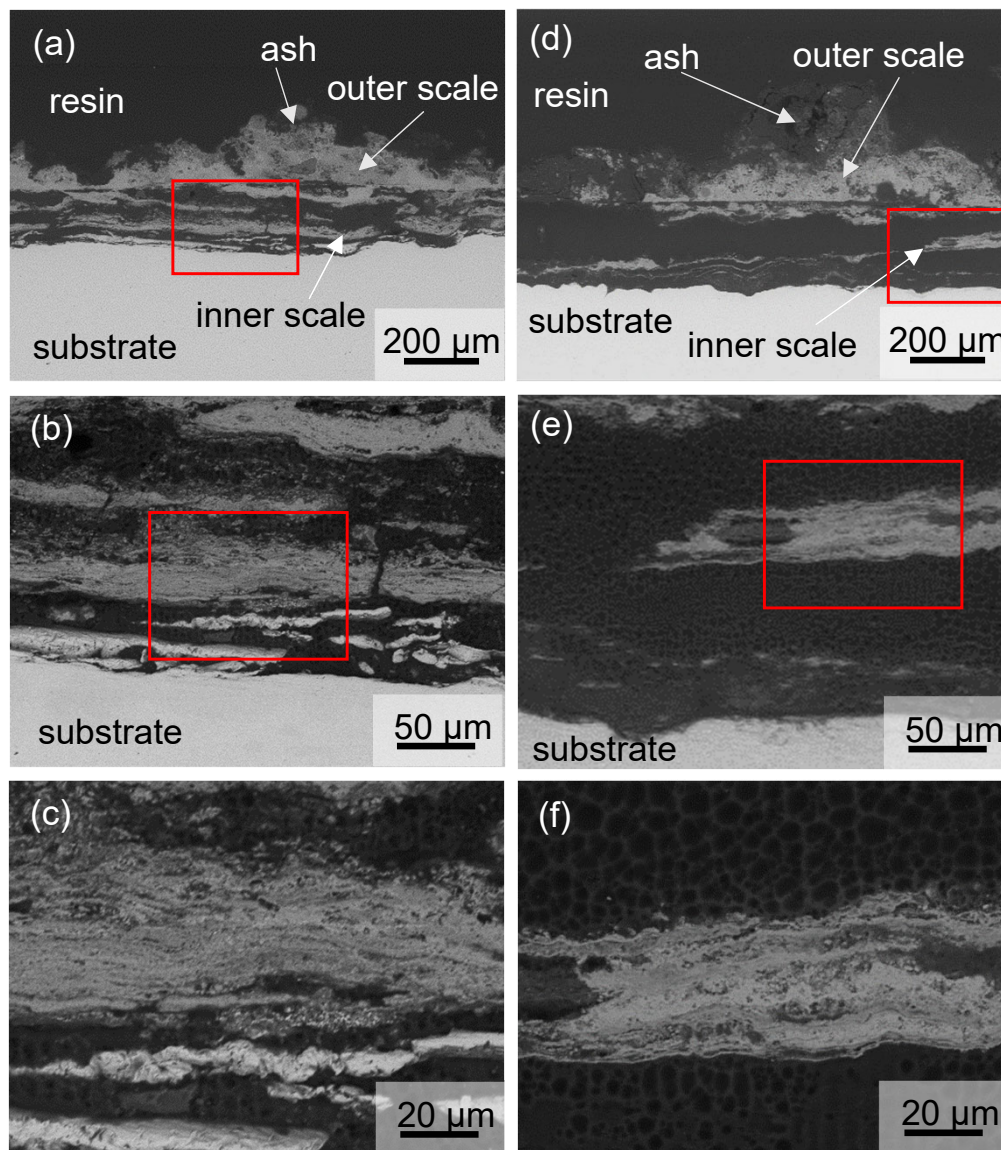
Figure 7 Cross-sections after temperature gradient corrosion test for 100 h:
(a), (b) and (c) SUS310S, (d), (e) and (f) QSX5

Figure 6 shows enlarged cross-sections of the specimen following the temperature gradient corrosion test for 100 h. The scale structure was similar for both steels, and the scale formed on the steels can be divided into two parts. The outer part of the oxide scale is very porous, and the ash has been incorporated into the oxide scale. The inner part of the oxide scale has a layer-by-layer structure and appears to penetrate into the alloy substrate.

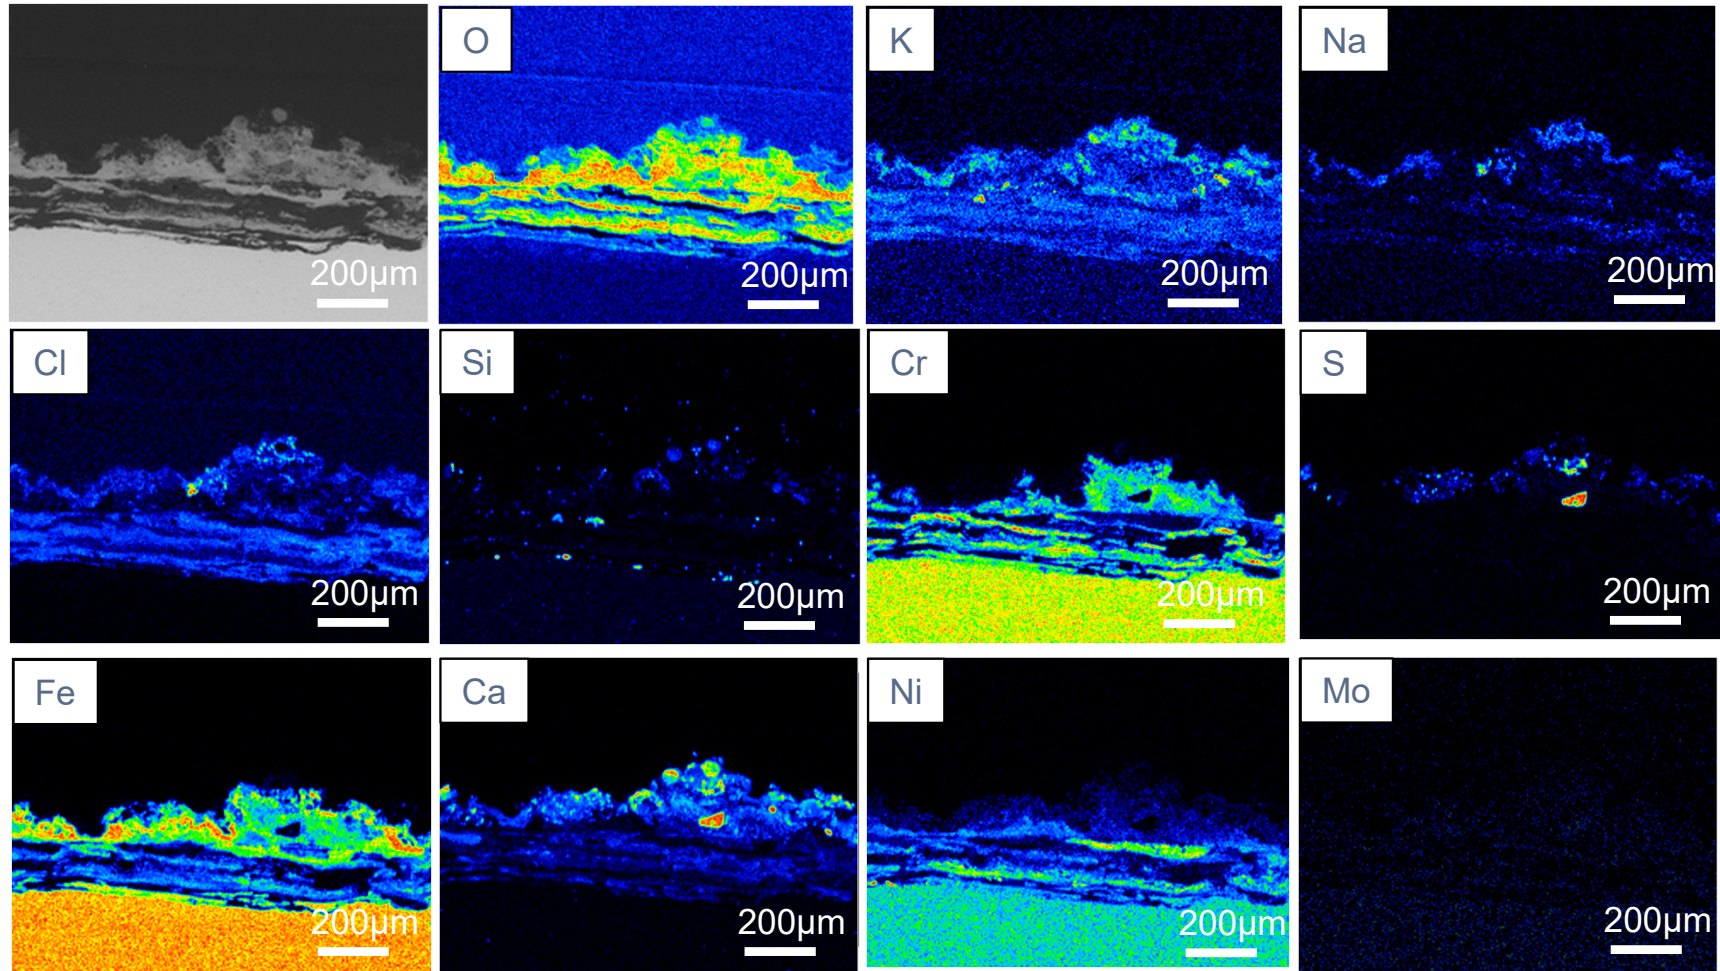
Figure 7 Elemental distribution maps of the cross-section of SUS310S after temperature gradient corrosion test

Figure 7 shows an electron probe microanalyzer (EPMA) map of each element in the oxide scale that formed on the SUS310S specimen after the temperature gradient corrosion test for 100 h. Although chlorine was detected over a wide area in the oxide scale, this might be due to contamination from the remaining ash and which occurred during polishing by oil. The regions where a strong chlorine signal was detected mainly corresponded to the ash, thus it was difficult to confirm chloride formation in the corrosion product based on this EPMA analysis. The outer porous oxide scale mainly consisted of an Fe-rich oxide and Cr is also detected in the Fe-rich oxide scale. The inner scale with a layer-by-layer structure mainly consisted of Cr-rich oxide but Ni+Fe oxides were also detected. Ca, K and Na were found not only in the ash but also in the areas of Cr oxide in the outer and inner oxide scale, suggesting that alkaline chromates had formed. Figure 8 shows the EPMA maps of each element in the oxide scale formed on the QSX5 specimen after the temperature gradient corrosion test for 100 h. The outer porous oxide scale consisted of mainly Fe-rich oxide, which contains a relatively high Ni content. Cr oxide was also observed locally below the outer Fe-rich oxide scale. Ca and Na were also detected in the inner Cr-rich oxide scale. K was mainly detected in the ash area. The inner scale with a layered structure mainly consisted of Cr-rich oxide, but Fe, Ni, Mo, and Si were also detected. Indistinct chlorine distribution in the oxide scale in Figure 8 could be also due to contamination during specimen preparation as mentioned above.

From the EPMA analysis results in Figs. 7, 8 and XRD in Fig. 9, the formation of chromates was confirmed. The vapor pressures of NaCl and KCl in the combustion ash at 460 °C were calculated using FactSage as $P_{NaCl} = 3.53 \times 10^{-9}$ atm and $P_{KCl} = 1.05 \times 10^{-8}$ atm, respectively. Then, the free-energy changes of K_2CrO_4 or Na_2CrO_4 formation by formulas (7) and (8) were calculated with chlorine and oxygen potential in the atmosphere, $P_{Cl_2}(T = 460^\circ C, \text{ in the atmosphere}) =$

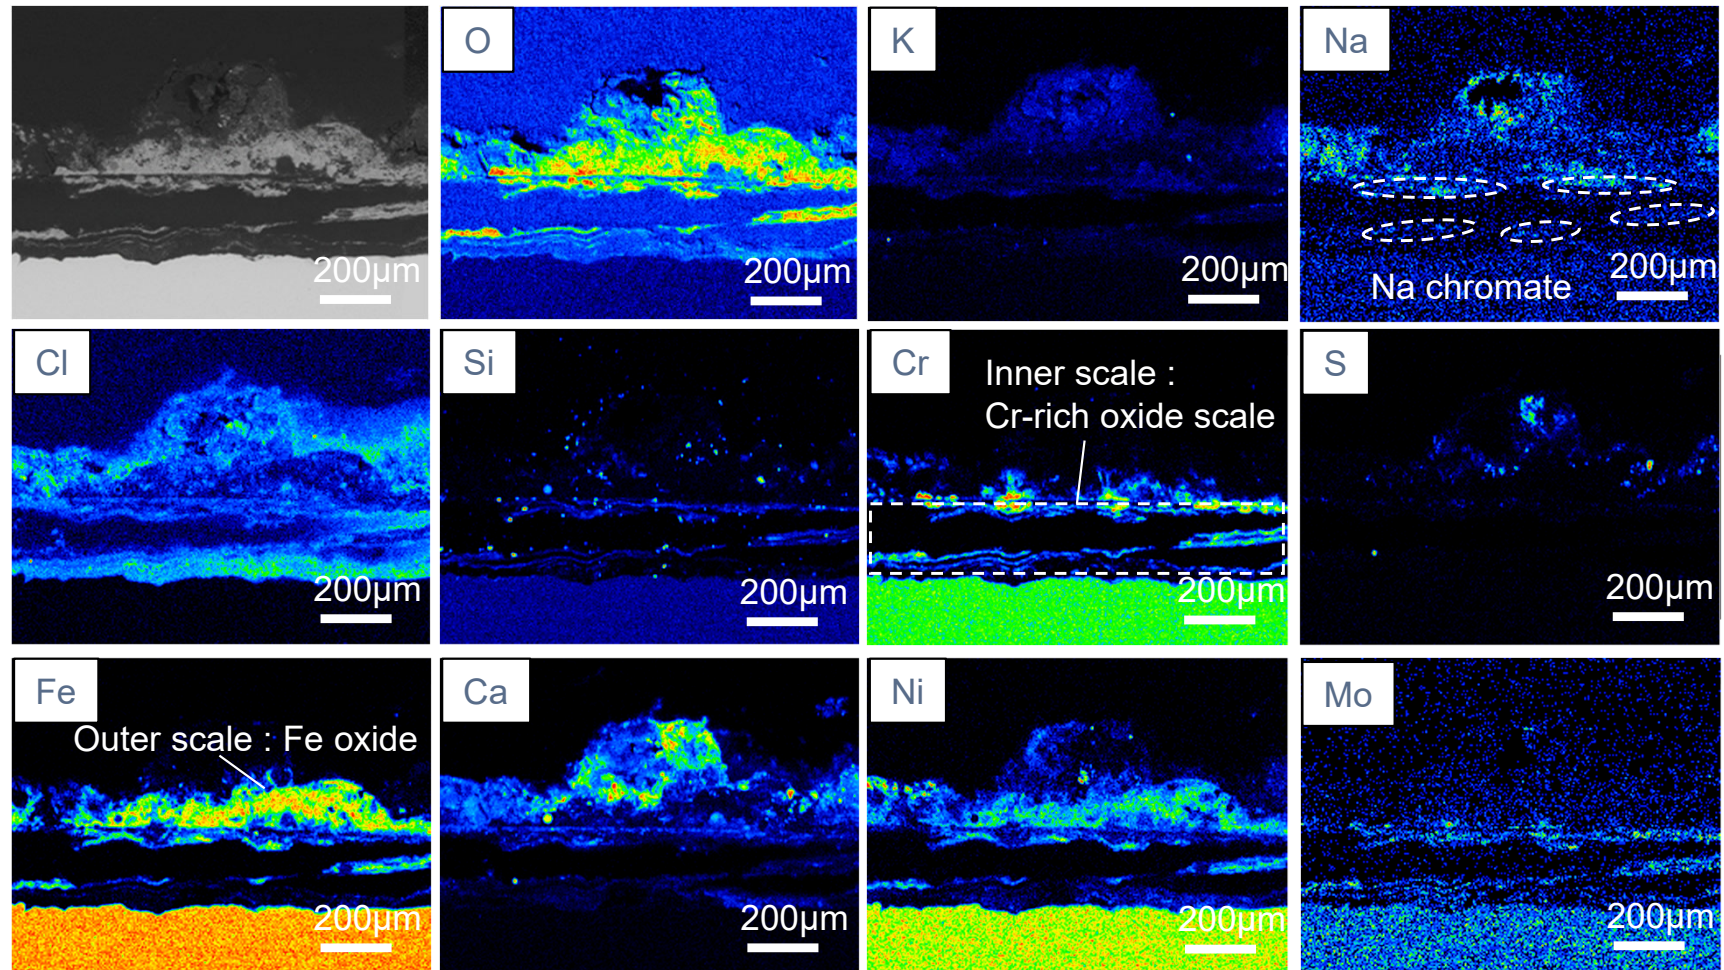
Figure 8 Elemental distribution maps of the cross-section of Q5X5 embedded in the tube side ash after corrosion

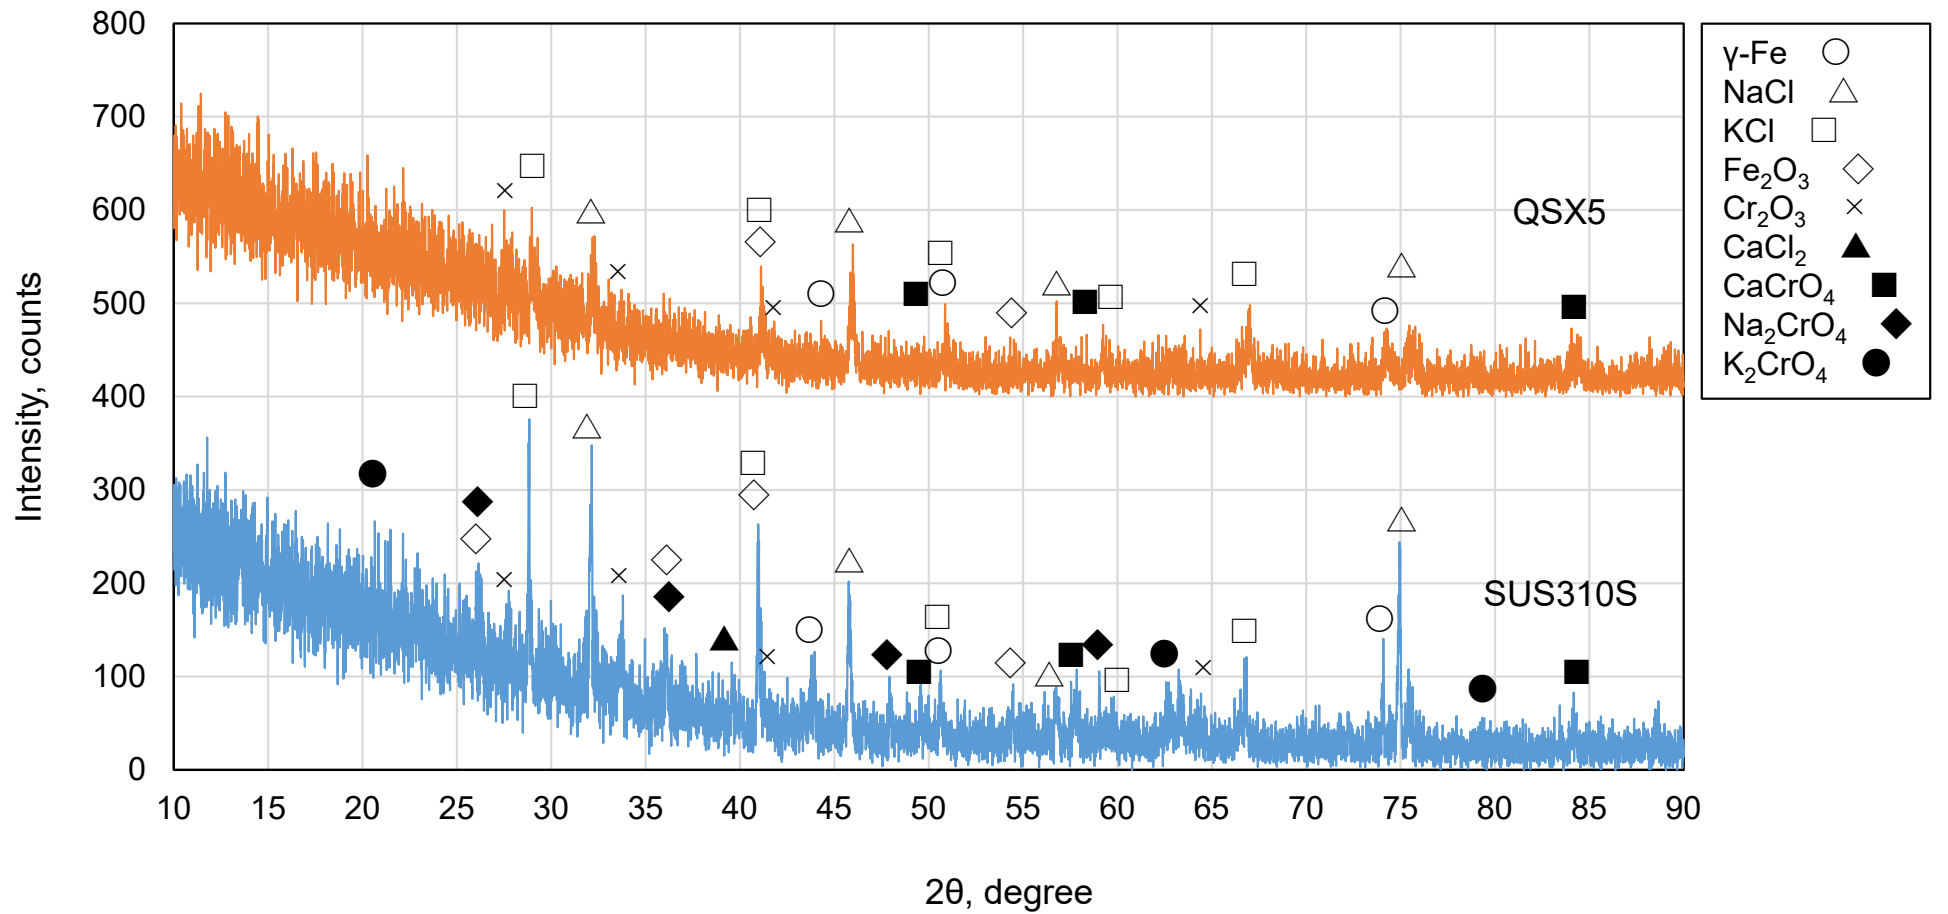
Figure 9 X-ray diffraction profiles of SUS310S and QSX5 after 100h of temperature gradient corrosion

Figure 9 shows X-ray diffraction patterns of the SUS310S and QSX5 specimens after the temperature gradient corrosion test for 100 h. In the case of the SUS310S, γ -Fe from the substrate, Fe_2O_3 , and Cr_2O_3 were identified from the main scale component, and Na, and Ca chromates, which were confirmed by EPMA, were also identified but K chromate was not detected. γ -Fe, Fe_2O_3 , Cr_2O_3 , Ca chromate, and the ash components NaCl, and KCl were also identified in the QSX5 specimen, however, Na and K chromates were not found even though they were detected by EPMA. It is possible that the amounts of those corrosion products formed on the QSX5 specimen were too small to be detected by conventional XRD.

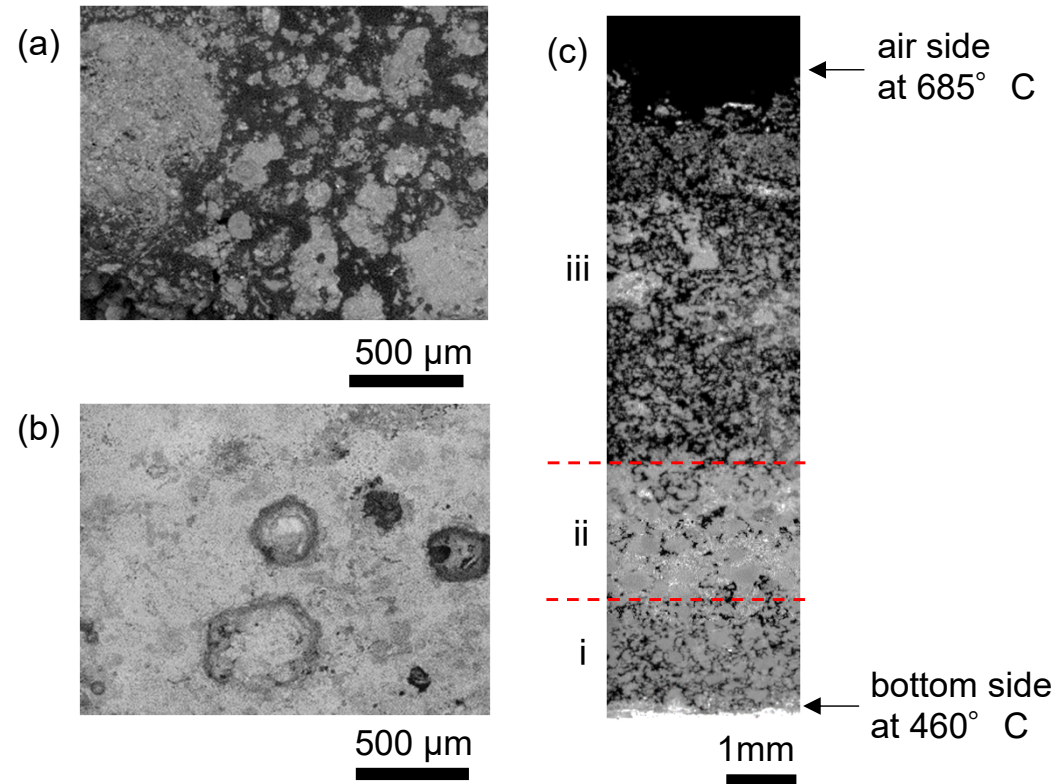
Figure 10 Ash cross-sections:

(a) non-heating,

(b) after heating with lid at 685 ° C in air

(c) after temperature gradient corrosion test

Figure 10 shows cross-sections of the ash. The first (a) shows a non-heated cross-section, the second (b) after being heated

in a crucible with a lid at 685 °C for 2 h, and the third (c) after the temperature gradient corrosion test for 100 h. The ash before heating consisted of different sized particles and components with bright contrast were dispersed in the particles. After heating at 685 °C for 2 h, the ash became dense due to partial melting. As shown in Figure 11, the Cl concentration in the heated ash was increased to about 41%, which is higher than that of that non-heated ash, 25.5%, which might be due to densification of the ash. The ash cross-section after the temperature gradient corrosion test showed a three-layered structure in the depth direction. In region 1 on the specimen side (bottom), the ash contrast was bright and porous, but the ash became dense in region 2, which was similar to heated ash at 685 °C for 2 h, and bright contrast precipitates were present. The ash in the region 3 (atmospheric side) was porous and similar to that of non-heated ash. Figures 11 and 12 show the concentration distributions of Ca, Na, K, and Cl and the temperature distribution of the ash in the depth direction after the temperature gradient corrosion test. The concentration of K, Na, and Cl is highest in region 2. The Cl concentration in regions 2 and 1 was higher than that of non-heated ash. However, the concentrations of Na, K, and Cl in region 3 gradually decreased towards the ash surface. Because the concentration of Ca was almost constant across the ash deposition, most of the alkali salts diffused from the melted region 2 as a vapor in both the surface and bottom directions. The vapor of salts diffused to the ash surface should be lost to the atmosphere during a corrosion test. However, the vapor of alkali salts diffused inwardly to the bottom side, the temperature of which is lower than the melting point, and this might contribute to the acceleration of the steel corrosion rate.

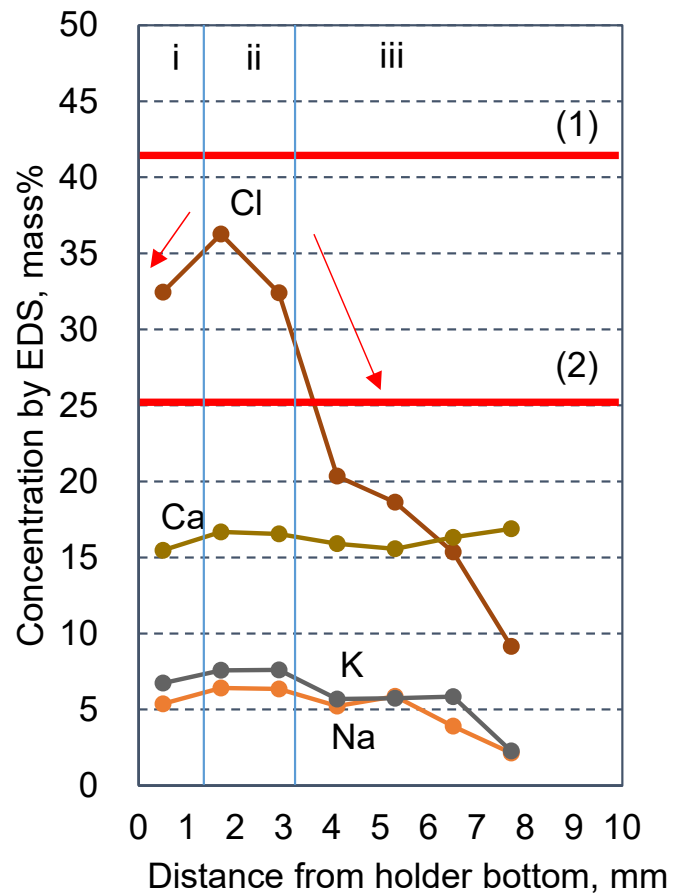
Figure 11 Cross-sectional concentration distribution of ash by EDS after temperature gradient corrosion test

- (1) Cl concentration at 685° C with lid for 2h
- (2) Cl concentration on non-heating

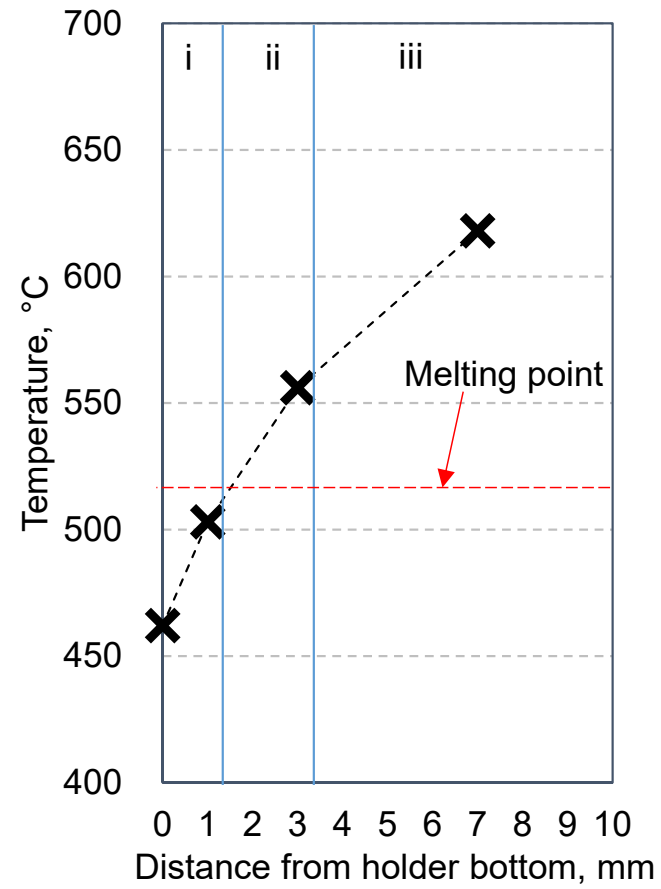
Figure 12 Temperature distribution of the ash during temperature gradient corrosion test

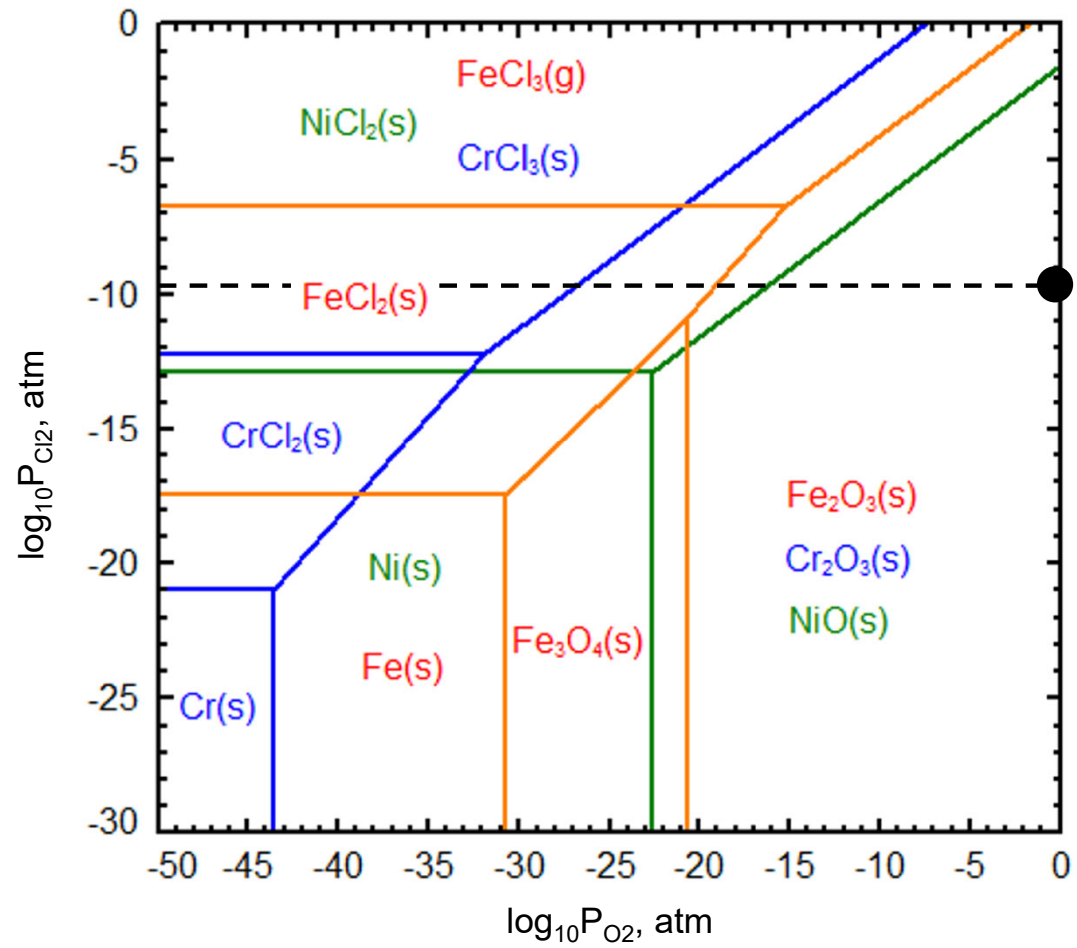
Figure 13 Quasi-stability diagram for the Fe-25Cr-20Ni system at 460°C with $a_{\text{Fe}} = 0.62$, $a_{\text{Cr}} = 0.28$, $a_{\text{Ni}} = 0.11$, $P_{\text{O}_2} = 0.2 \text{ atm}$

Figure 13 shows phase stability diagrams of Fe-Cl-O, Cr-Cl-O, and Ni-Cl-O at 460 °C. Fe, Cr, and Ni in Figure 13 were calculated from the activity of those elements in the Fe-25Cr-20Ni alloy using FactSage software. The chloride

region in the figures includes a gas phase having a vapor pressure of 10^{-4} atm or more. The equilibrium chlorine potential when the combustion ash was held at 460 °C in the air is given by Formula (1) from the calculation using the FactSage software.

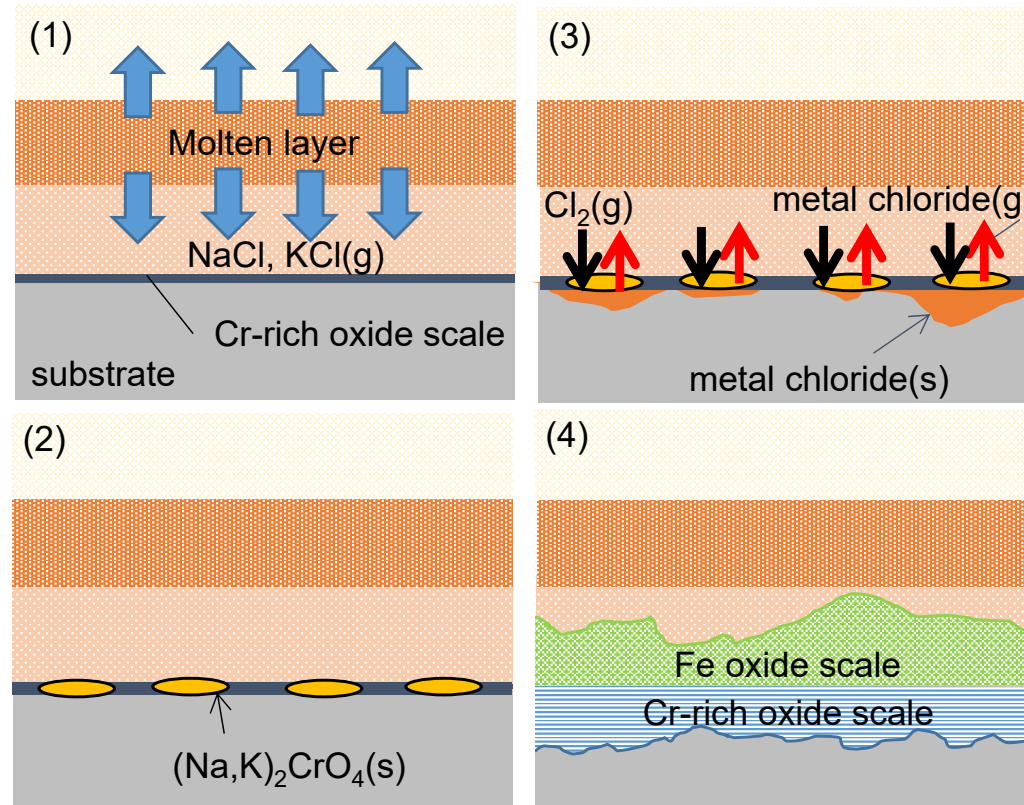
Figure 14 Schematic of corrosion model in the combustion ash containing alkali salt in the air

Figure 14 is a schematic representation of the corrosion behavior of heat-resistant steels in a temperature gradient corrosion test. At the initial corrosion stage, a protective Cr-rich oxide scale is formed on the surface of the specimen, and the melts is formed in the temperature range above the melting point of the ash. The alkali salt vapor diffuses from the molten layer to the surface of the specimen as shown in Figure 14 (1). Alkali salt vapors react with the Cr-rich scale to form Na and K chromates (the breakdown of the protective Cr-rich scale, Figure 14 (2)). The chlorine partial pressure increases due to the chromate formation reaction, and more metal chloride is formed and volatilized at the scale/metal interface (Figure 14 (3)). Once the breakdown areas cover the entire surface of the specimen within a short time, the entire surface becomes covered by a porous Fe oxide and the layer-by-layered inner layer is formed (Figure 14 (4)). Deposit-induced corrosion as this study is described as occurring in two stages: an “incubation stage” in which corrosion is slow and then a “propagation stage” in which corrosion is rapid [17]. Therefore, it is presumed that the corrosion rate of heat-resistant steel changes rapidly due to the breakdown of the Cr_2O_3 scale.
