A challenge to dam improvement for the protection of both salmon and human livelihood in Shiretoko, Japan's third Natural Heritage Site

Article type: Report

The Shiretoko Peninsula was placed on the World Heritage List in July 2005 as Japan's third Natural Heritage Site, being valued for its unique ecosystems formed by the interaction between marine and terrestrial environments. Prior to its listing, however, the International Union for Conservation of Nature and Natural Resources requested the development of measures to allow for the free movement of salmonids through the nominated area via artificial in-stream structures. This report introduces a pioneering effort to modify check dams in order to improve ecosystem linkages. The River Construction Working Group has intensively discussed and implemented restoration projects for three years, and the results have been monitored after implementation. Of 44 streams within the Shiretoko World Natural Heritage site, 14 streams have had one or more in-stream structure(s) built. A total of 123 structures, mainly soil conservation dams, are distributed sporadically in these streams. Following assessment, the Working Group concluded that i

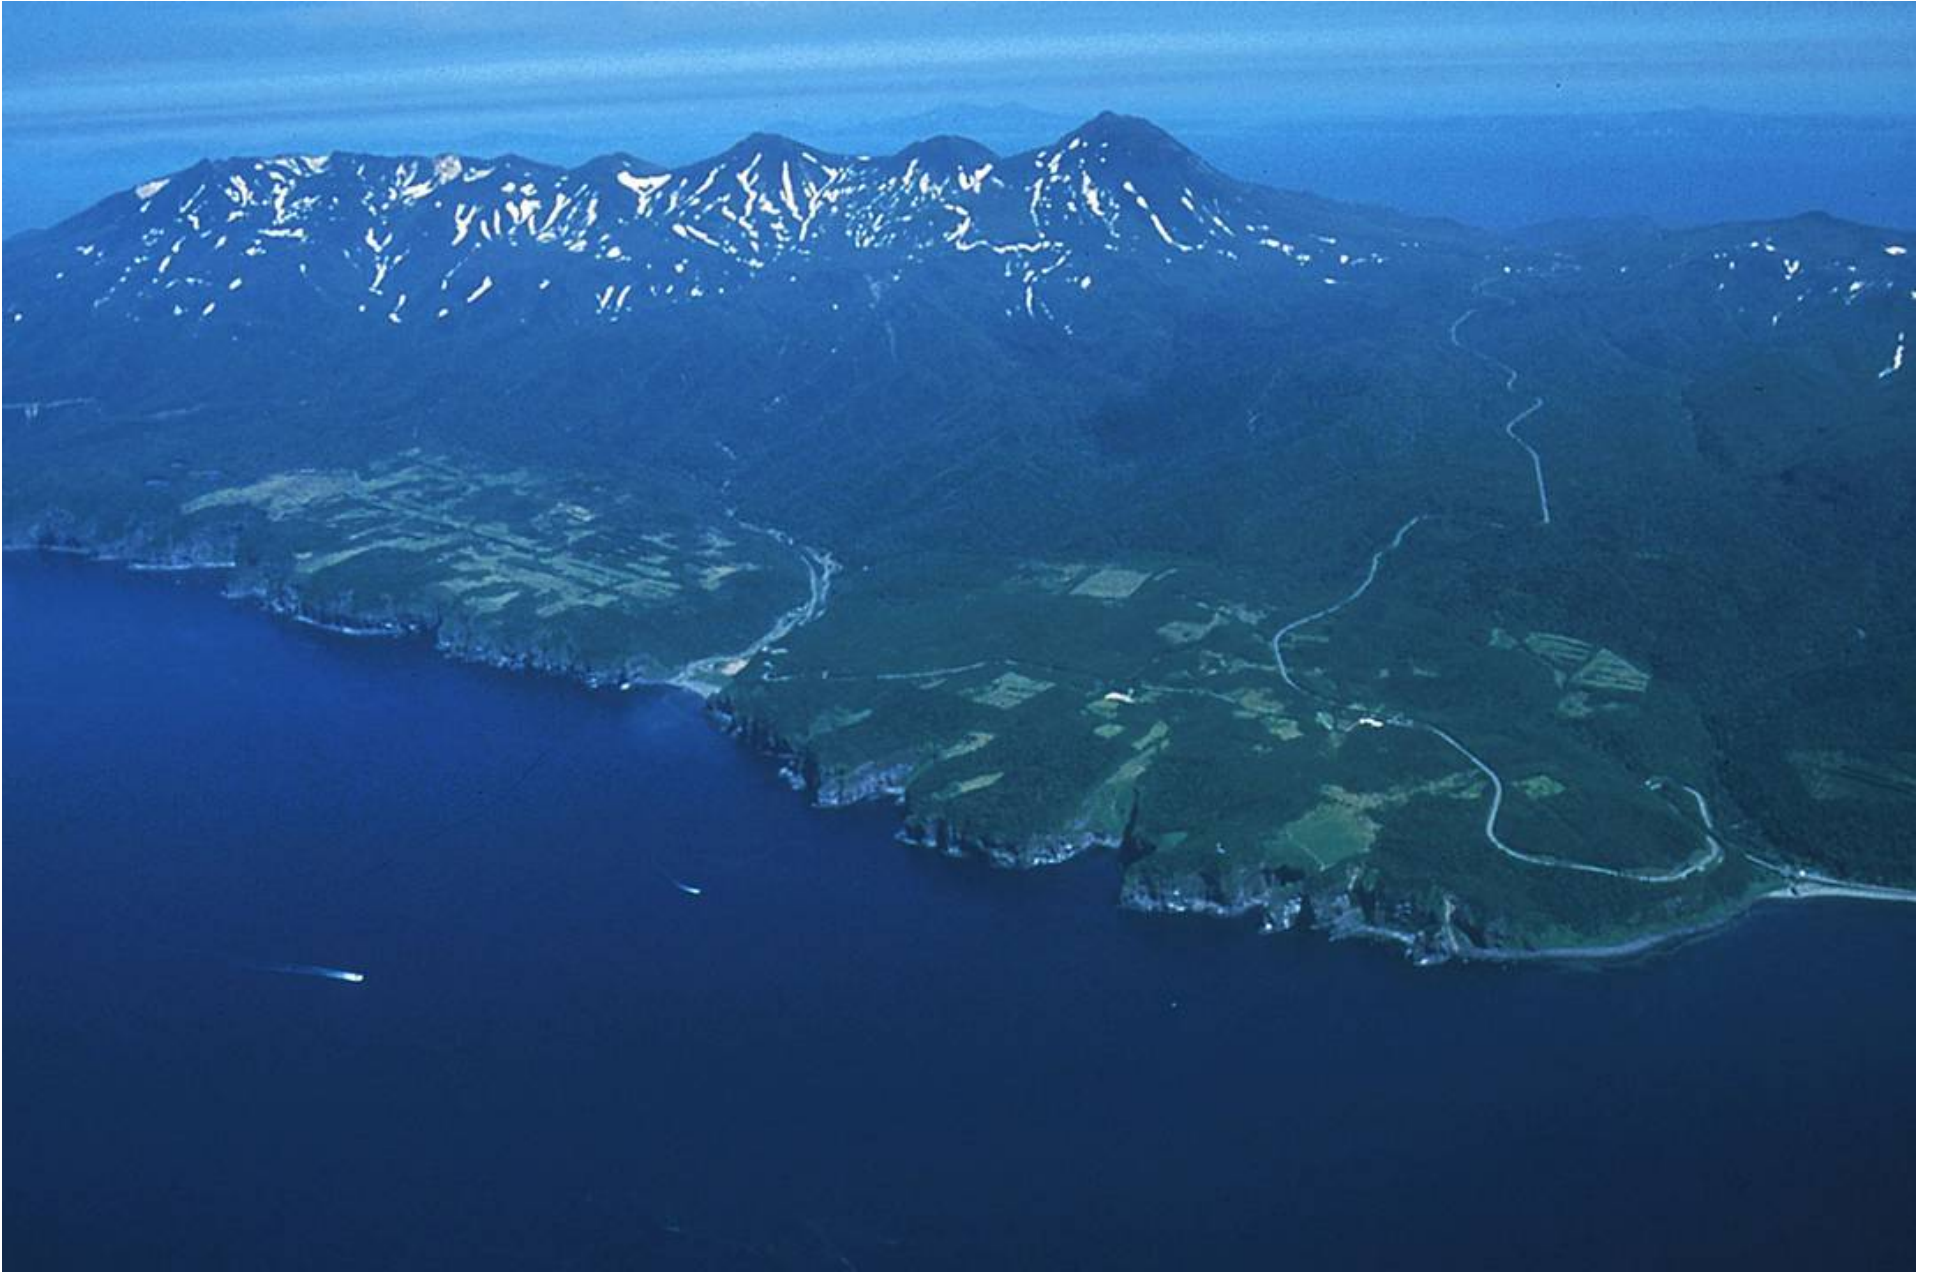
Fig. 2 A view of the Shiretoko peninsula, exhibiting steep slopes from the mountain peaks to the coastline.

The name Shiretoko is derived from the Ainu (indigenous) word ‘sir.etok’, which means ‘the end of mother earth.’ Located at the northeastern tip of Hokkaido Island (Fig. 1), Shiretoko is a narrow peninsula with a length of approximately 70 km and a width of 15 km at its middle (Fig. 2). It is bordered by the Sea of Okhotsk in the west and by Nemuro Strait in the east. The Shiretoko mountain range (including the highest peak, Mt. Rausu, at its center, and Mts. Shiretoko, Iou and Onnebetsu) runs along the center of the peninsula. The peninsula is steep, with little flat ground between the peaks and the coastline.

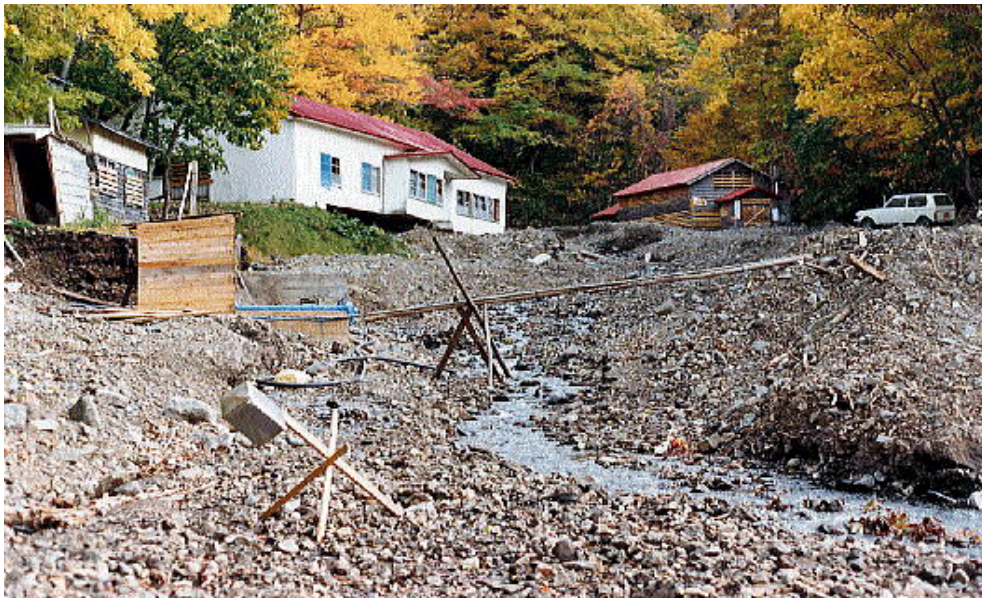
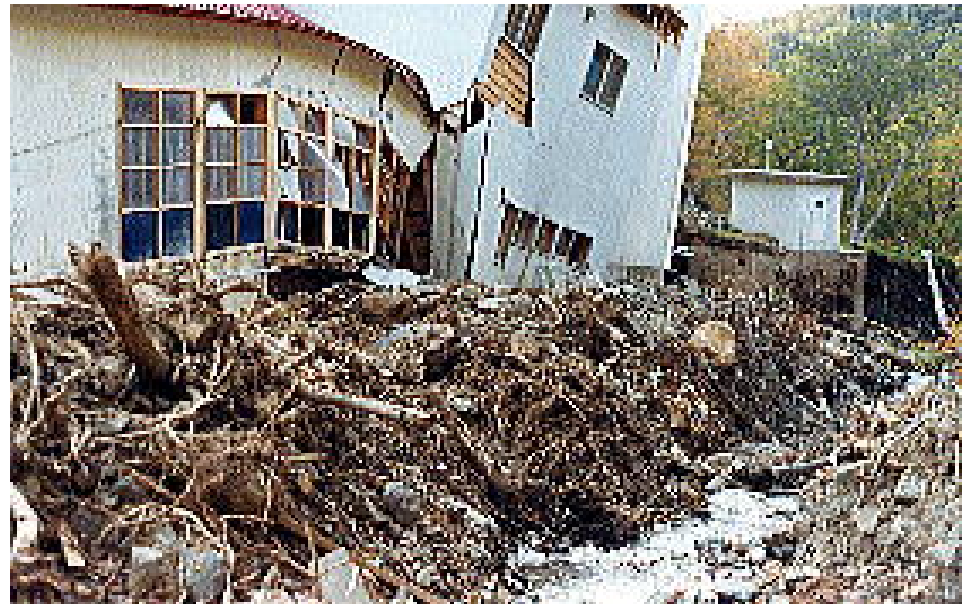
Fig. 5 Debris flow damage from the Iwaubetsu Stream in August 1981.

The total channel length of Iwaubetsu Stream is 10.5 km, and the watershed area is 41.0 km². A town road has been laid along the mainstem. Other human developments along the stream are the town road to Shiretoko-goko Lakes and a bridge in the lower reaches, Iwaubetsu Hot Spring Resort in the middle and a trail to Mt. Rausu in the upper reaches. There is a salmon hatchery in the furthest-downstream watershed. The 1979 and 1981 typhoons triggered debris flow and swept away a part of the town road to the hot spring (Fig. 5).

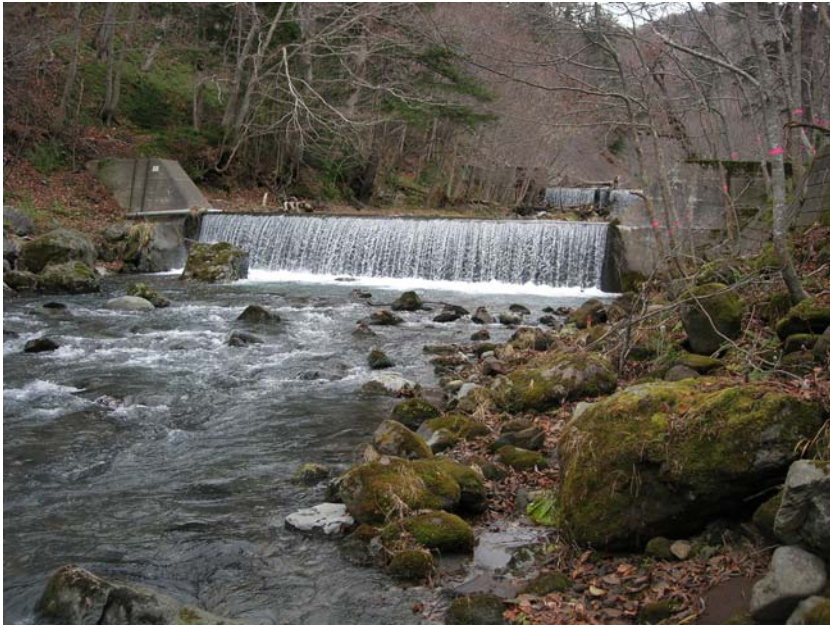
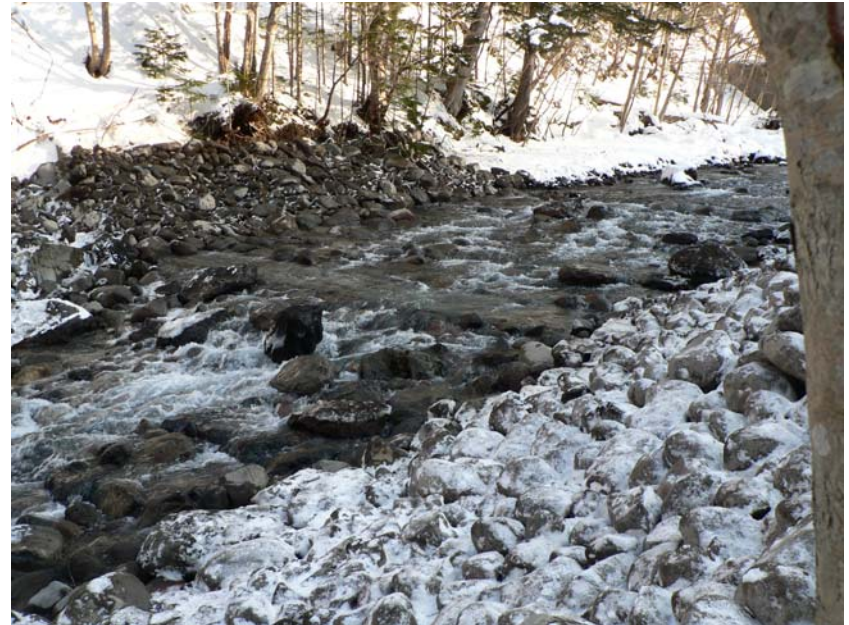
Fig. 6 Dam modification in Iwaubetsu Stream: before and after improvement.

The channel slope was manufactured experimentally from natural rocks to meet three conditions: unimpeded upstream migration, a restored view worthy of a world natural heritage site, and retention of the original erosion control function. The height of the dam was cut down by 1 m, and the channels above and below the dam were sloped with natural rocks. Rocks were fixed with wires. A field test using pink salmon confirmed passage over the modified dam.

The RCWG decided to cut down the bulkhead of the dam by 1m. The channels above and below the dam were sloped with natural rocks. Rocks were fixed with wires using a stone assembling technique, in an irregular arrangement to create a natural appearance. The bed slope was designed to not impede upstream migration, to restore a view worthy of a world natural heritage site, and to retain the original erosion control function (Fig. 6).

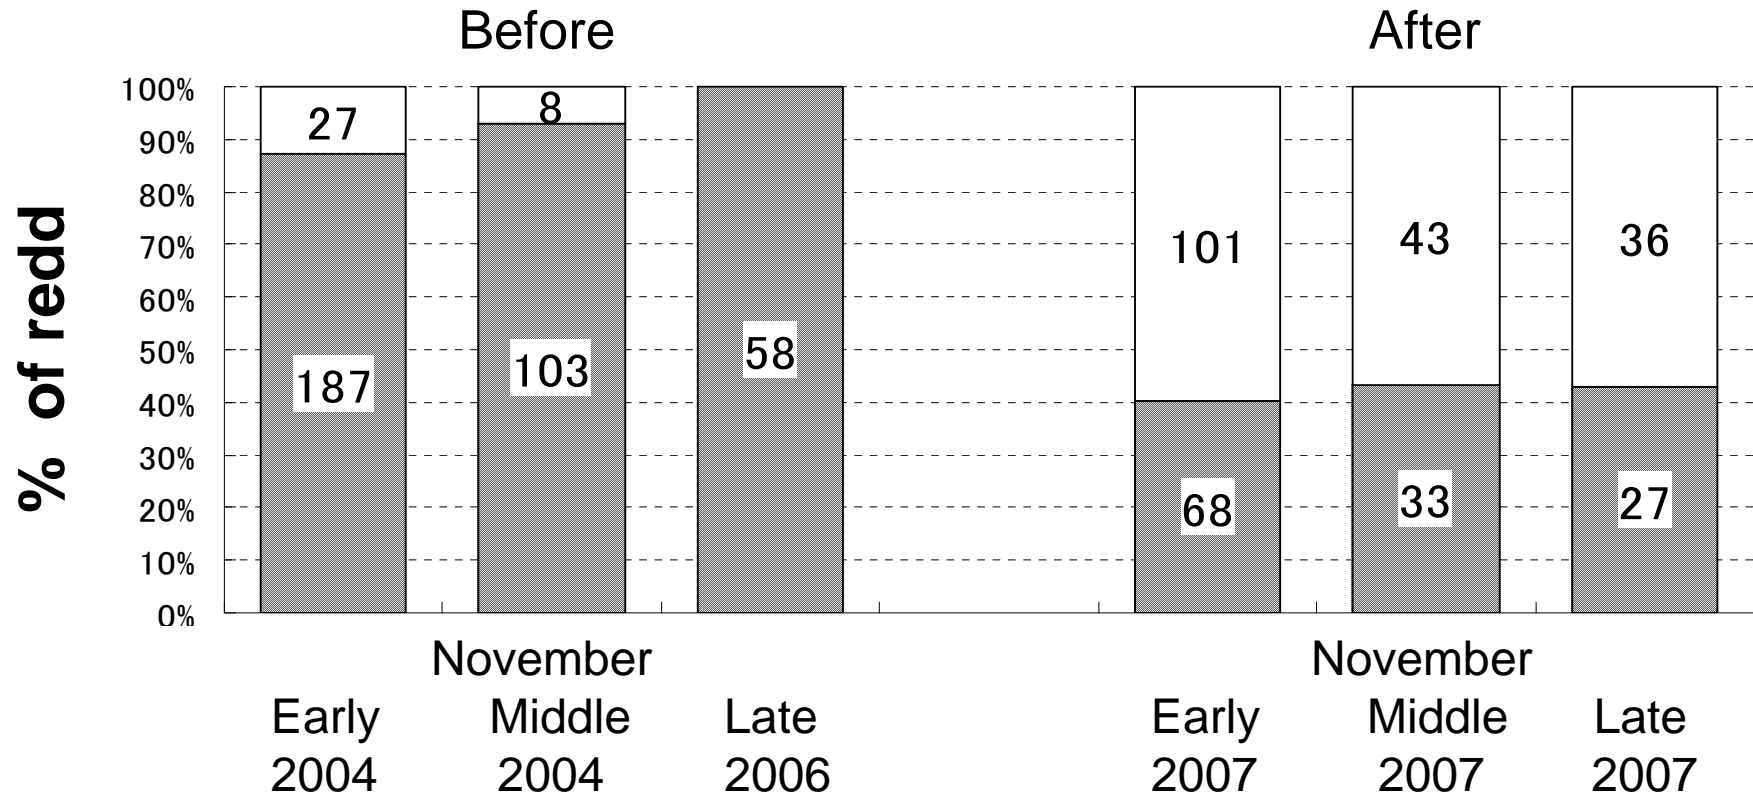
Fig. 8 The redd count for chum salmon before and after modification (the original data were provided by the Hokkaido Prefectural Government).

The percentage of redd counted above the most upstream dam increased after modification. This shows that dam modification improved upstream migration.

We monitored the upstream run in November, when water temperature is low but chum salmon still migrate upstream for spawning. The redd can be identified from typical gravel-bed feature consisting of mound and pit structure. Salmonid fish returning from the ocean and redds were counted around the two modified soil conservation dams and beyond the most upstream modified dam. When comparing the redd count for chum salmon before and after modification, the percentage of redd counted above the most upstream dam clearly increased after modification. This shows that dam modification facilitated upstream movement and that more adequate spawning habitats are provided in the upstream reaches (Fig. 8). The air temperature in November of 2004, 2006 and 2007 monitored at the nearest observatory in Utoro Town were similar (5.0, 4.7, and 3.0 degrees C, respectively), although precipitation was high in November of 2006 (81, 176, and 66 mm, respectively).

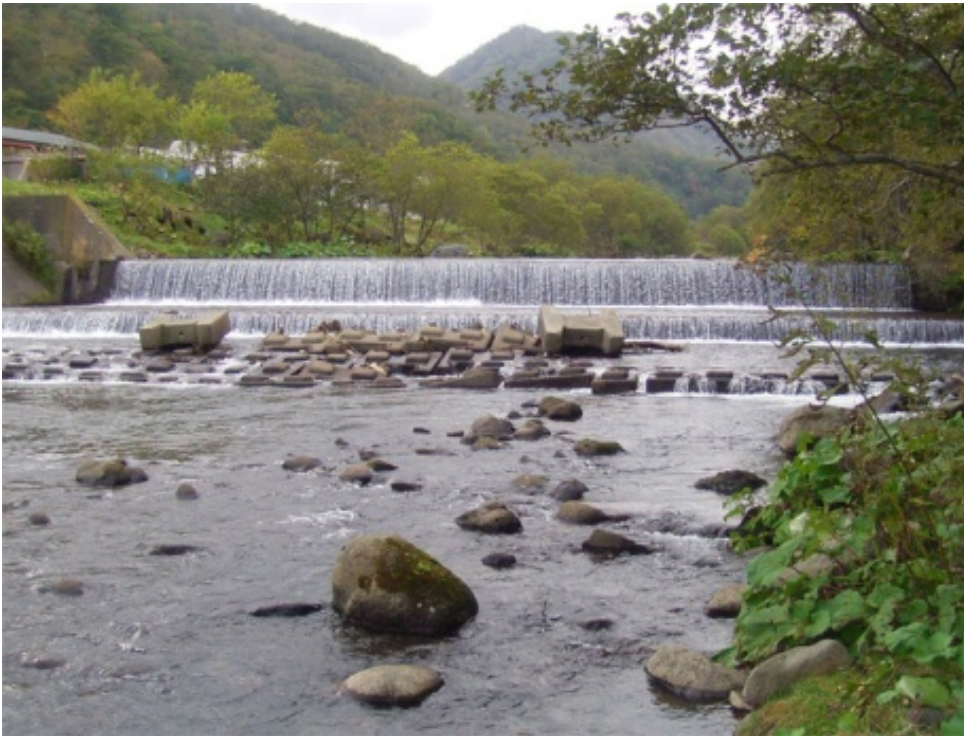
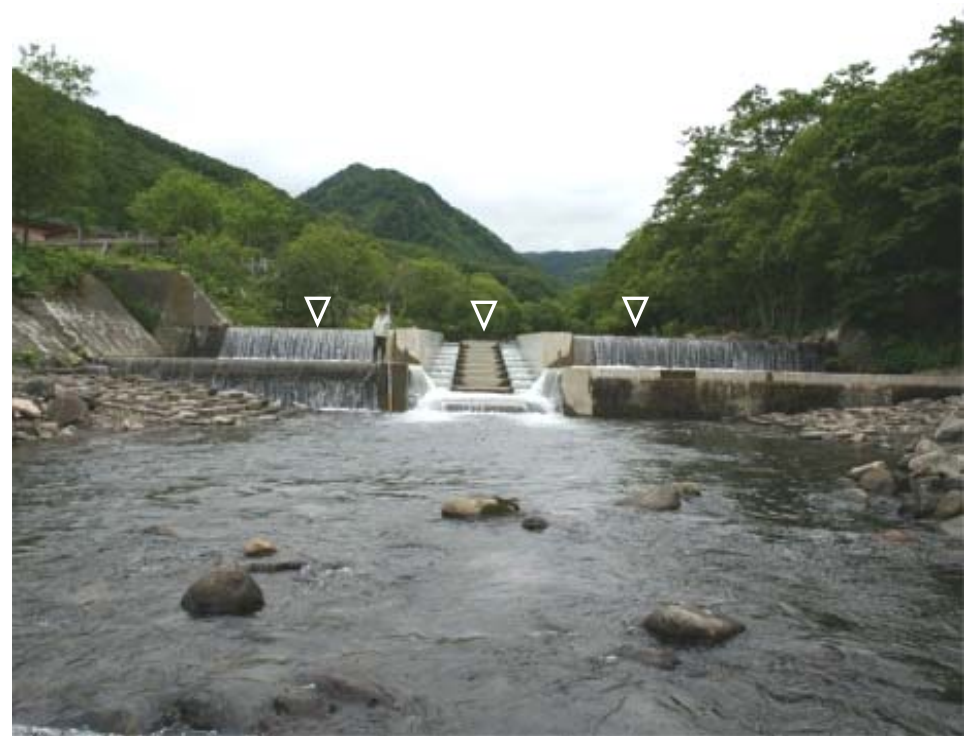
Fig. 10 Dam modification in Rausu Stream: before and after improvement.

A slit was created at the center of the dam, and a fish ladder was built extending from the slit to upstream of the dam. Fish are able to find an entrance of the ladder easily if fish ladder extends upstream from the dam. Water drains not only into the fish ladder at the center but also through spillways on both sides as indicated by “▽”.

Of these, we modified 18 weir dams by installing slits and fish ladders: five in 2005, six in 2006, five in 2007 and two in 2008 (Fig. 9). The slit in each dam was created at the center of the dam, and a fish ladder was built from the slit to upstream of the dam. Fish may lose their way if the fish ladder extends downstream from the dam, but they can easily find the entrance if the fish ladder extends upstream as in the modification design used in Rausu Stream (Fig. 10). One problem with this style of fish ladder is that a large amount of stream water concentrates in the fishway, and the water velocity in the ladder may exceed the appropriate level for upstream migration of fish. In order to prevent this situation, stream water was split upstream of the dam by the sidewalls of the fish ladder (Fig. 11).

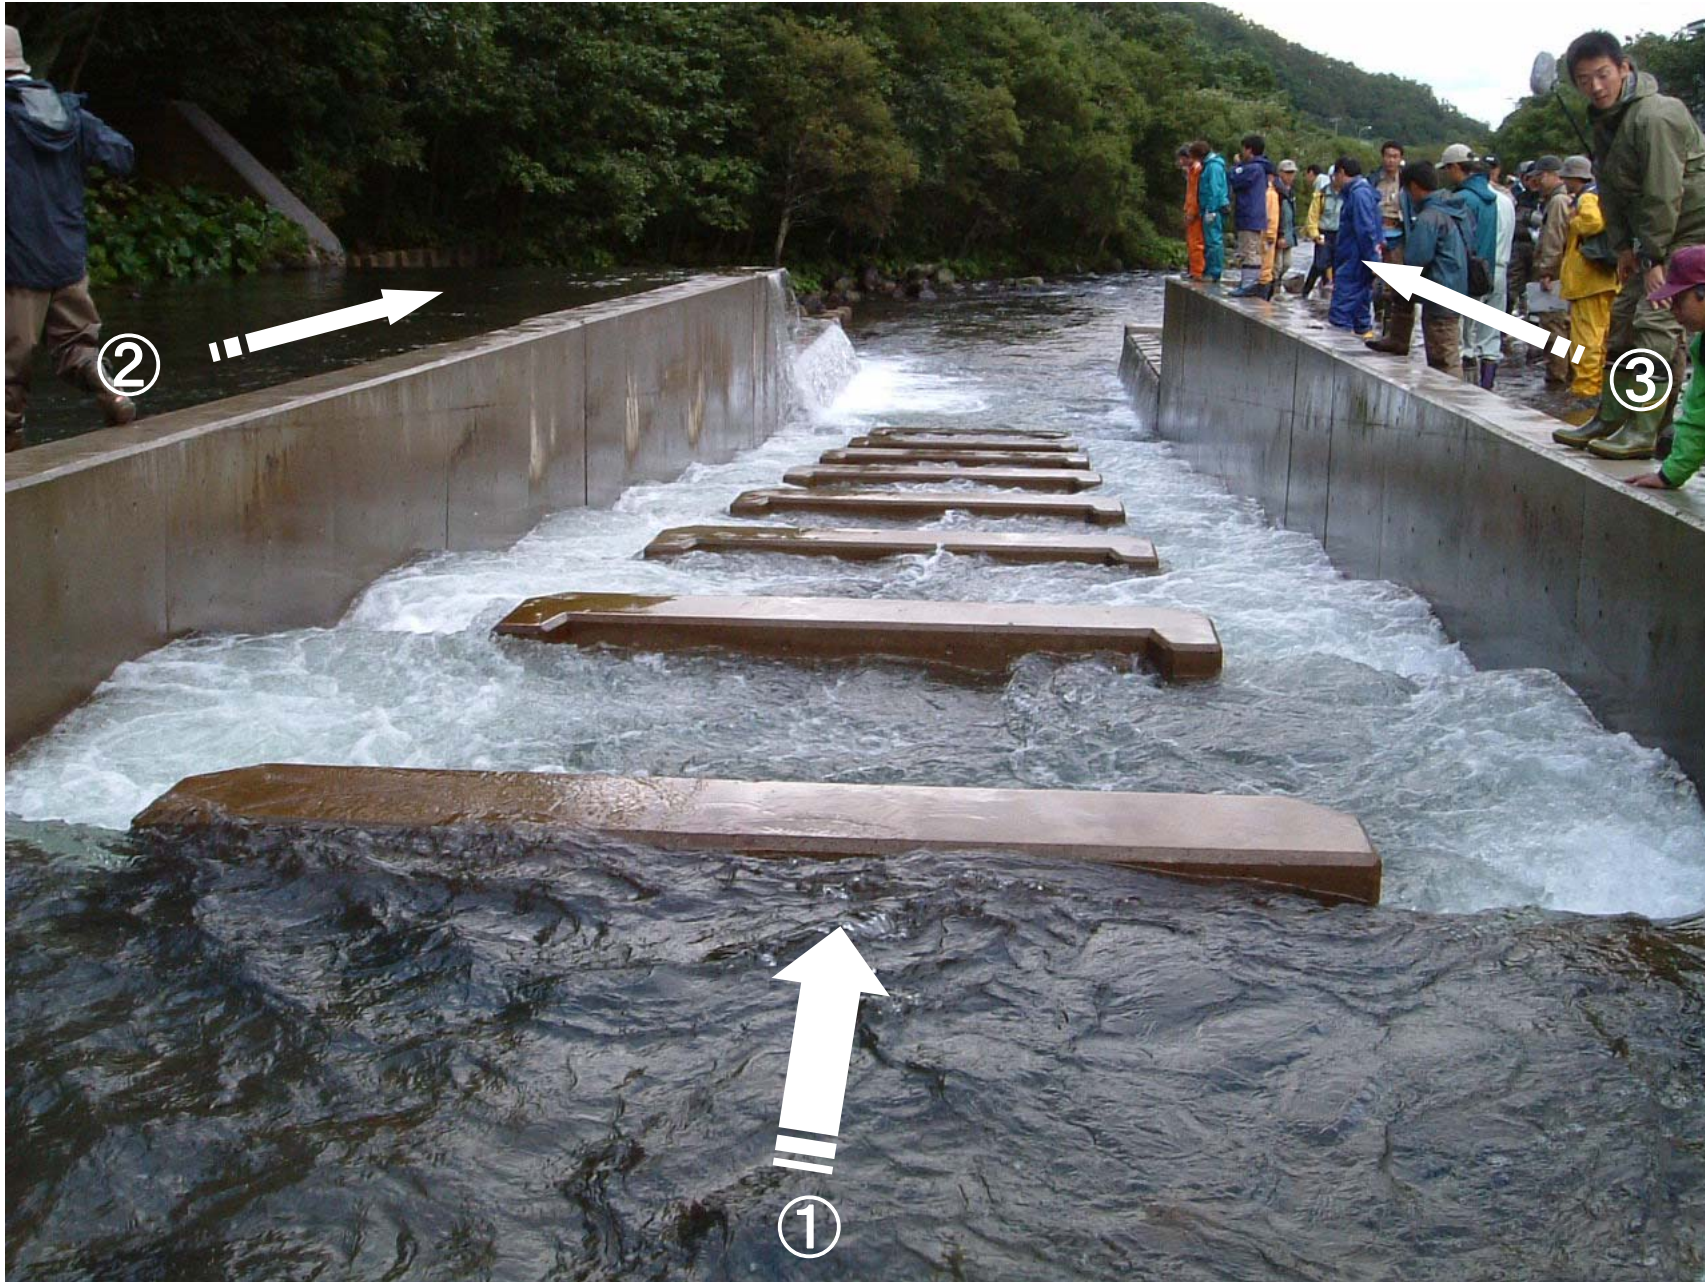
Fig. 11 Upstream conditions of dam modification in Rausu Stream.

In order to avoid all stream water draining into the fish ladder, the stream flow is diverted (① - ③ in the picture) upstream of the dam by the concrete sidewalls of the fish ladder, which are aligned parallel to the stream flow. Arrows in the picture indicate flow direction.

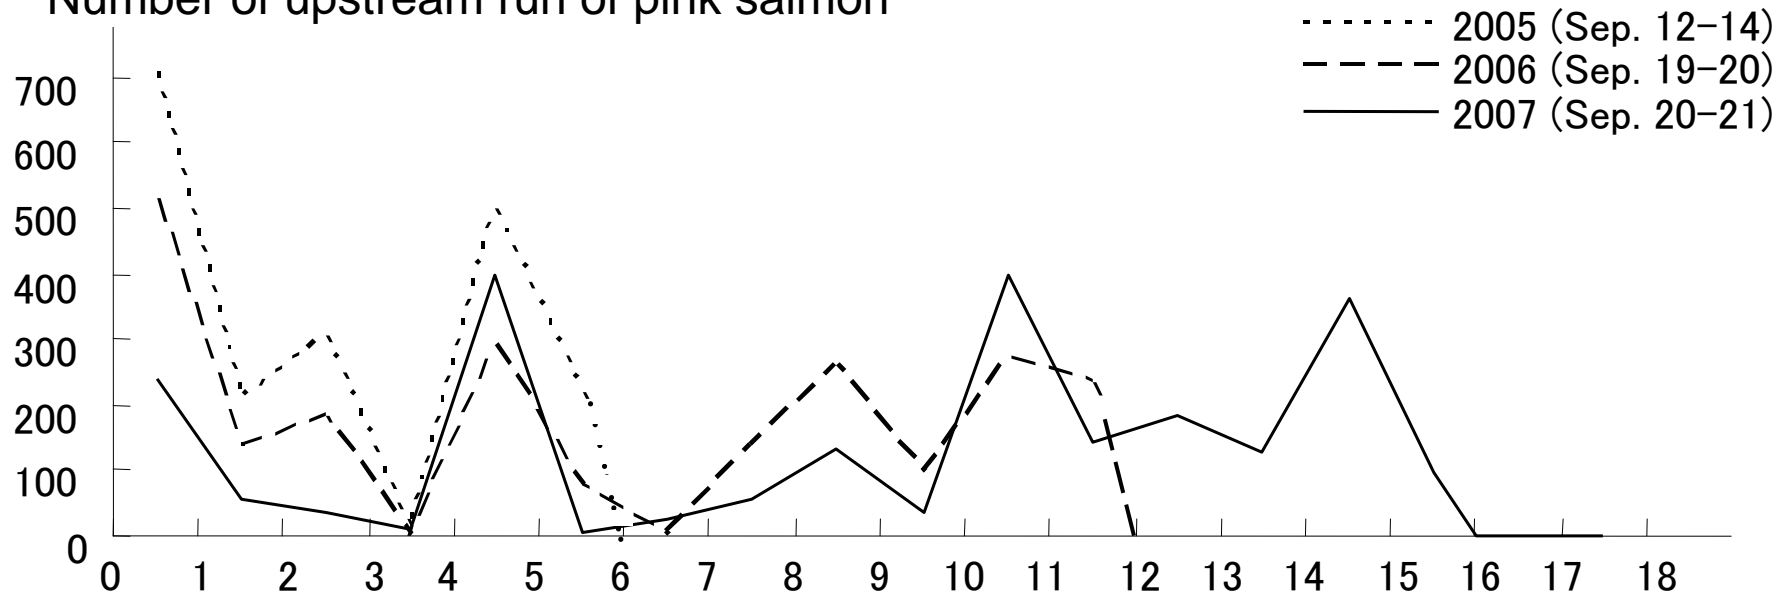
Fig. 12 Changes in the number of upstream run and redd count of pink salmon in Rausu Stream from 2005 to 2007 (the original data were provided by the Hokkaido Prefectural Government). Numbers on the abscissa indicates the locations of 18 weir dams. The locations of weir dams and the dates of modification were shown in Figure 9.

The total numbers of pink and chum salmon and redd were monitored in the area of the 18 weir dams from 2005 to 2007. Pink salmon return to their mother rivers earlier than chum salmon. When the numbers of pink salmon and their redd are compared for the same season (middle to late September), the results clearly indicate that the total number of migrating fish and spawning beds was greatly increased by the progressive dam improvements (Fig. 12). The total number of migrating pink and chum salmon was 3300 in 2005, and increased to 5800 in 2006 and more than 6200 in 2007. The total number of redd was 1850 in 2005, and increased to 2700 in 2006 and more than 3700 in 2007.
