| Title | Vibration analysis during grass harvesting according to ISO vibration standards |

# Vibration Analysis during Grass Harvesting According to ISO Vibration Standards

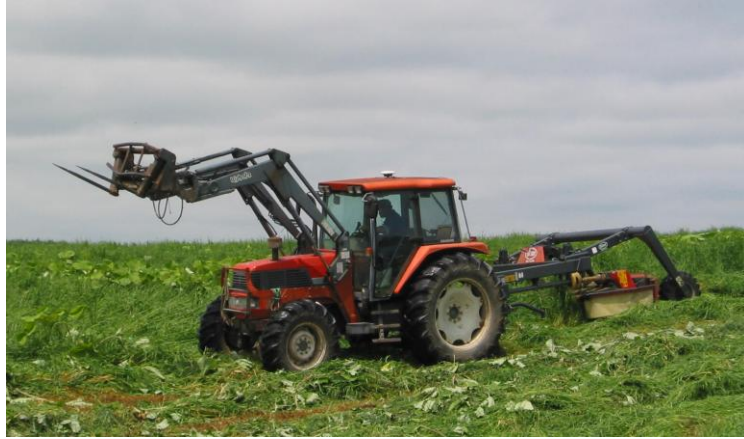
Fig. 1 Grass harvesting at Hamanaka grassland.

The field experiment was performed at Hamanaka, Hokkaido grassland in 2007. The total area of the grassland is 3.6 ha, but the GIS map covered only an area of 2.4 ha, where the vibration during grass harvesting was actually measured using a Kubota MD 107 (78 kW) tractor. During grass harvesting, a mower conditioner with a mowing width of 3 m was attached to the tractor and vibration data was collected while driving at a work speed of 3.0 m s<sup>-1</sup>. This speed was the normal practical speed for this operation. The working speed was almost constant. The data sets recorded during turning were omitted and only those of straight paths were used for analysis. We interviewed the operator to determine the regions where he felt it was difficult to work. We will refer to the combination of factors, including the risk of the tractor rolling over on the operator, an increase in the drag of the mower conditioner, and unstable work postures of an operator during harvesting, as *workability*. Fig. 1 shows the MD 107 harvesting grass at the Hamanaka grassland and Table 1 shows the tractor's main

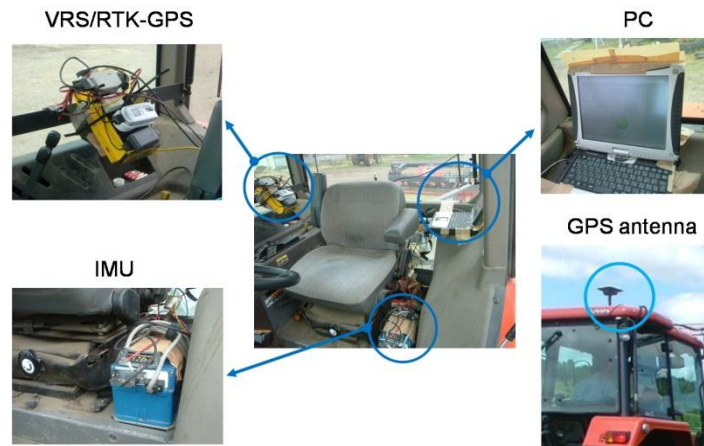
Fig. 2 Installation of the tractor vibration data-acquisition system.

2 An RTK-GPS (MS750, Trimble Navigation Ltd., Sunnyvale, CA) and an IMU (Japan  
3 Aviation Electronics Industry Ltd., Tokyo, Japan) installed in a tractor normally used by  
4 farmers during actual grass harvesting measured the positions and vibrations. A virtual  
5 reference station (VRS)/RTK-GPS receiver with 2-cm precision acquired the position data at  
6 a data frequency of 20 Hz. The acceleration in the  $a_x$ ,  $a_y$ , and  $a_z$  directions was measured by  
7 the IMU with a frequency of 25 Hz. The acceleration data in the three directions was  
8 corrected by subtracting gravity. These data were stored in a laptop through an RS-232C  
9 interface. Fig. 2 shows the locations of the installed sensors. For studying vibration  
10 acceleration, the location of the vibration acceleration sensor is most important. ISO  
11 8041(2003) and JIS B 7760-1(2004) stipulate that the sensor should be installed in the same

12 plane as the seat surface for measurement. In this study, however, installing the vibration  
13 acceleration sensor on the seat interfered with the operator during harvesting; thus, it was  
14 installed on the side of the operator's seat to perform measurements without obstructing the  
15 work.
