IWSMT-9

Mechanical properties and microstructural stability of 11Cr-ferritic/martensitic steel cladding under irradiation

Yasuhide Yano¹⁾, Shinichiro Yamashita¹⁾, Satoshi Ohtsuka¹⁾, Takeji Kaito¹⁾, Naoaki Akasaka¹⁾, Tamaki Shibayama²⁾, Seiichi Watanabe²⁾ and Heishichiro Takahashi^{1),2)}

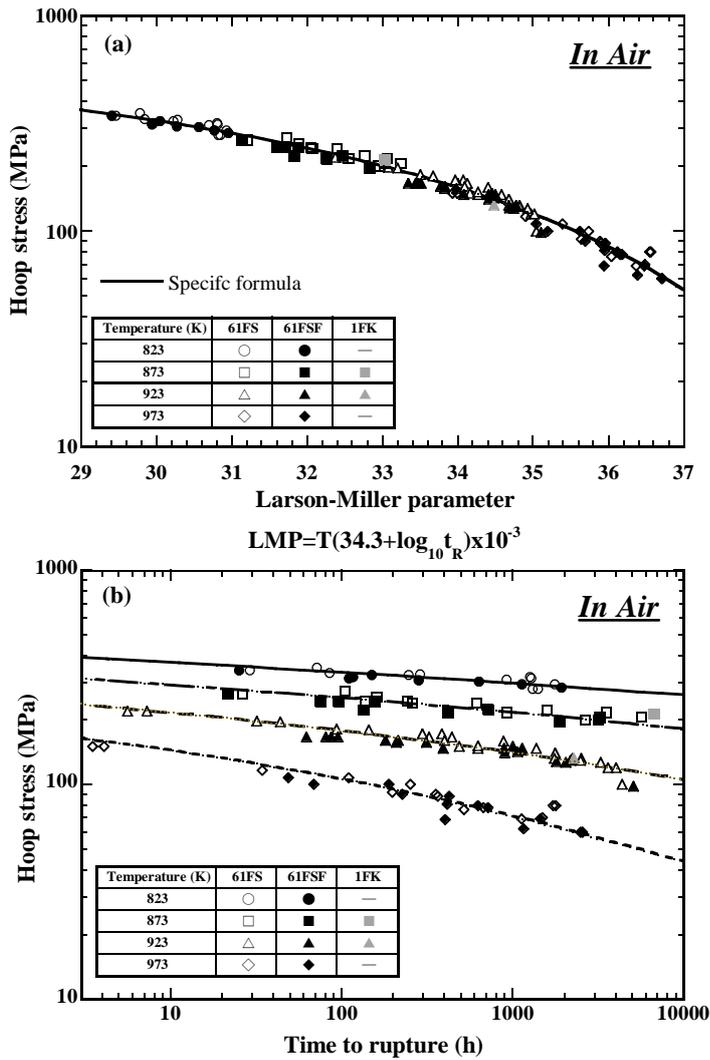
Figure 1 Summary of the thermal stress rupture behavior of as-received PNC-FMS cladding. (a) The rupture time t_R is in hours and the temperature T is in Kelvin in the Larson-Miller parameter. (b) Relationship between hoop stress and time to rupture at the temperature from 823 to 973 K. The trend curve indicates the fitting from LMP.

Figure 1 (a) shows the thermal control data for the as-received PNC-FMS claddings in air atmosphere as a function of a Larson-Miller Parameter (LMP) plot [2-4] which is most appropriate way to estimate trend curves of time to rupture at each test temperature. The specific formula for the LMP that was used in this work is given by

where T is the temperature in Kelvin and t_r is the time to rupture in hours. The thermal control experimental results and creep-rupture trend curves at each test temperature that were estimated from LMP are shown in Fig. 1 (b). The creep rupture strength of lots 61FS, 61FSF and 1FK specimens are located on the same lines with only small data scatter (shown in Fig. 2 (b)), therefore each lot appears to have similar creep rupture properties.

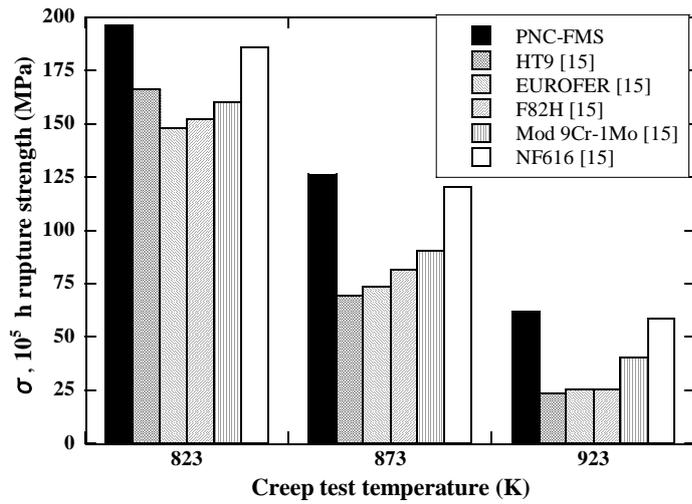
Comparison of the 10^5 h rupture strengths for PNC-FMS, Sandvik HT9, EUROFER, F82H, modified 9Cr-1Mo and NF616 at 823, 873 and 923 K.

where σ_{eff} is the effective uniaxial stress and σ_h is the hoop stress. This correlation between uniaxial and hoop stresses is based on the Von Mises theory [6, 12]. Figure 2 shows the estimated 10^5 h uniaxial rupture stresses at 823, 873 and 923 K with the data for the other F/M steels [15]. PNC-FMS creep rupture strength that converted hoop stress to uniaxial stress was superior to the creep rupture strength of other F/M steels at all test temperatures.

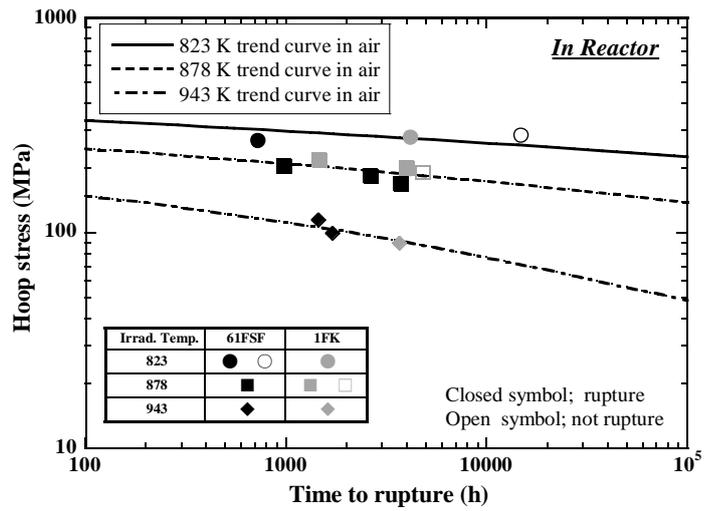
Figure 3 Results of in-reactor creep rupture tests of PNC-FMS at temperatures of 823, 878 and 943K.

The in-reactor creep rupture properties of the PNC-FMS claddings are shown in Fig. 3. A previous study by Puigh and Hamilton [4] suggested that the in-reactor creep lifetimes decreased with increasing exposure time over approximately 2,000 h in austenitic stainless steels although they were nearly equal to out-reactor creep lifetimes under 2,000 h. Ukai et al. [2] also reported that in-reactor creep rupture lifetimes were shortened in 20% cold worked modified 316 stainless steel as compared with the results of out-of-reactor creep rupture tests. On the other hand, in Fig. 3, the in-reactor creep rupture times were

equal or greater than those of out-reactor creep even after neutron irradiation, although the creep rupture times of PNC-FMS claddings were much longer than 2,000 h. This result suggested that there was no significant degradation in creep rupture strength comparison with out- and in-reactor creep rupture tests and that the irradiation effects on the tendency for creep rupture strength of F/M steels were different from those of austenitic steels.

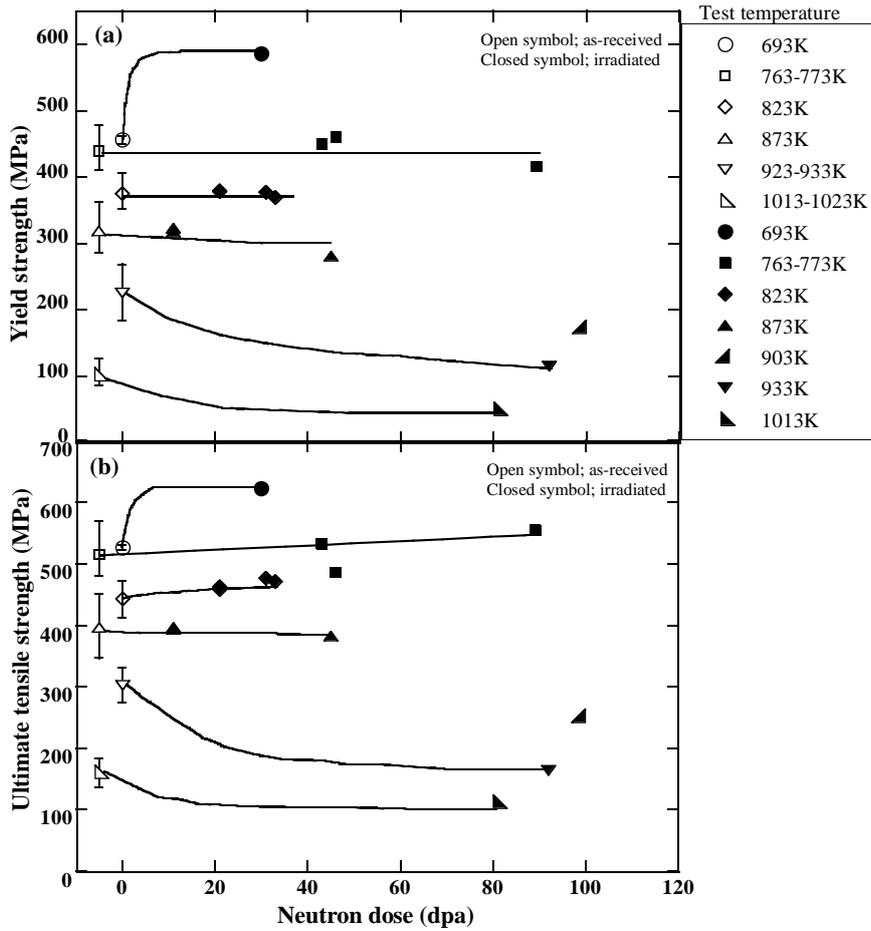
Figure 4 Relationship between tensile strength and neutron dose of irradiated PNC-FMS claddings: (a) yield strength and (b) ultimate tensile strength

Figures 4 (a) and (b) show the YS and ultimate tensile strength (UTS) for PNC-FMS claddings before and after irradiation as a function of neutron dose, respectively. The relationship between neutron dose and failure temperature (transient burst strength) is shown in Fig. 5. At the irradiation temperature of 693 K, irradiation caused an increase in both YS and UTS in Fig 4. A significant degradation in tensile strength could not be clearly observed at irradiation temperatures between 763 and 873 K [16-17] and thus no irradiation effects on tensile strengths were recognized in this irradiation temperature range. On the other hand, at irradiation temperatures over 903 K, irradiation caused a decrease in both YS and UTS [17]. In Fig. 5, essentially no change in transient burst strength occurred at irradiation temperatures below 853 K [16-17] and there were no irradiation dependent effects in this irradiation temperature range. On the other hand, at irradiation temperatures over 943 K, there was significant degradation in transient burst strength due to the effects of neutron irradiation and/or thermal aging [17].

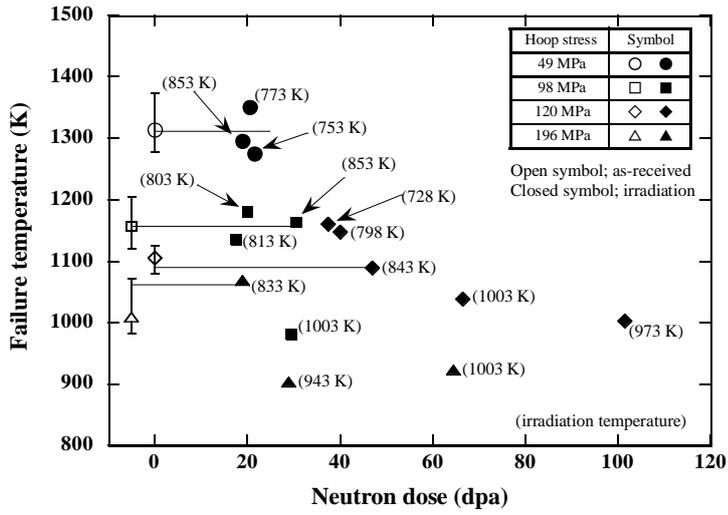
Figure 5

Relationship between transient burst strength and neutron dose of irradiated PNC-FMS claddings. Error bars with maximum and minimum data points are for as-received specimens.
