| Title | Surface cracking on $\Sigma 3$ , $\Sigma 9$ CSL and random grain boundaries in helium implanted 316L austenitic stainless steel |
| Author(s) | Sakaguchi, N.; Ohguchi, Y.; Shibayama, T. et al. |

# **Surface Cracking on $\Sigma 3$ , $\Sigma 9$ CSL and Random Grain Boundaries in Helium Implanted 316L**

## **Austenitic Stainless Steel**

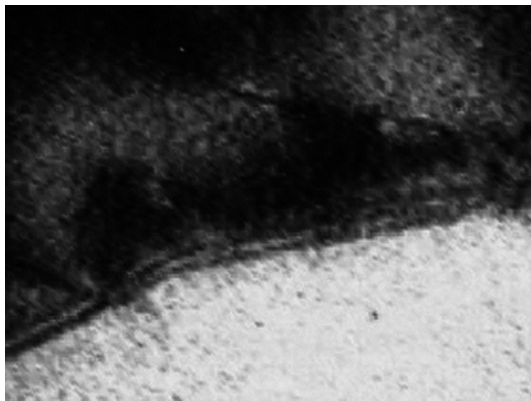
Fig.2 Behavior of helium bubble nucleation and growth on a random grain boundary during *in-situ* annealing in the MBHVEM up to 923 K.

Fig. 2 shows the helium bubble formation behavior in helium ion implanted 316L steel during the *in-situ* heating experiment in the MBHVEM. Before heating, no helium bubbles were seen at the random grain boundary, twin boundary or in the matrix. When the sample temperature reached 773 K, tiny helium bubbles (~10 nm) formed exclusively at the random grain boundary. The bubbles grew slowly upon further heating of the sample to 873 K. Finally, upon heating to 923 K, the bubbles coalesced forming a channel of helium gas along the random grain boundary. No helium bubbles were seen at the twin boundary during this heating experiment.

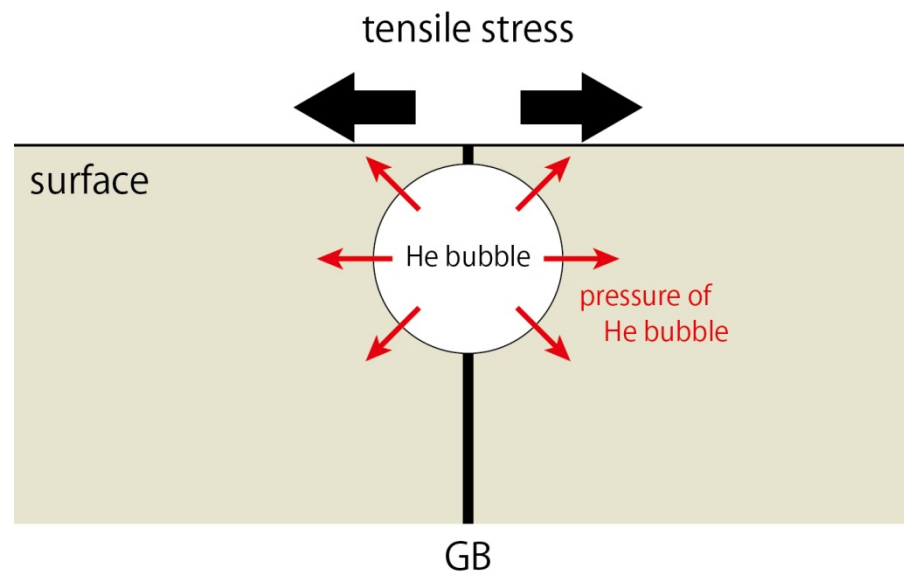
Fig.8 Schematic illustration of the generation of surface stress caused by helium bubble overpressure formed on the grain boundary near the surface.

After annealing of the helium ion implanted 316L stainless steel in the MBHVEM, surface cracking occurred along the random boundary and some CSL boundaries. This is due to the formation and rupture of helium bubbles at the grain boundaries. Helium cracking is known to occur during welding of stainless steel containing helium atoms. In the heat-up period of welding, helium bubbles nucleate at grain boundaries and grow by thermal vacancy absorption because of helium gas overpressure in the bubbles [26]. In the cooling period, the helium bubbles continuously grow by stress-induced vacancy absorption [26] due to the tensile stress associated with the solidification of the melting zone. When the tensile stress exceeds the fracture stress of the grain boundary decorated
