| Title | Influence of Fracture Width on Sealability in High-Strength and Ultra-Low-Permeability Concrete in Seawater |
| Citation | Materials, 6(7), 2578-2594<br><a href="https://doi.org/10.3390/ma6072578">https://doi.org/10.3390/ma6072578</a> |

# Influence of Fracture Width on Sealability in High-Strength and Ultra-Low-Permeability Concrete in Seawater

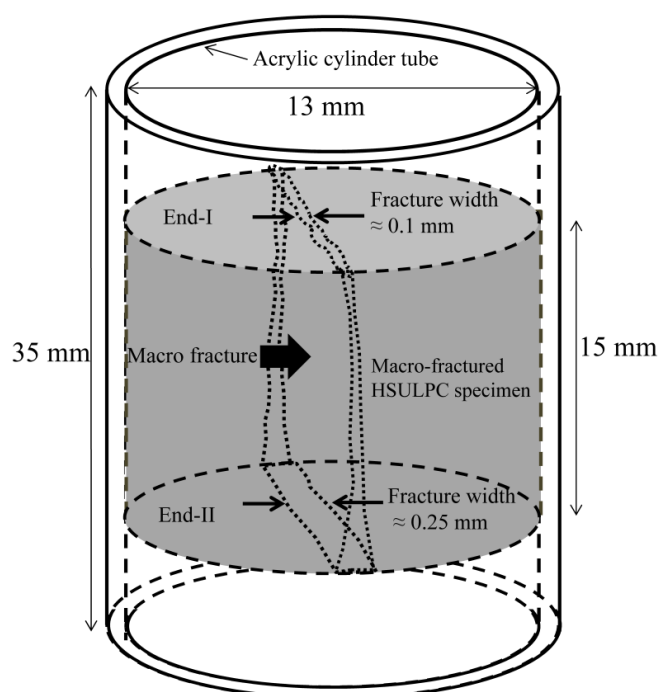
Figure 1 shows a schematic illustration of the macro-fractured HSULPC specimen prepared for this study. This sample was prepared by following the same way in Fukuda *et al.* [17]. An initially intact

cylindrical specimen of HSULPC with the diameter and height of approximately 13 and 15 mm, respectively, was split in half axially using a diametrical compression test (also known as diametrical tensile test, Brazilian disk test, indirect tensile test, compact crushing test, or compact hardness test) [25,26], and was set in an acrylic cylinder tube with the height of approximately 35 mm using epoxy glue. To keep the induced fracture open between the induced fracture planes, a thin stainless steel plate with the thickness of 0.10 mm was inserted. Consequently, the initial fracture widths for each outermost part of the fractured surface of specimen became approximately 0.10 mm and 0.25 mm. The terms “End-I” and “End-II” are used to describe the ends with fracture widths of 0.10 and 0.25 mm, respectively. The fracture width inside the specimen gradually increased from End-I to End-II according to preliminary observations by X-ray CT. The age of the HSULPC specimen used in this study was approximately two years. To minimize the errors regarding the water under environmental conditions and scanning position, comparison was conducted within one HSULPC specimen.

**Figure 1.** Schematic of macro-fractured HSULPC specimen.

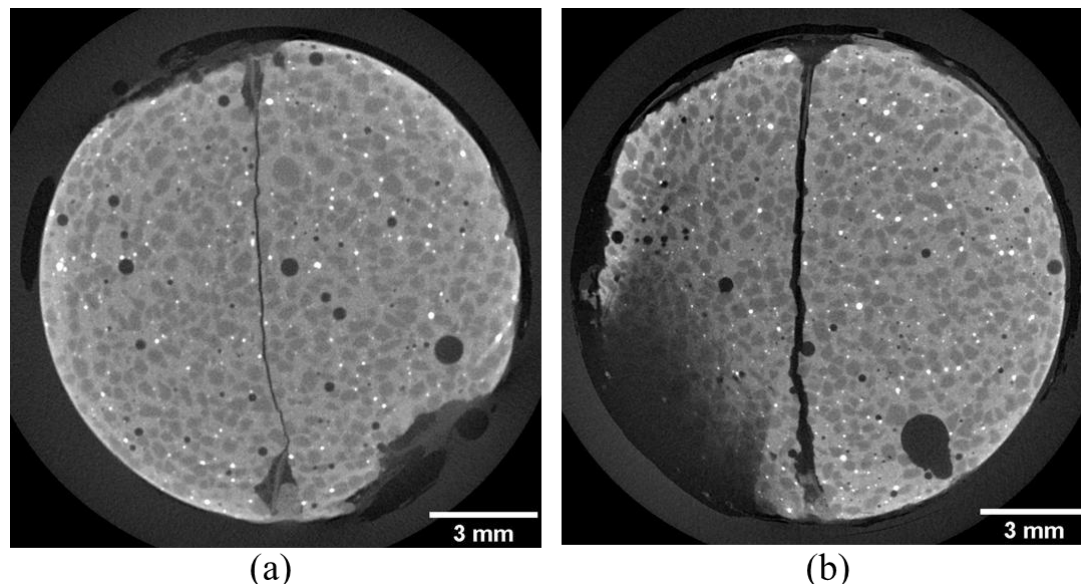
Typical CT slice images near End-I and End-II of the specimen in the initial stage are shown in Figure 2. The cross sections also correspond to the tops in the image analysis described in the next section. These images are presented in gray-scale with a range of 256 shades from black to white. High CT values, shown in white or brighter colors, correspond to regions with higher density. Regions of low CT values, shown in black or darker colors, correspond to areas of lower density. The straight black lines through the specimen found in the central part of each image are the macro-fractures with approximate widths of 0.10 and 0.25 mm, respectively. The dark circular shapes of various sizes are pores, with approximately spherical shapes in the three-dimensional sense. Small white granular regions having higher density are also found over the whole slices of End-I and End-II, *i.e.*, over the whole specimen, and these correspond to metal included in the silica fume as a byproduct of metal refining. The other regions, shown in gray, are the HSULPC matrix and consist of cement and aggregates.

Most of the pores with diameters greater than  $\sim 20\ \mu\text{m}$  were isolated from one another, and some of the pores were on the specimen surface. However, the pore connectivity of much smaller size ( $<1\ \mu\text{m}$ ) was not visible because of the aforementioned CT image resolution.

**Figure 2.** X-ray CT slice images of macro-fractured HSULPC specimen at the initial stage (a) near End-I and (b) near End-II.

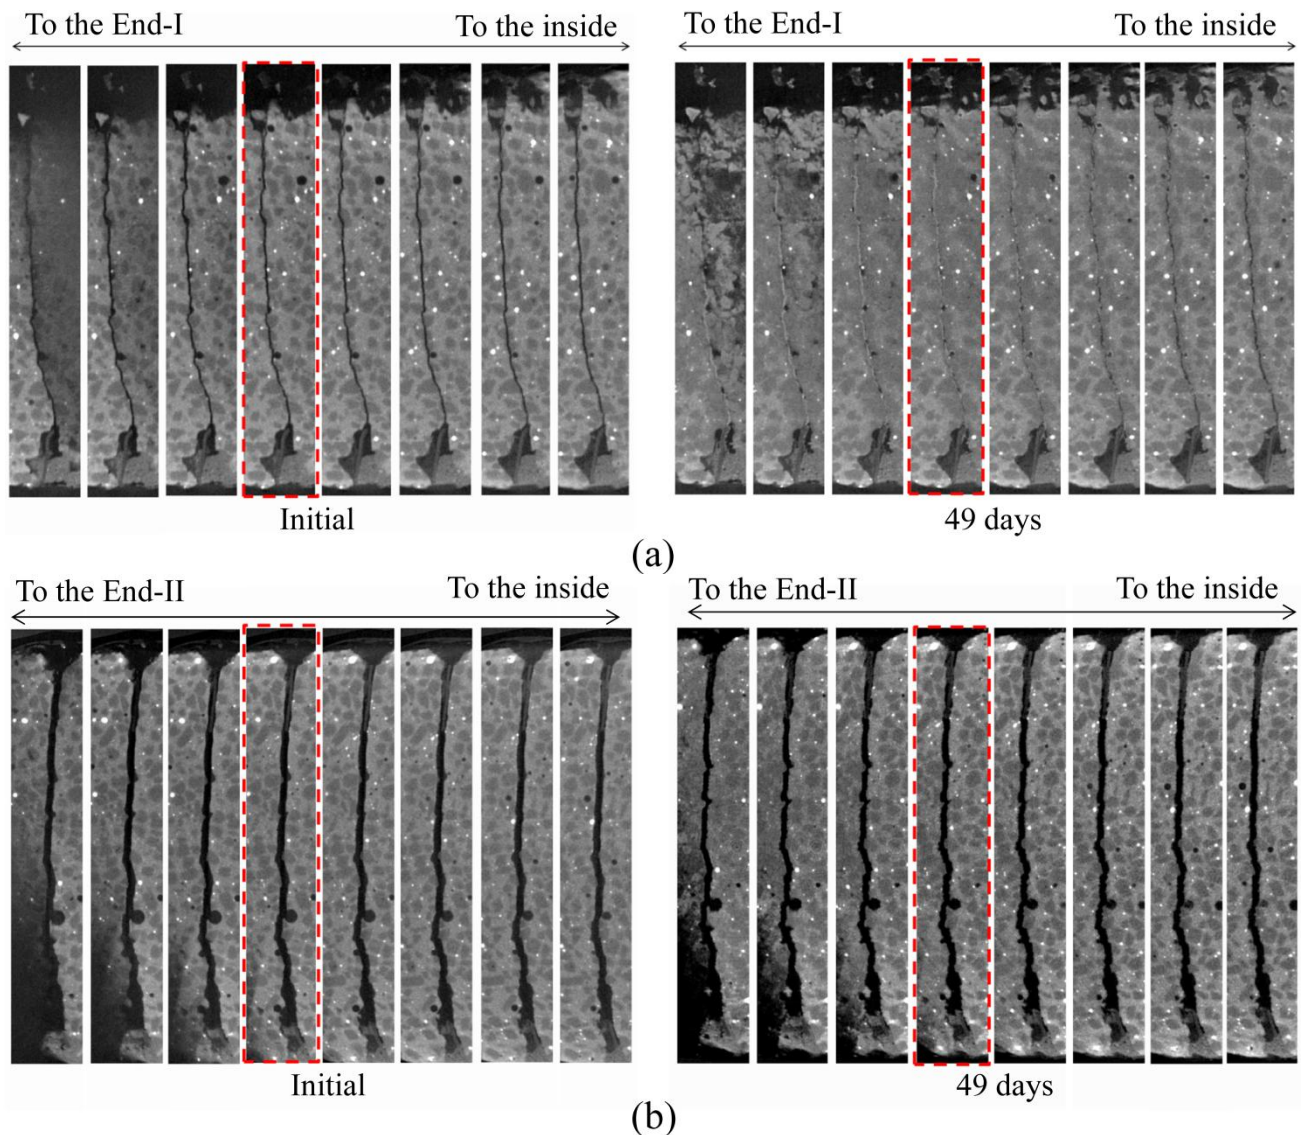
Figure 3 shows CT images of the macro-fracture for approximately the same cross sections near End-I and End-II, respectively. These images were extracted from seven CT images of the specimen at intervals of  $24\ \mu\text{m}$  from each end to the interior of the specimen, at the initial stage and after being kept in seawater for 49 days. In the region close to End-I, most parts of the macro-fracture were sealed in the specimen kept in seawater for 49 days, and less sealing was observed towards the specimen interior. This result shows a similar tendency reported by Fukuda *et al.* [17] where the macro-fracture of the HSULPC was approximately  $0.10\ \text{mm}$ . In the region close to End-II, although precipitation occurred in the macro-fracture in the specimen kept in seawater for 49 days, sealing was not observed. In addition, less precipitation was found towards the specimen interior. Note that the CT images nearest both ends showed more or less blurring because of the partial volume effect (e.g., [32]), where voxels are affected by including both solid parts and air within them. Such blurring is also caused by the tilted surface of the specimen at both ends.

**Figure 3.** Comparison of CT images of macro-fracture at initial stage and after being kept in seawater for 49 days for (a) End-I and (b) End-II. Height and width of each image are 14 and 2 mm, respectively. Note that the red dashed lines correspond to the top cross sections of each region of interest (ROI) in Figure 5.

The following observations were clarified by X-ray CT. Precipitation occurred at End-I and End-II with different fracture widths to the interior of the specimen within a range of approximately 0.3 mm. The amount of precipitate increased with elapsed time closer to each end. Thus, significant sealing was attained only in the macro-fracture close to End-I and sealing could be attained only in the case of the smaller fracture width.

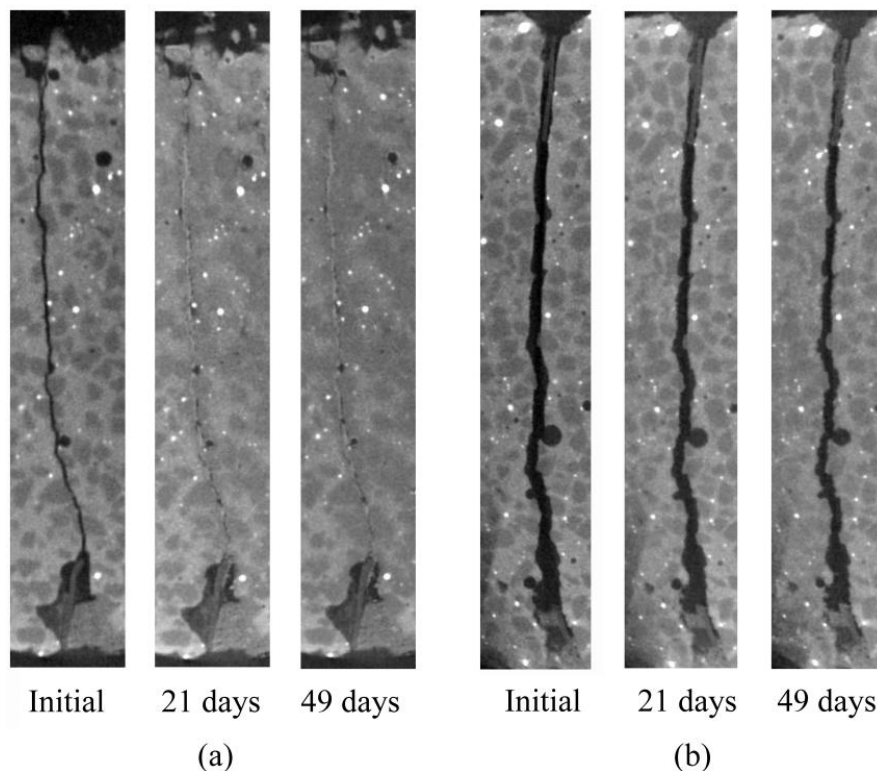
Figure 4 shows the temporal change in precipitation on the macro-fracture for one cross section near End-I and End-II, respectively. These cross sections are approximately the same sections near each end as those in Figure 2, and are also those indicated by dotted lines in Figure 3. In Figure 4a, precipitation occurred when the specimen was kept in water for 21 days and the sealed area increased with elapsed time. Because no re-opening of the sealed crack was found, we did not consider that dissolution of the precipitates occurred over the period of observation. No swelling of the specimen was found during the period of observation. In Figure 4b, a smaller amount of precipitation compared with that in Figure 4a was found when the specimen was kept in water for 21 days, and the precipitated area increased slightly with elapsed time, although significant sealing was not observed when the specimen was kept in water for 49 days.

**Figure 4.** Comparison of CT images for a particular section near (a) End-I and (b) End-II. Height and width of each image are 14 and 2 mm, respectively.

Near End-I, most parts of the macro-fracture were sealed after 21 days because of precipitation. Once such sealing was achieved, little precipitation was observed in the macro-fracture below the sealed part. For End-II, it seems that precipitation in the macro-fracture was still in progress after 49 days. In addition, in terms of the influence of fracture width on the attainment of sealing, although the considered cementitious material was different, the results obtained in the HSULPC showed a similar tendency in the self-sealing of engineered cementitious composites reported by Yang *et al.* [9].

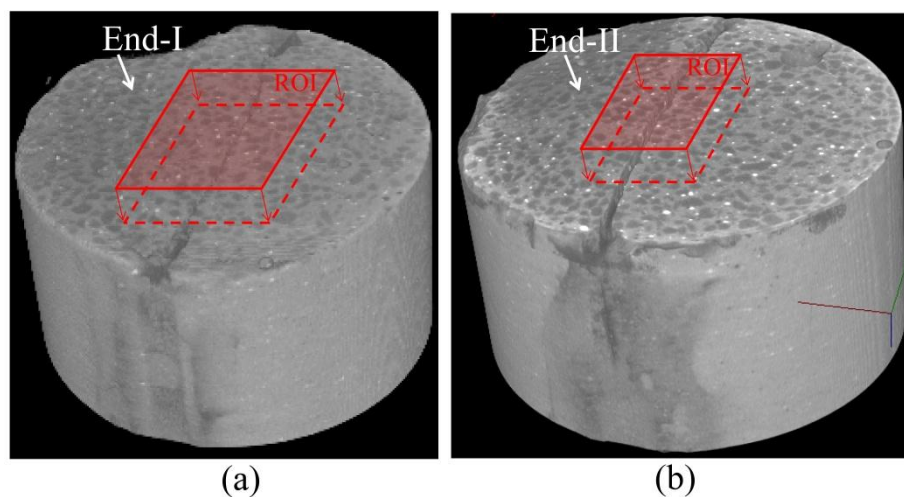
This research applied the same image registration approach used by Fukuda *et al.* [17] and a complete description of the approach is provided there. Briefly, CT images obtained after keeping the specimen in water were mapped onto those at the initial stage through an affine transform. To estimate the transform coefficients, the least square method was applied using gaps found in multiple sampling points represented by white granular regions. Then, the transform was optimized by utilizing the maximum value of the volume correlation between comparison images in the particular regions of interest (ROIs). The shapes of the ROIs for End-I and End-II were set as rectangular parallelepipeds (Figure 5), where the ROIs are presented by red lines with the 3D images of the upper and lower halves of the HSULPC specimen. The thicknesses of both the ROIs are equivalent to 30 slices from

each end to the interior of the specimen. Considering the precision of the image subtraction, the cross sectional matrix sizes of each ROI were  $270 \times 300$  and  $180 \times 280$  pixels, respectively. Because the nearest cross section to each end results in blurred CT images and can cause significant error in the image analyses, blurred CT images were excluded from the top of each ROI. Consequently, the top cross sections of each ROI are those surrounded by dashed lines in Figure 3. Following the image registration, image subtraction was conducted for each end.

**Figure 5.** 3D CT image of (a) upper and (b) lower halves of the HSULPC specimen used in image analysis, where the ROIs used in the image registration are indicated by rectangular parallelepipeds. Height, width and depth of each parallelepiped are  $4.3 \text{ mm} \times 4.8 \text{ mm} \times 0.7 \text{ mm}$  and  $2.9 \text{ mm} \times 4.5 \text{ mm} \times 0.7 \text{ mm}$ , respectively. The rectangles shown by red solid lines are on the cross section of each end of the specimen and red arrows indicate the depth toward other end of the specimen.

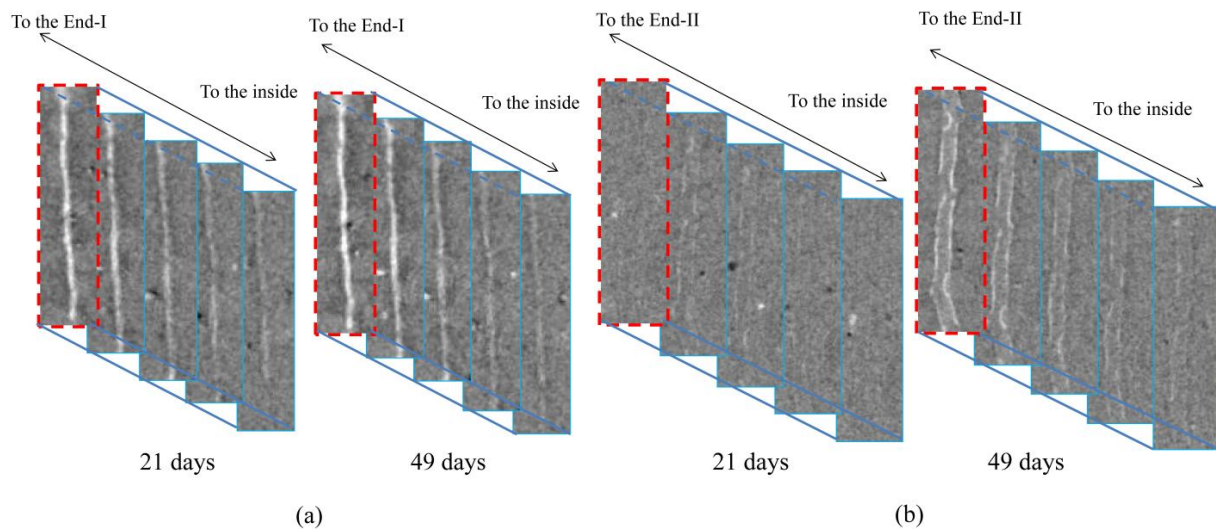
Figure 6 shows results of the image subtraction process (*i.e.*, subtraction images) in each ROI in Figure 5. In the image subtraction process, the reference images correspond to the specimen at the initial stage, and comparison images correspond to the specimen after 21 or 49 days in seawater. In Figure 6, the images surrounded by red dotted lines correspond to the same plane for each time. From these images toward the inside of the specimen, the images surrounded by blue dotted lines show the same planes, respectively, for each time. In the subtraction images, only the macro-fractures in each ROI are presented at an interval of  $48 \mu\text{m}$  from the top of each end to the interior of the specimen. These images are displayed in gray-scale, with a range of 256 shades from black to white, for a window level and width of 0 and 1000, respectively. In regions where no change occurred, the differences between the CT values are approximately zero. In this case, images are displayed in gray. In regions where precipitation occurred, the difference between the CT values is positive. In this case, the color is white. From Figure 6, the regions of precipitation observed in Figure 3 are extracted successfully from each macro-fracture.

**Figure 6.** Subtraction images between initial images and those obtained after specimen was kept in seawater for 21 or 49 days for (a) End-I and (b) End-II. Height and width of each subtraction image are (a) 2.9 and 0.7 mm; and (b) 3.5 and 0.9 mm, respectively.

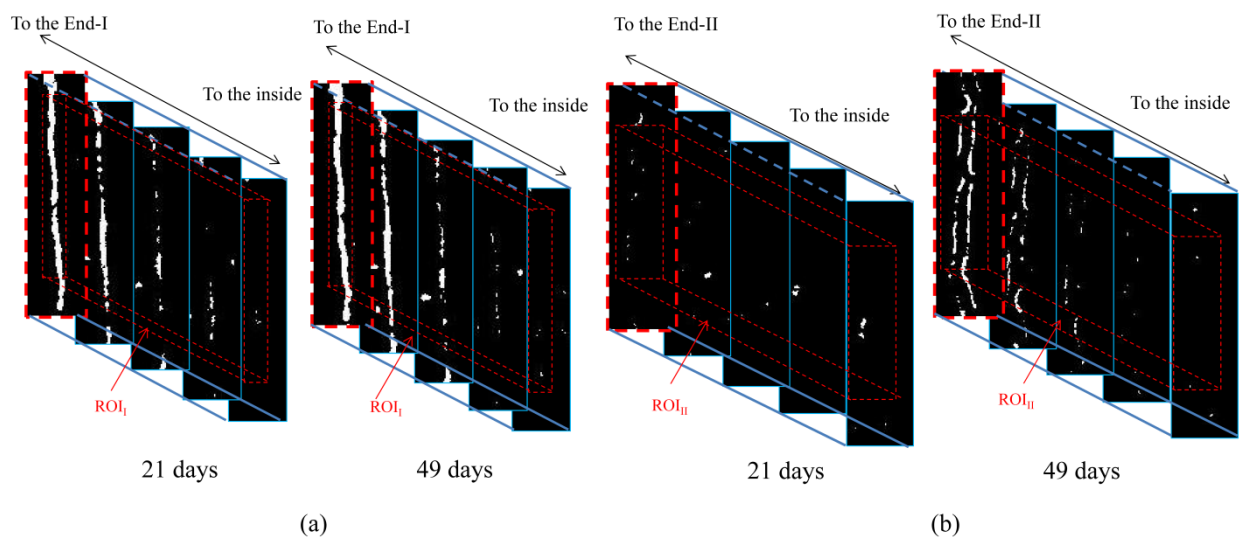
In the subtraction images, reasonable segmentation between precipitated and non-precipitated regions was required. If a voxel [32] includes both the precipitated and non-precipitated regions, the CT value of this voxel takes an intermediate value between these two phases. This kind of voxel is called a “mixel” [33–35]. A maximum likelihood thresholding method considering the effect of mixels [33,34] was used to set an appropriate threshold. The calculation of threshold in Figure 6 was based on exactly the same procedure described in Fukuda *et al.* [17] using a histogram of the probability density function in each ROI of the subtraction image. Binarized images obtained from the subtraction images in Figure 6 by the maximum likelihood thresholding method are shown in Figure 7. The images show the cross sections from the top to the interior of each ROI at an interval of 48  $\mu\text{m}$ , and demonstrate the increase in amount of precipitation with elapsed time successfully.

**Figure 7.** Binarized images obtained by segmentation of subtraction images in Figure 6 for (a) End-I and (b) End-II. Height and width of each subtraction image are (a) 2.9 and 0.7 mm; and (b) 3.5 and 0.9 mm, respectively.

The 30 binarized images obtained in the previous section were used to evaluate the precipitation process, especially in ROI<sub>I</sub> and ROI<sub>II</sub> in Figure 7. Figure 8 shows a schematic illustration of precipitation in the macro-fracture. The percentages of sealing deposits in the macro-fracture,  $P_{\text{seal}}$  (%), in each slice, having slice thickness  $T_{\text{slice}}$ , were calculated:

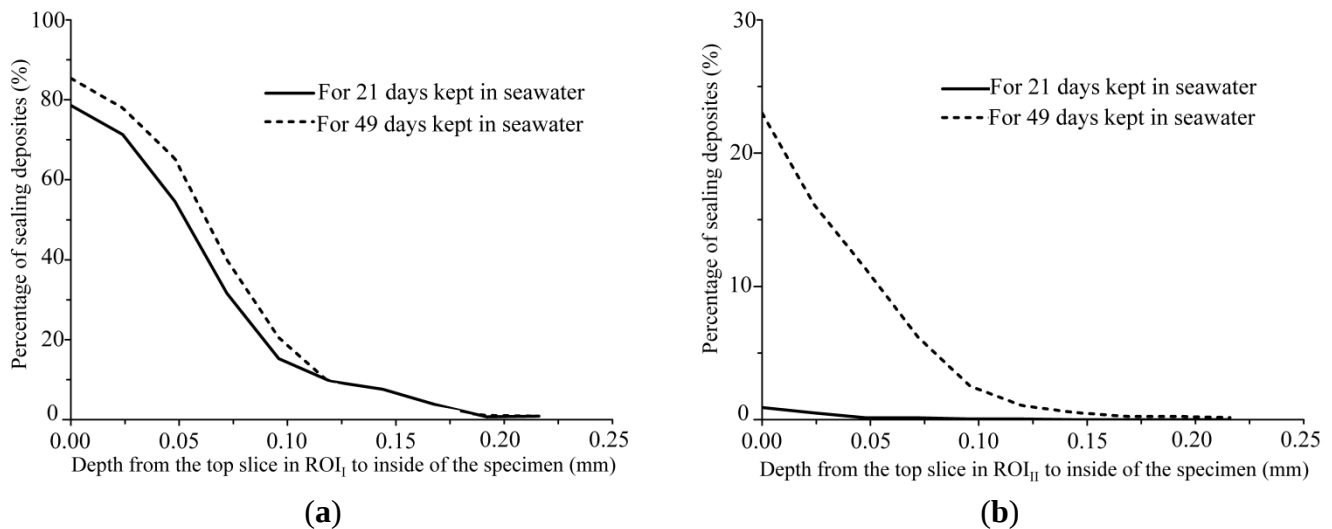
$P_{\text{seal}}$  in each ROI is shown in Figure 9 with respect to the depth from the top to the interior of each ROI. In Figure 9,  $\Delta t$  was 21 days if taken 21 days after placing the specimen in water. Similarly,  $\Delta t$  was 28 days if the specimen was placed in water at 22 days and taken out of the water at 49 days. From these figures,  $P_{\text{seal}}$  increased towards both ends in each period, and  $P_{\text{seal}}$  at a depth of 0.2 mm for both ROIs increased with elapsed time. If the thickness of the excluded blurring images in each ROI corresponds to approximately 0.10 mm mentioned in Section 3 is considered, precipitations for both ends were found within a depth of 0.3 mm from each end to the interior of the specimen. In addition, considering the macro fracture of unit fracture length for the tops of ROI<sub>I</sub> and ROI<sub>II</sub>, Figure 9 shows that the values of  $P_{\text{seal}}$  for each ROI are largely different from each other. However, as shown in Table 3, maximum amounts of precipitation at 49 days for the tops of each ROI are roughly the same. Thus, if it can be assumed that the expected amount of precipitation is determined by the composition of HSULPC and surrounding water and that such amount is approximately given by that at the top in ROI<sub>I</sub>, further significant sealing in End II could not be expected because the expected amount of precipitation has been almost attained at 49 days.

**Figure 9.** Relationship between percentage and position of sealing deposits in specimen kept in seawater for 21 and 49 days for (a) ROI<sub>I</sub> and (b) ROI<sub>II</sub>.

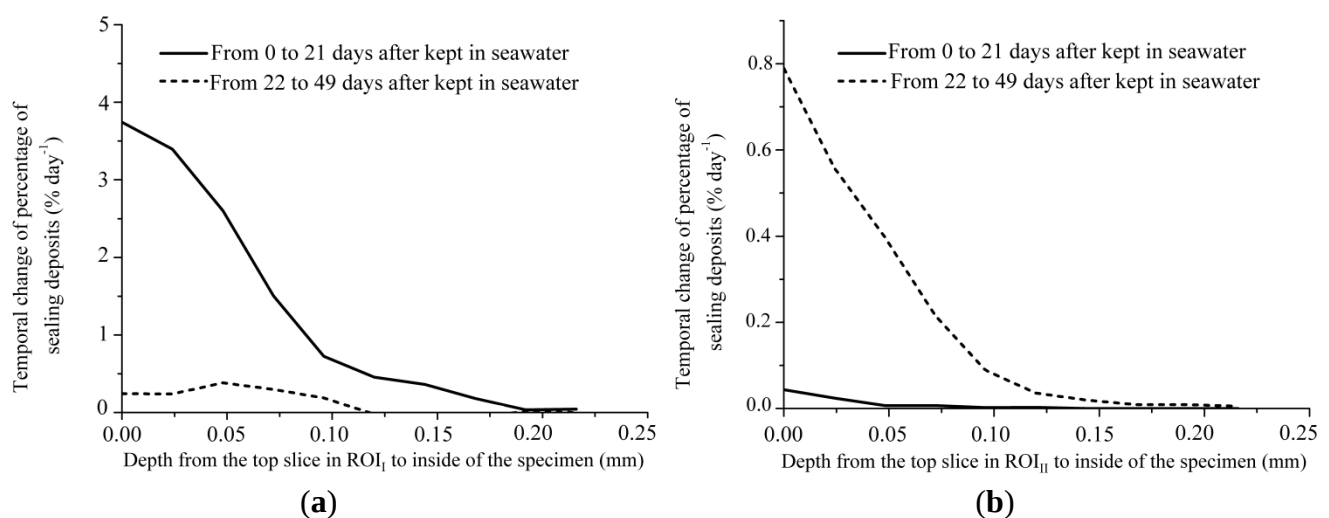
Similarly,  $R_{\text{seal}}$  in each ROI is shown in Figure 10 with respect to the depth from the top to the interior of each ROI. From Figure 10,  $R_{\text{seal}}$  towards each end tends to be larger than that in the inner region. In ROI<sub>I</sub>, the maximum  $R_{\text{seal}}$  was found at 21 days, and then  $R_{\text{seal}}$  decreased. It is also suggested that little precipitation could be expected to occur after 49 days in ROI<sub>I</sub>, and, once the macro-fracture is almost sealed, less precipitation could be expected in the region below the sealed parts. This tendency supports the view that the sealing of macro-fractured HSULPC specimens with fracture width of 0.10 mm occurs by 21 days in seawater as noted by Fukuda *et al.* [17]. On the other hand, in

ROI<sub>II</sub>, the maximum  $R_{\text{seal}}$  at 49 days was larger than that at 21 days. Thus, although further precipitation after 49 days may occur in ROI<sub>II</sub>, considering the above discussion regarding  $P_{\text{seal}}$ , the required time for the sealing of a fracture in ROI<sub>II</sub> will be much longer. The difference of  $R_{\text{seal}}$  in each ROI was caused by the difference in fracture width and greater calcite nucleation was enhanced in the smaller fracture width.

**Figure 10.** Temporal change of percentage of sealing deposits for specimen kept in seawater for 0–21 days and 22–49 days in (a) ROI<sub>I</sub> and (b) ROI<sub>II</sub>.
