| Description | The Thirteenth East Asia-Pacific Conference on Structural Engineering and Construction (EASEC-13), September 11-13, 2013, Sapporo, Japan. |

# TEMPERATURE FIELD AND ITS EFFECTS ON A LONG-SPAN STEEL CABLE-STAYED BRIDGE BASED ON MONITORING DATA

Yi ZHOU<sup>\*</sup>, Limin SUN<sup>†</sup>, and Shouwang SUN

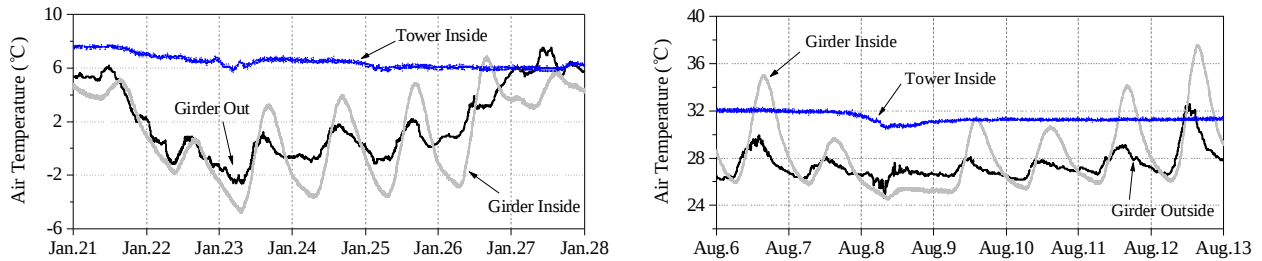
Figure 1 shows air temperatures recorded by the weather station on the deck of the west girder during two weeks in Jan. and Aug., respectively. It is evident that: 1) whether in winter or in summer, the air temperature inside the steel box girder has much larger variation amplitude than that outside the steel girder; meanwhile, the former lags behind the latter about 2 hours. This phenomenon can be explained by the fact that the air inside the girder exchanges heat with the steel box girder, and heat conduction needs time. 2) The air temperature of girder possesses both diurnal and seasonal changes whereas the air temperature inside the concrete tower only has seasonal variation, which implies the concrete is less able to gain or lose heat from their exterior surfaces.

**Figure 1: Air temperature comparisons**

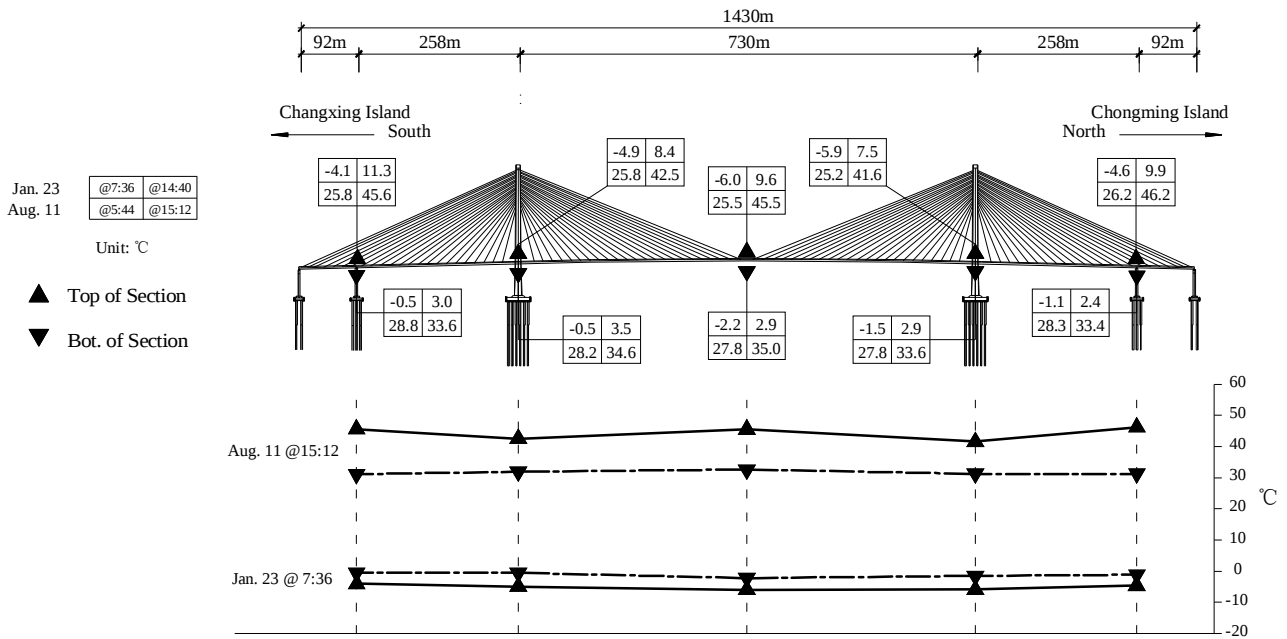
The temperature on the girder is compared at different sections along the bridge. As shown in Figure 2, 4 time instants are chosen, in which 7:36 and 14:40 are time when the girder's top plate reaches its minimum and maximum temperature on Jan. 23, while 5:44 and 15:12 corresponds to the temperature peak and trough time on Aug. 11. All the temperature values in Figure 2 are the average ones of the two separated box girders. It is worth noting that though the temperature lags among these cross-sections are diminutive, however, the highest temperatures at the two tower-girder intersections are about 5 °C lower than the other 3 sections, which might be due to the tower's block of sunshine.

Figure 2: Longitudinal temperature distribution

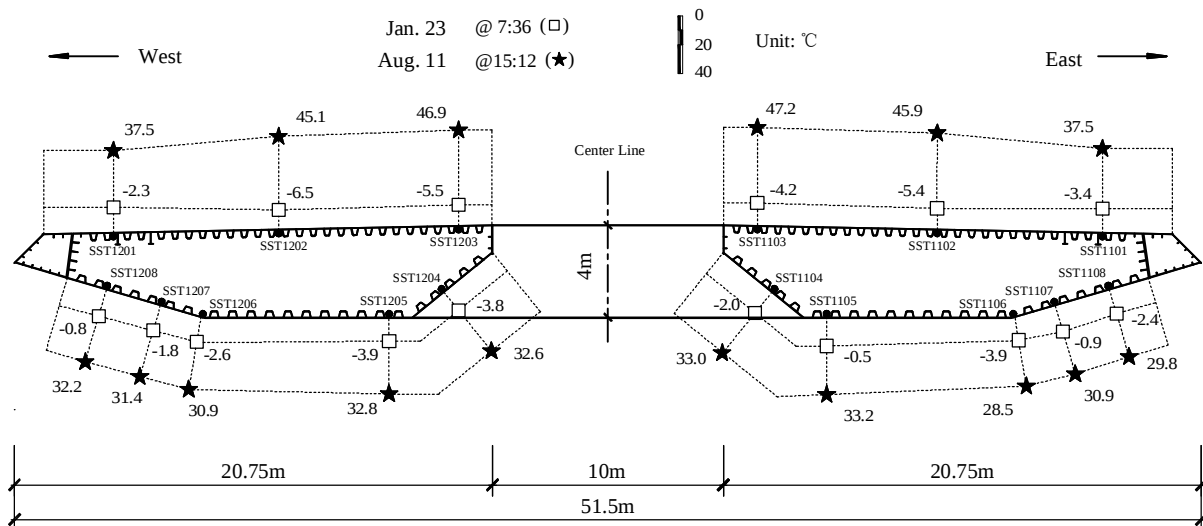
Figure 3 is the distribution pattern of structural temperature at the middle section of the bridge's main span. Upon close examination it can be found that: 1) during the high temperature periods, the vertical thermal gradient is much larger than the transverse one, while for the low temperature case, this difference is unclear; 2) steel top plate has a larger thermal variation than bottom plate. Of particular note is that the temperature of these two sensors SST1104 and SST1204 reach their peaks about 3 hours later than the other sensors, which might have something to do with the heat convection condition for the air circulation is weak around their locations.

Figure 3: Temperature field at mid-span

Figure 4 serves the temperature comparison of different structural components and atmosphere. Here, the girder's top plate temperature is the average of SST1102 and SST1202 (Figure 3), and the

bottom one is the average of SST1105 and SST1205 (Figure 3); the cable's temperature is the average of the two longest cables SSZ1105 and SSZ1205 (Figure 5) and the tower's temperature is the average of SCT1311 and SCT1314, which locate on the exterior surface facing the south and thus have a larger daily variation than the sensors in the north surface. From Figure 4, the girder's top plate is subjected to the most temperature variation of all, there being a distinct difference in magnitude between the structural temperature and the ambient temperature. So certain modification is required for the temperature range in structural design, which usually comes from the weather database. As a note for the reader, the cable temperature sensor is enclosed in a protective box which also protects the cable force sensor, and is directly attached on the cable's wrapping. As a result, the measured cable temperature is suspected to be different from that of the high-strength steel wires.

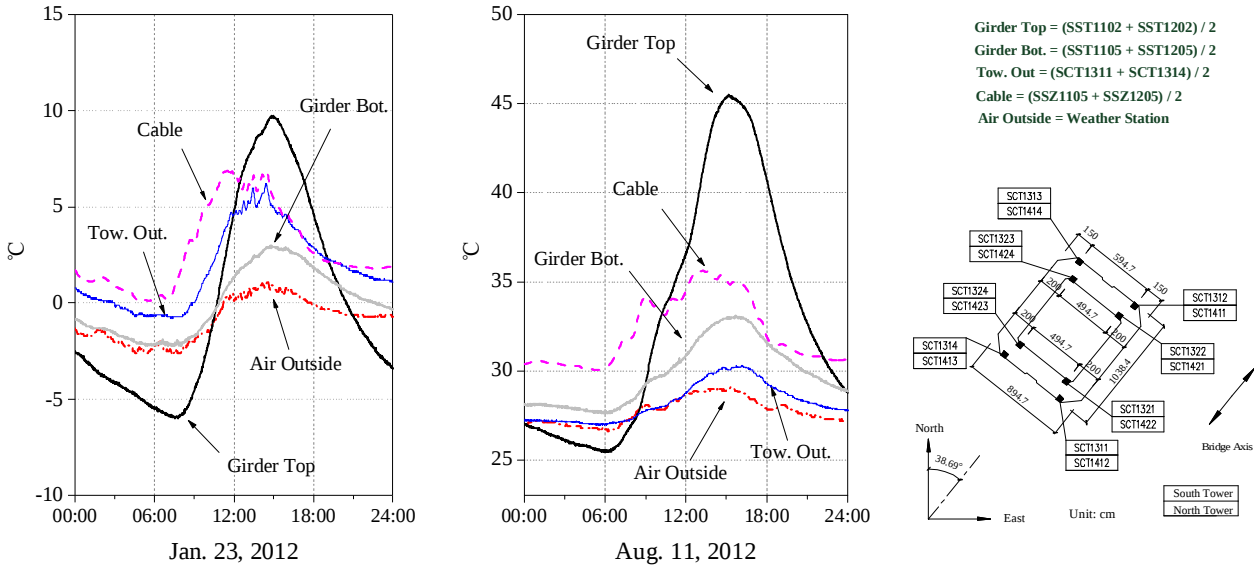
**Figure 4: Structural temperature comparison**

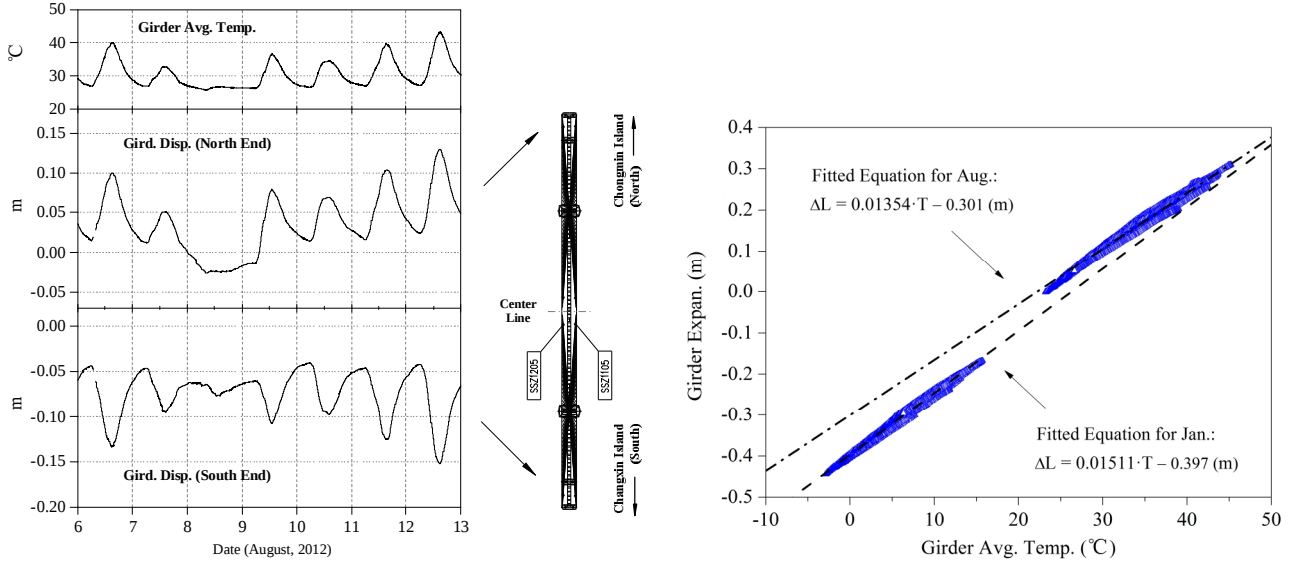
There are totally 4 extensometers installed at the north and south ends of the girder, 2 for each side with a sampling frequency of 20 Hz and the measurements increase if the girder's ends move towards north. In addition, the displacement of the north end minus the south end could approximate the girder's expansion. Figure 5 manifests the strong correlation between girder's longitudinal expansion and the averaged temperature of the girder's top and bottom plates, and the lines of best fit for Jan. and Aug. are also plotted in the figure. The slight difference of the thermal coefficients indicates the existence of somewhat non-linearity seasonally for this cable-stayed bridge.

**Figure 5: Girder expansion Vs. Girder temperature**

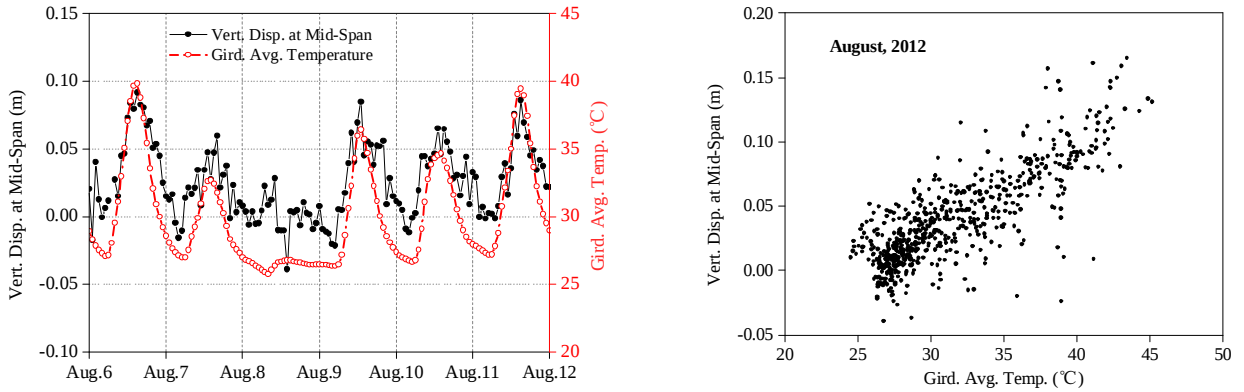
GPS technology is used to monitor the girder and tower's displacements at the mid-span and both towers' top with a sampling frequency of 10 Hz. Compared to data from tower, the girder's deflection is seriously affected by the traffic loads. Considering the temperature causes static structural responses, the hourly averages are adopted for GPS data. Figure 6 depicts the relationship between the girder's deflection and its average temperature in August, where an increasing value of the deflection means the girder goes upward. It is obvious that the girder curves upward in the middle with the rise of temperature, and vice versa. This phenomenon is similar to (Cao et al. 2011) but opposite to the observations by (Xu et al. 2010; De Battista et al. 2011), so the mechanism behind this difference remains to be decoded.

**Figure 6: Girder deflection Vs. Girder temperature**

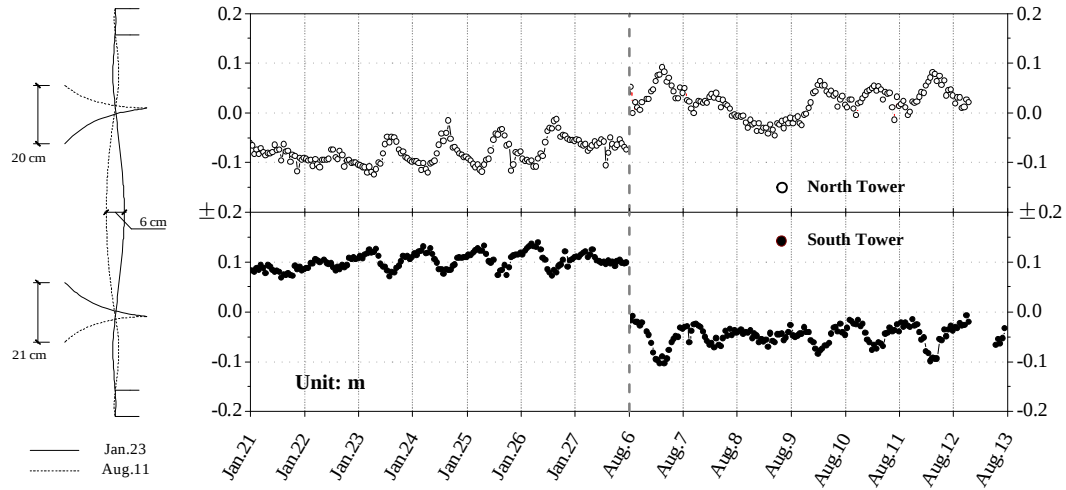
The tower's longitudinal displacement is also 1-hour average and the increasing value indicates it moves to the north. From Figure 7 it is interesting to note that the two towers move away from each other when the temperature rises and move close to each other when temperature drops, which follows both the diurnal cycles and the seasonal cycles. Such a result is not so surprising, for it is compatible with the main girder's expansion deformation and elevation changes.

**Figure 7: Tower displacement (longitudinal)**

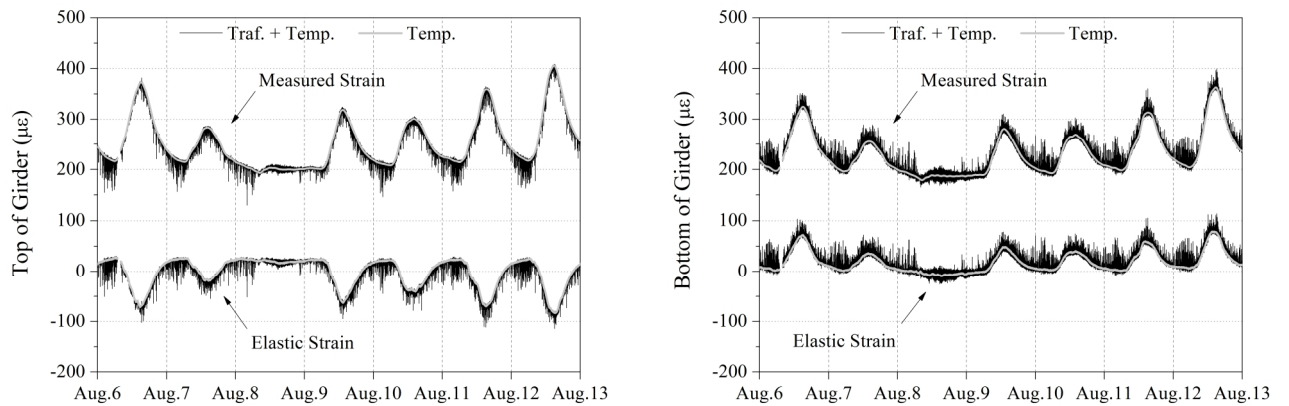
As a local quantity, strain measurement is collected by FBG sensors with a sampling rate of 20 Hz. In Figure 8 both the measured total strain and elastic strain at the mid-span section are plotted in each subplot, with a positive value representing stretch or tension. Here the measured strain is total strain which contains two parts, i.e. stress-free strain  $\alpha \cdot \Delta T$  and elastic strain, the latter being directly related to the stress by the elastic modulus  $E$ . Except the temperature, the strain measurements are also affected by random traffic loads significantly; thus 1-min mean value is firstly calculated and then a wavelet packet de-noising algorithm is performed to separate out a smooth thermal-induced strain time history, as represented by the light gray lines in Figure 8. Figure 9 illustrates the relationship between thermal-induced elastic strain and the girder's average temperature based on the August data. The rising temperature will cause an increase of the compressive stress at the top plate; on the contrary, the rising temperature will cause an increase of tensile stress at the bottom plate. A straightforward but not rigorous explanation is that this stress variation pattern comes from the mutual constraints between the upper fibers and lower fibers at the mid-span section in order to keep compatibility condition; after all, the fibers at the top and bottom plates experience much different temperature variation magnitudes.

**Figure 8: Strain at mid-span of girder**

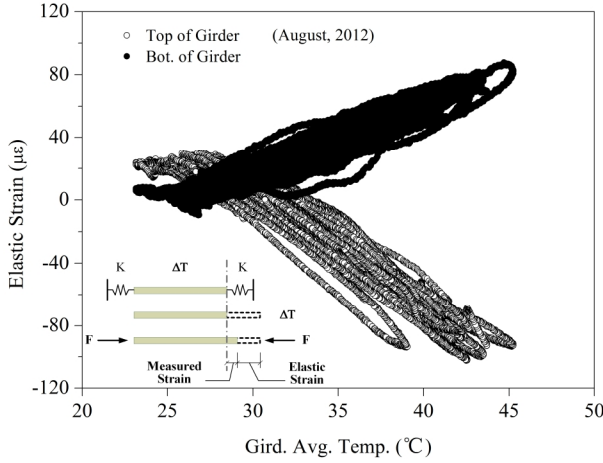
**Figure 9: Elastic strain Vs. Girder temp.**

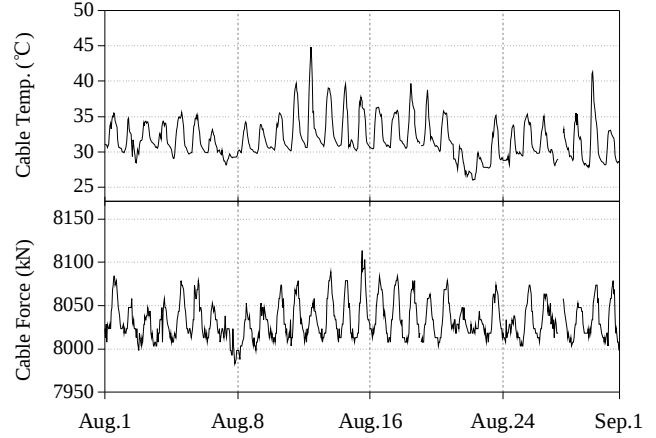
**Figure 10: Cable force and temperature**

The cable force is estimated from the acceleration signals, which are acquired at a frequency of 50 Hz. For a specific cable, its tension is approximately proportional to the squared natural frequency of some order. Figure 10 shows the time histories in August of the cable SSZ1105's tension and temperature, samples' time interval being 1 hour. The cable force has a positive association with its temperature and the daily variation is rather clear. It should be noted that even though the cable force, boundary conditions and the sag hold constant, the measured frequency of stay-cable would decrease as the temperature increases. According to (Xia et al. 2006) the measured frequency depends more on the elastic modulus  $E$ 's change than the cable length's variation and the thermal coefficient of  $E$  is about  $-0.036\%/^{\circ}\text{C}$ ; on the other hand, cable tension  $T \propto f^2 \propto E$  and thus the  $20^{\circ}\text{C}$ 's increment of cable temperature in August would cause a decrease of "nominal tension" about  $0.72\%$  with all the other conditions unchanged. However, the measured maximum relative change of the cable tension is an increase of  $1.48\%$ . Hence, it is inferred that the actual tension change should be more than  $1.48\%$ , up to about  $2.2\%$  after the temperature modification.
