| Title | A NONLINEAR FINITE ELEMENT ANALYSIS OF CONCRETE RAILWAY SLEEPER DAMAGED BY ICE EXPANSION |
| Description | The Thirteenth East Asia-Pacific Conference on Structural Engineering and Construction (EASEC-13), September 11-13, 2013, Sapporo, Japan. |

# A NONLINEAR FINITE ELEMENT ANALYSIS OF CONCRETE RAILWAY SLEEPER DAMAGED BY ICE EXPANSION

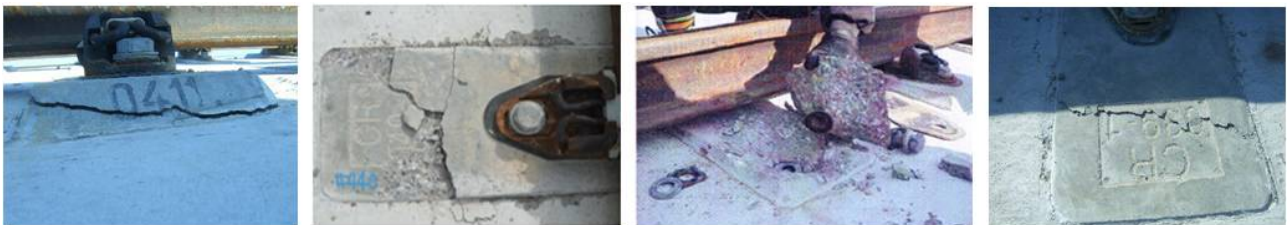
The slab track system for high speed railway system was adopted in Kyengbu railway in Korea. There are 153,394 concrete sleepers placed for the construction from 2007 to 2009. Some of them were found damaged. A conical crack was formed near a fastening bolt of a sleeper as shown in Figure 1. It initiated from the top of the insert was extended to the top of the sleeper. In this paper, a three dimensional finite element analysis was used to probe into the reason for this crack forming and compared with experimental results for verification.

**Figure 1: Cracks developed in the railway sleeper**

The conical crack which was formed near a fastening bolt of a sleeper is investigated in this study. It is found that the failure of sleeper was caused by unexpectedly ice expansion of freezing water leaking into the inserts of the fastener hole. A three dimensional finite element model is developed to analyze the behavior of failure, and the effect of parameters for the maximum freezing force.

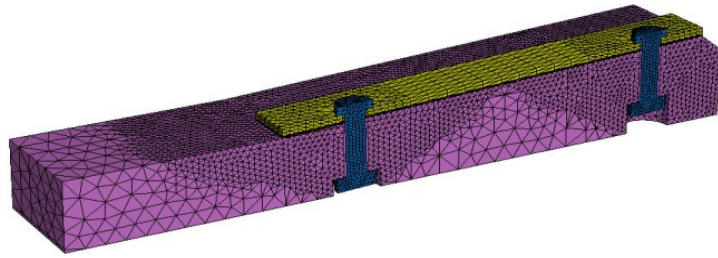
A three dimensional nonlinear finite element model was implemented to a widely used commercial code, ABAQUS(Hibbitt, Karlson & Sorensen, 2005). Because of the symmetry in the longitudinal direction, half of sleeper was only modeled as shown in Figure 2. The crack growth was simulated by the crack band model(Bazant and Oh, 1985). The size of elements in the region where the crack would cut through was fixed as the characteristic length which is defined as cube root of element volume. The characteristic length was set to five millimeters in this study.

Figure 2: Finite element mesh using tetrahedral elements

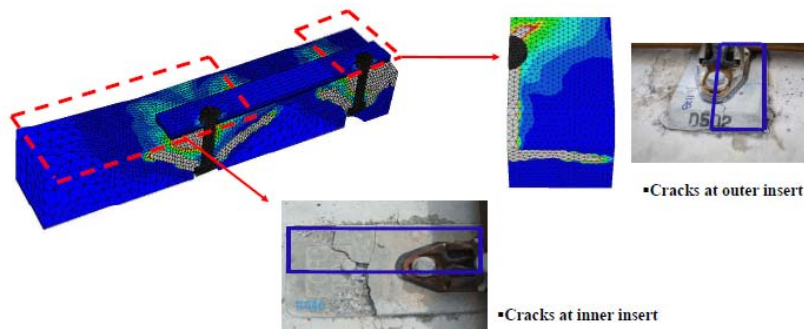
It is found that the crack was caused by unexpectedly ice expansion of freezing water leaking into the inserts of the fastener hole. A sleeper has been applied two types of loads: (1) ice expansion caused by water leaked inside the insert, and (2) fastening force applied to the bolts. The loading sequence in failure analysis was as follows. At first, the fastening force was applied to the bolt. And then, the expansion of ice was applied. The fastening force was carried by the strain decreases, and the ice expansion was modeled by upward displacement at the bottom surface of the nut. The contour of principal strain when the ice expansion was applied is shown in Figure 3.

Figure 3: Distribution of the principal strain

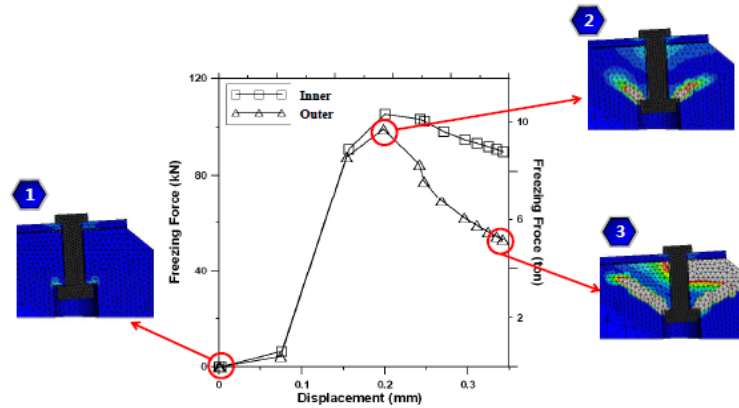
**Figure 4: Evolution of the damage on different levels of softening**

The development of the crack at different points of the force-displacement diagram is shown in Figure 4. As expected, the initial fastening force introduced a high stress gradient near the insert hole. At the peak, almost half of the height of the sleeper was damaged. Beyond the peak, the crack growth became spontaneous if a freezing force is applied by a pressure.

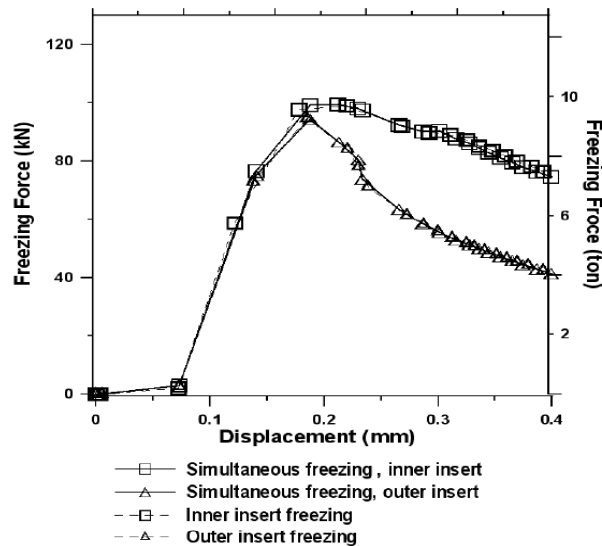
**Figure 5: Behavior of the inner and outer insert holes**

The freezing of the two inserts could take in place independently or simultaneously, which was considered as a variable. The freezing force-displacement diagram is shown in Figure 5 for different locations of frozen inserts. It was found that there is no difference in the behavior between the

curves of simultaneous and independent freezing. The maximum freezing force of the inner insert hole was larger than that of the inner insert hole. It is because the inner insert hole is confined by surrounding concrete.

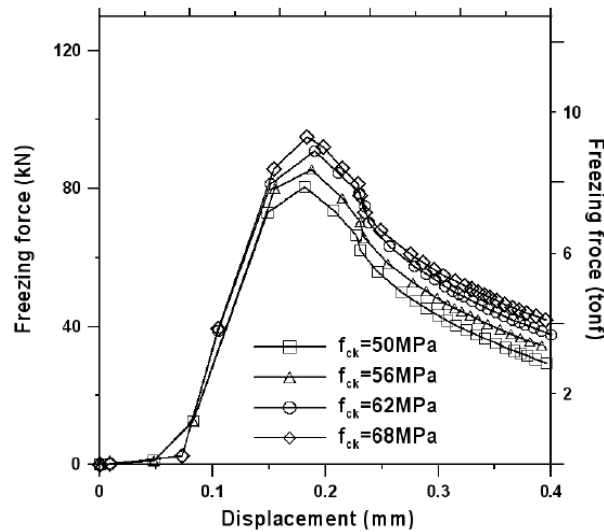
**Figure 6: Influence of the concrete compressive strength**

Figure 6 shows the influence of the concrete compressive strength to the resistance of the sleeper. The resisting force increases as the compressive strength increases as expected.
