| Title | LOW-CTCLE FATIGUE FAILURE MECHANISM OF WIND TURBINE FOUNDATION DUE TO VIBRATION OF UPPER STRUCTURE |
| Description | The Thirteenth East Asia-Pacific Conference on Structural Engineering and Construction (EASEC-13), September 11-13, 2013, Sapporo, Japan. |

# LOW-CYCLE FATIGUE FAILURE MECHANISM OF WIND TURBINE FOUNDATION DUE TO VIBRATION OF UPPER STRUCTURE

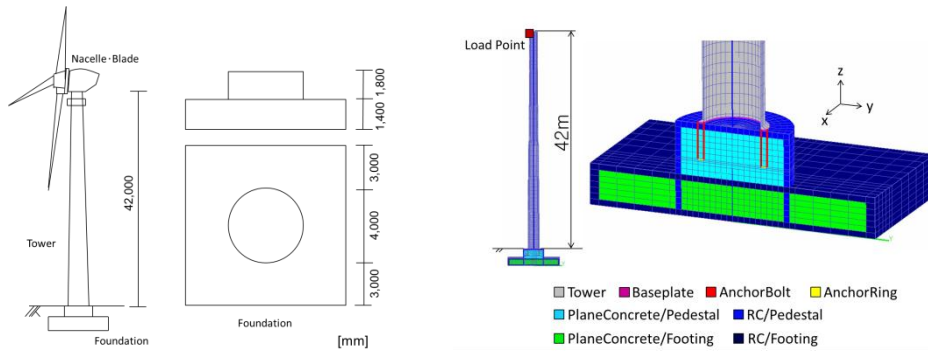
**Figure 1: Schematic and model for analysis**

Fig. 1 shows a schematic of targeting wind turbine and its model for-analysis. Hub height of the model is 42 m. The tower and foundation are connected by 88 anchor bolts and an anchor ring. Because of symmetry, only half of the wind turbine is needed to be modeled. The model is made primarily from solid elements. Only the anchor bolts are modeled by line elements, with particular tension strains representing torque. To account for bond and friction between steel and concrete, interface elements are used between tower and foundation (Yasojima and Sakamoto 2012).

Concrete strength of the pedestal and footing are  $28.6 \text{ N/mm}^2$  and  $29.3 \text{ N/mm}^2$ , respectively. Yielding strength of the tower and anchor bolts are  $400.0 \text{ N/mm}^2$  and  $931.6 \text{ N/mm}^2$ , respectively. The total dead weight of nacelle and blades are applied as a 650 kN axial force on the tower. The torque tightening the tower and foundation is  $2.12 \text{ kN}\cdot\text{m}$ .

The bottom of the model was fully restrained in the vertical. The X-axis was restrained in a symmetrical cross section. In this study, it is assumed that the influence of elasticity of the ground can be ignored.

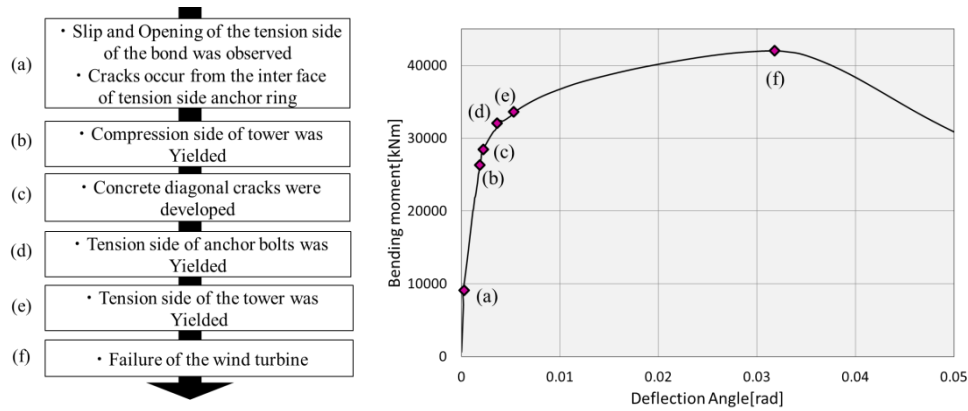
**Figure 2: Failure process for static analysis**

Fig. 2 shows the result of the static analysis in this study. The cone-shaped failure from the anchor ring was confirmed from principal strain contour and deformation. This means that the behavior of the anchor bolt affects the failure of the wind turbine. The failure process observed can be broken

down into steps (a) to (f), which are represented in the diagram of bending moment versus deflection angle of the bottom of the tower. The results agree with past research.

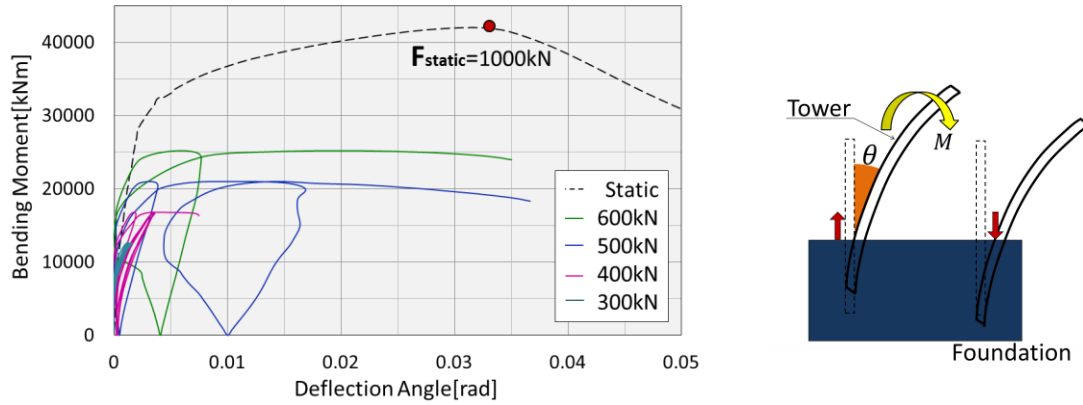
**Figure 3: Relation of the bending moment to the deflection angle**

Fig. 3 shows the relation of the bending moment to deflection angle of the tower at the bottom. The deflection angle of the tower at applied tension side was adopted as an indicator. The deflection angle at an amplitude of 300 kN overwrote the same path during the whole load history, although deflection angles at amplitudes 400 kN, 500 N and 600 kN increased rapidly after particular load cycles. In other words, repetition of a load whose amplitude is over 40% of the ultimate load  $F_{static}$  could cause failure of the wind turbine.

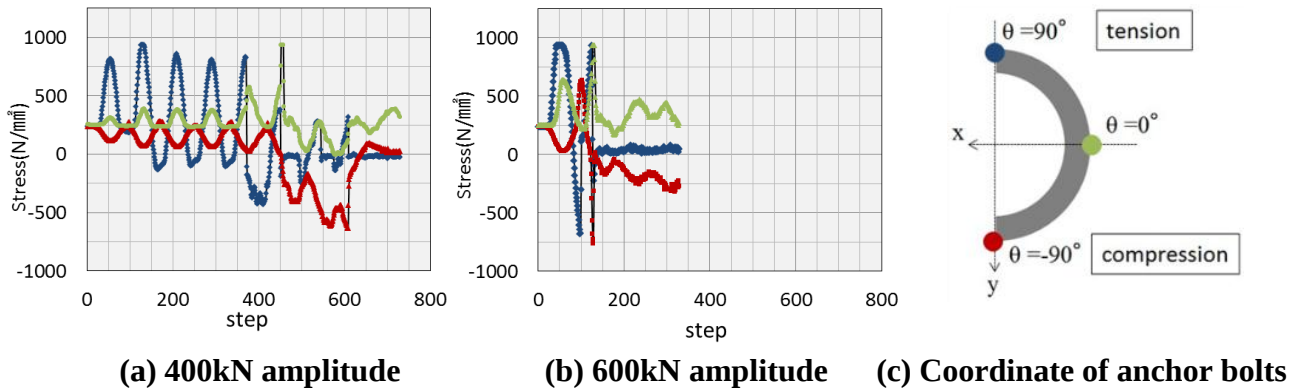
**Figure 4: Stress of the anchor**

Yielding of anchor bolts due to dynamic load was guessed by the relation of stress-step. In order to simplify the description, the location of an anchor bolt was defined using polar coordinates. The anchor bolt in the neutral area was defined as  $\theta = 0$  degrees. As well, tension side of the anchor bolt and compression side of the anchor bolt were defined as  $\theta = 90$  degrees and  $\theta = -90$  degrees, respectively (Fig. 4(c)).

The stress of anchor bolts at amplitudes 400 kN and 600 kN are shown in Fig. 4(a) and (b). For 400 kN, the order of yielding of the anchor bolts was 90 degrees, 0 degrees, -90 degrees (Fig. 4(a)). The anchor bolts yielded from tension side to compression side. On the contrary, for 600 kN, anchor yield of focused three anchor bolts coincided at the first loading.

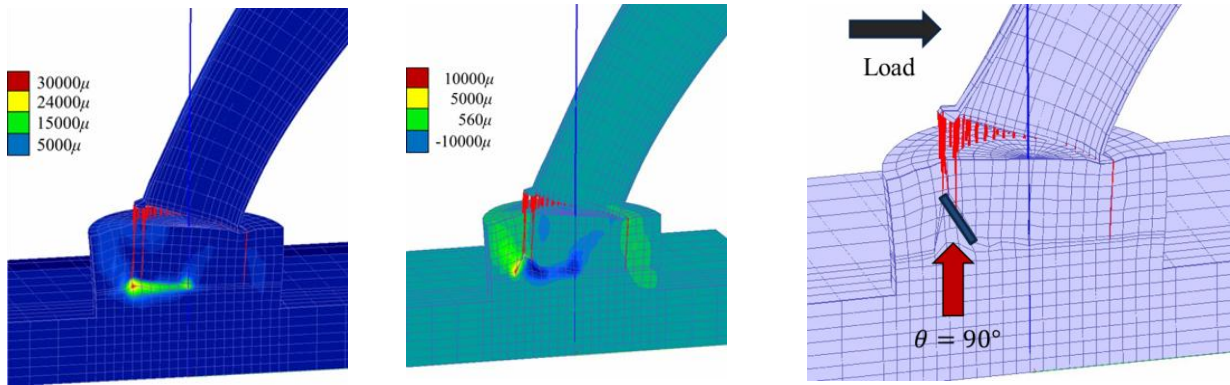
**Figure 5: Strain contour and deformation of foundation for 400 kN at failure**

The mechanism of failure was revealed in detail by strain contour and deformation of the foundation. First, failure mode at amplitude 400 kN was studied. Fig. 5(a) shows the contour of the principal strain and 10 times magnified deformation at the failure. The predominant strain areas were cone-shaped from the tip of the anchor ring to the top surface of the pedestal. The cone-shaped failure can be observed from the contour of shear strains shown in Fig. 5(b) as well. Fig. 5(c) shows

a 10 times magnified deformation of the foundation. At cycle number 28, the anchor ring at  $\theta = 90$  degrees looked like it was being pulled out. At cycle number 290, the anchor ring at  $\theta = -90$  degrees was pushed out. This behavior of the anchor ring could be due to the concrete fracture which was simulated by advanced dynamic analysis. We define this failure process as Mode I.

(a) Principal strain contour (b) Shear strain contour (c) Magnified deformation (disp. x50)

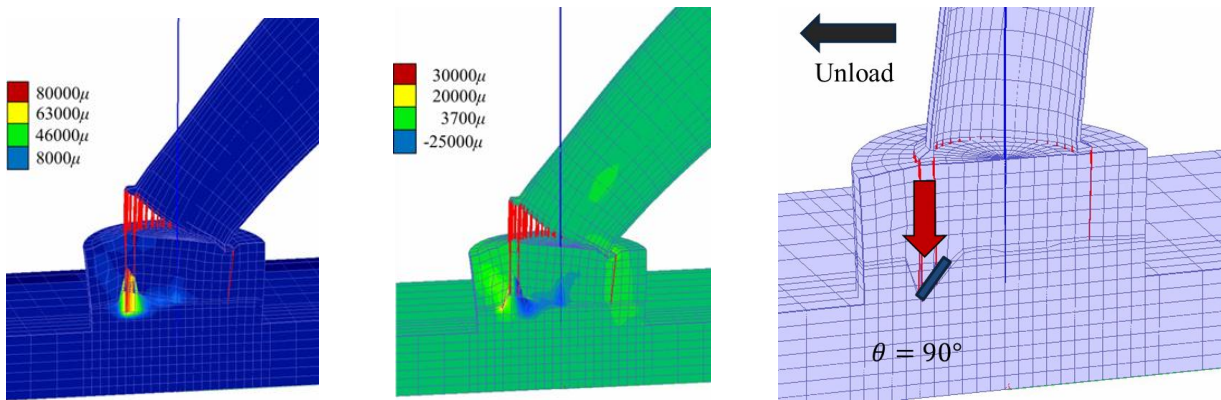
**Figure 6: Strain contour and deformation of foundation for 600kN at failure**

Second, load amplitude 600 kN was studied. Cone-shaped failure similar to that of 400 kN was not clearly observed from principal strain contour, though it could be inferred from shear strain contour (Fig. 6(a), 6(b)). At 50 times magnified, just before the failure, at the first loading, the anchor ring at  $\theta = 90$  degrees looked like it was being pushed out, as shown in Fig. 6(c). During the following loading, the anchor ring at  $\theta = 90$  degrees was pulled out and the anchor ring at  $\theta = -90$  degrees was pushed out. This behavior of the anchor ring was caused by concrete fracture due to the dynamic load of tension and compression alternating. We define this failure process as Mode II.

(a) Principal strain contour (b) Shear strain contour (c) Magnified deformation (disp. x50)  
(Just before failure)

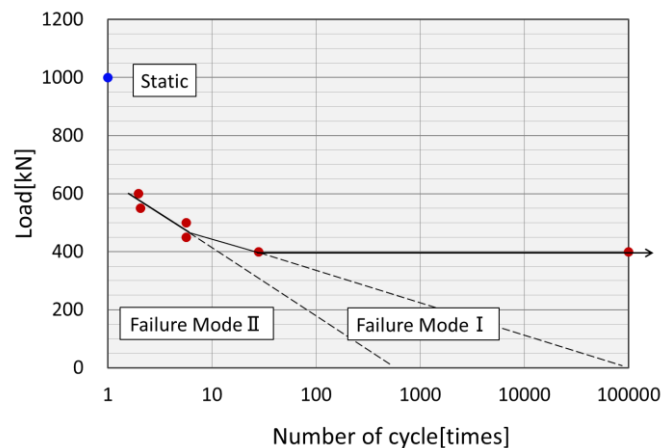
**Figure 7: Load – Number of cycle**

The relation of load amplitude and number of cycles at failure are shown in Fig. 7. The area was separated into two that correspond to failure modes I and II. In dynamic and static load, the

relevance of the relation of the load and failure mode was not confirmed. Failure occurred in low-cycle fatigue at less than 100 cycles. However, with amplitude less than 400 kN, no number of cycles resulted in a collapse of the wind turbine. This suggests that wind turbine collapse during low-cycle fatigue requires a minimum threshold amplitude.
