| Description | The Thirteenth East Asia-Pacific Conference on Structural Engineering and Construction (EASEC-13), September 11-13, 2013, Sapporo, Japan. |

# ON THE DETERIORATION TENDENCY OF BRIDGE SLABS AFTER REPAIR WORK (IN THE CASE OF A LOCAL AUTONOMY)

Hiroyuki Sugimoto<sup>1\*†</sup>, and Naotaka Shibuya<sup>2</sup>

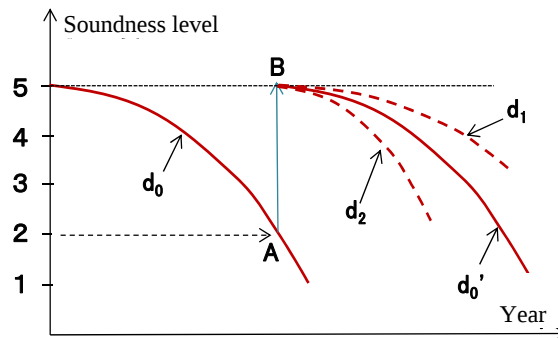
**Fig. 1 Repair and deterioration curves**

Figure 1 shows the relationship between the deterioration curves and repair of a component. It was assumed that the inspection results were evaluated on a scale of 1 (bad) to 5 (good). First, the degree of aging deterioration was calculated using the deterioration curve  $d_0$ . For example, it was assumed that repair was conducted when this component's soundness level became 2, which is shown as Point A in the figure. Conventionally, the soundness level was assumed to return to 5, and the deterioration curve  $d_0'$ , which was the same as the initial curve  $d_0$ , was used to calculate the degree of deterioration. These assumptions present two problems: 1) whether the soundness level actually returns to 5 (Point B in the figure), and 2) whether deterioration progresses with the same slope as that of the initial deterioration curve. In regard to the former, although some argue that the level may be higher than 5 depending on how repair is implemented, it is safe to assume that the value returns to 5 after repair because the initial value itself is not reached even with strict performance evaluation. Post-repair performance is also included in the slope of the deterioration curve after repair. Deterioration should be slow if the repair is good and fast if it is not. Figure 1 highlights the problem of what the actual condition of  $d_1$  or  $d_2$  is. As it is considered difficult to determine these values theoretically, post-repair deterioration was examined based on actual floor slab data in this study. The soundness level on the vertical axis of the figure is used to represent the degree of deterioration.

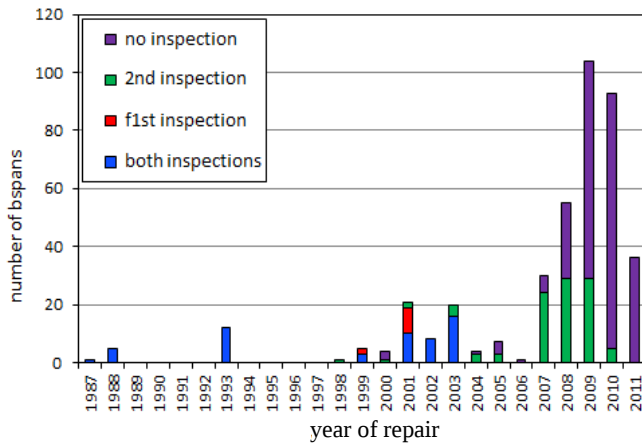
Figure 2 shows years and the number of spans (379 in total) on which partial slab repair has been conducted since 1987. The details of slab repair were not recorded before this time. The number increased dramatically from 2007.

In the figure, blue shading represents the number of spans for which results from the first and second rounds of inspection were found. The red and green areas indicate those for which only results from the first or second round, respectively, were found. Purple represents spans for which no inspections had been conducted since recent repair.

**Fig. 2 Years and number of spans (379 in total)**  
with partial slab repair since 1987

Figure 3 shows years and the number of spans (28 in total) in which full-length slab replacement has been conducted since 1987. No yearly characteristics are seen, presumably because the work was conducted for reasons other than slab deterioration response. The color-coding of the bars in the figure is the same as that for Fig. 2.

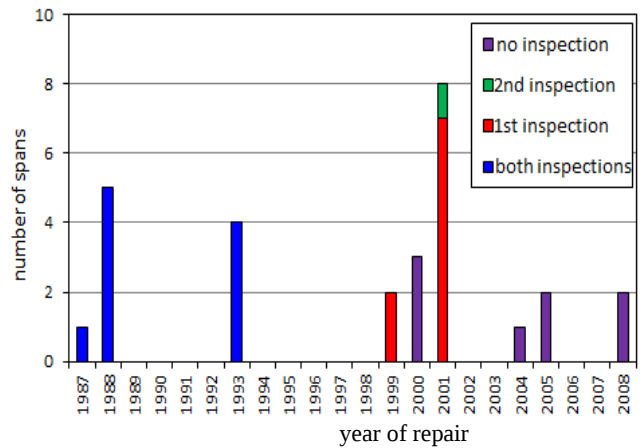
**Fig. 3 Years and number of spans (28 in total)**  
with full-length slab repair since 1987

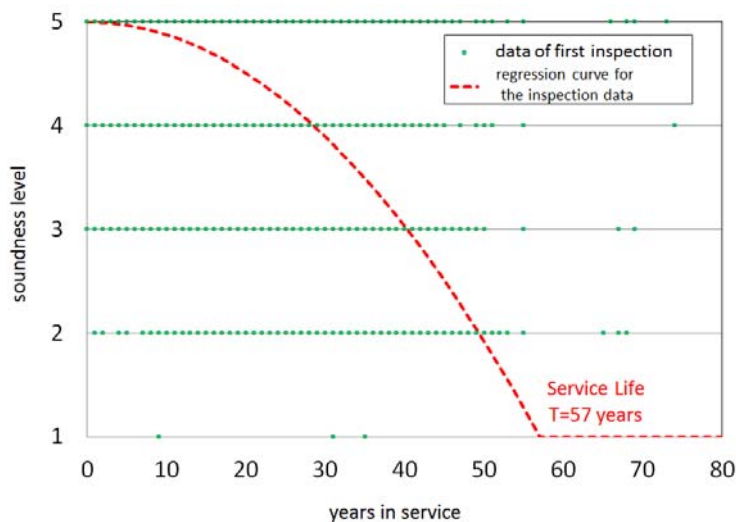
Figure 4 shows the slab deterioration curve found from the results of the first round of inspections with data on 6,468 spans. Figure 5 shows curves found in the same way from the results of the second round with data on 6,378 spans. The green dots indicate individual data samples, and the red dashed lines were found using the least squares method on the data. The two curves show almost the same tendency.

**Fig. 4 Deterioration curve using the first round inspection (6,468 data)**

is 21. However, as the spans inspected in both the first and second rounds were counted twice, there were actually 31 data samples. The purple dashed-dotted lines indicate curves found using the least squares method. As seen in the figure, the lines exhibit almost the same tendency as the standard curves shown in figs. 4 and 5. This suggests that with slab repair based on full-length replacement, post-repair deterioration will show a tendency of progress similar to that of the standard slab deterioration curves.

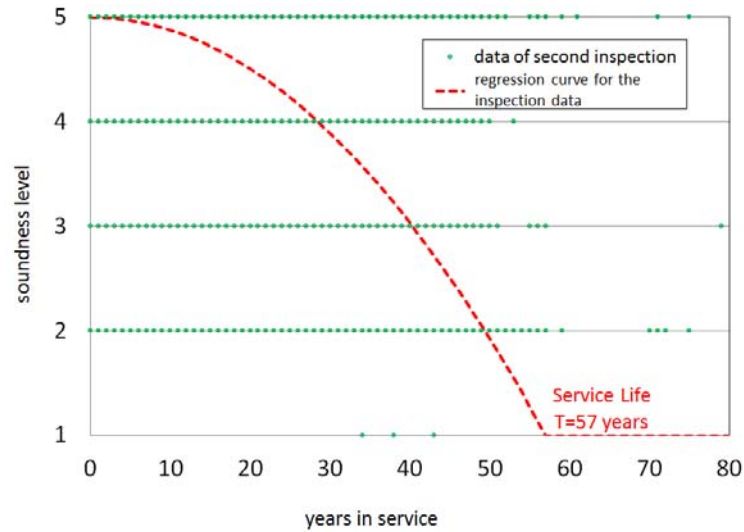
**Fig. 5 Deterioration curve using the second round inspection (6,378 data)**

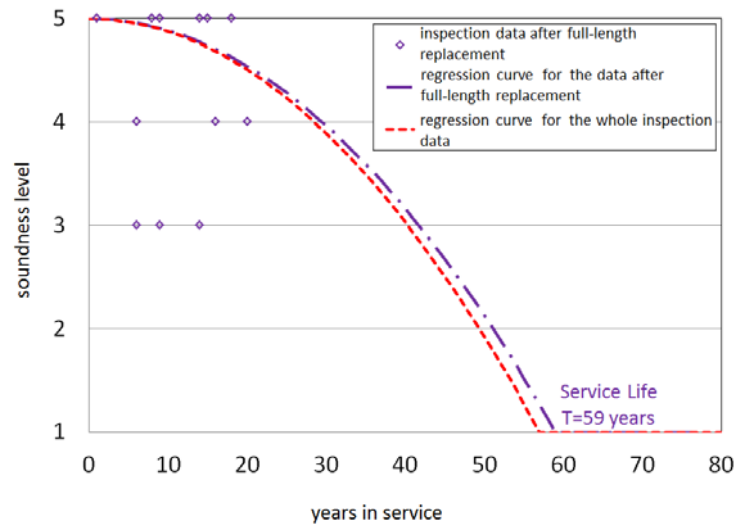
Figure 6 shows slab deterioration curves found from the results of inspection after full-length slab replacement. The purple  $\diamond$  symbols represent inspection data; the corresponding number of spans

**Fig. 6 Deterioration curves using the inspection data after full-length replacement (31 data)**

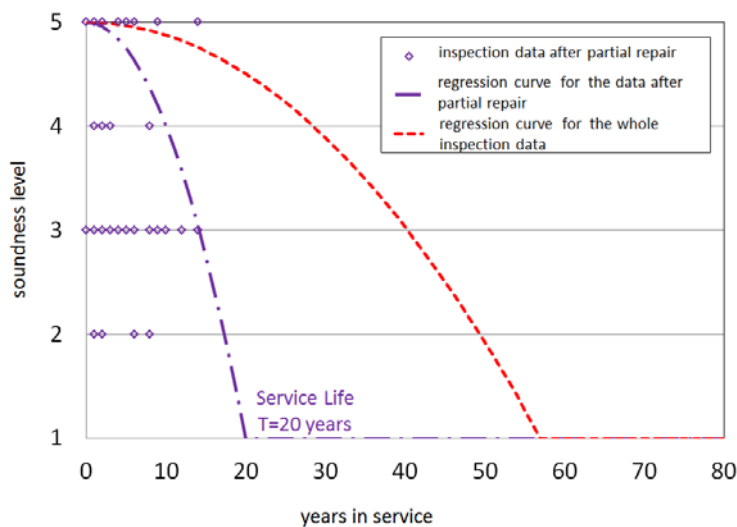
**Fig. 7 Deterioration curves using the inspection data after partial replacement (177 data)**

Figure 7 shows slab deterioration curves found from the results of inspection after partial repair. The purple  $\diamond$  symbols represent inspection data. The number of data samples is 177 for 132 inspected spans for the reason outlined above. The purple dashed-dotted line indicates the curve found using the least squares method. Compared to that for full-length replacement, the deterioration curve indicates a much faster rate of decline. While the number of years until the soundness level reaches 1 is approximately 57 on the standard deterioration curve, it is 20 years after partial repair (approximately a third of the standard), indicating that deterioration progresses three times as quickly.

The authors analyzed repair and inspection data selected from a data set managed by a municipal construction department to study changes in bridge component deterioration curves at the post-repair stage. From the results obtained, this paper outlines the outcomes of bridge slab analysis. The study produced results of inspection item evaluation corresponding to repair work (rather than simply comparing repair and inspection outcomes) in order to provide a basis for post-repair tendency clarification, and these outcomes are outlined here. Full-length replacement resulted in a level of performance similar to that seen with new slabs. However, with partial repair, dramatic acceleration of the deterioration curve decline was seen, and the level of performance decreased to almost a third of that observed with new slabs.
