| Description | The Thirteenth East Asia-Pacific Conference on Structural Engineering and Construction (EASEC-13), September 11-13, 2013, Sapporo, Japan. |

# BASIC STUDY ON DAMAGE LOCALIZATION OF STEEL BRIDGES BASED ON THE CHANGES OF MODAL AMPLITUDE

N. KOUSO<sup>1\*</sup>, Y. MIYAMORI<sup>2†</sup>, S. MIKAMI<sup>3</sup>, T. OSHIMA<sup>4</sup> and T. SAITO<sup>5</sup>

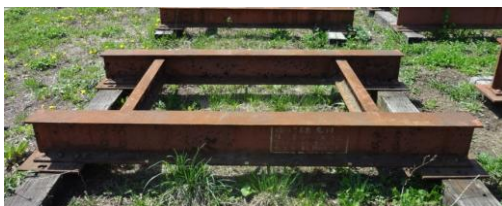
The bridge used in this paper is Iwaogawa Bridge moved from old Chihoku Kougen Railway as shown in Figure 1. This 2.4m bridge is composed of 2 I shaped beam girders and 2 channel steel crossbeams. Main girders are supported by 4 round steel bar on timbers as shown in Figure 2. Material properties of bridge are summarized in Table 1. Figure 3 shows the section of each

**Figure 1: Target steel bridge**

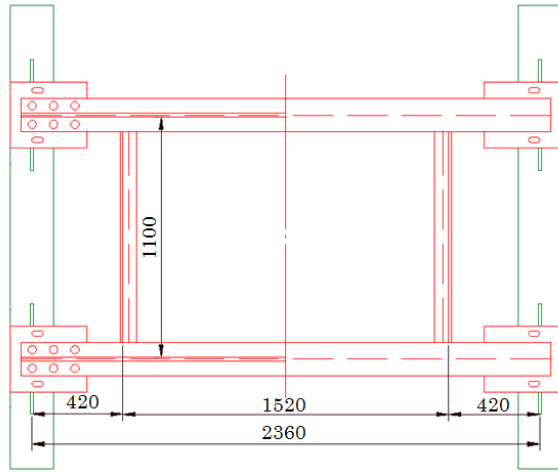
(a) Plan view (mm)

(b) Side view (mm)

(c) Cross section (mm)

Figure 2: General drawing

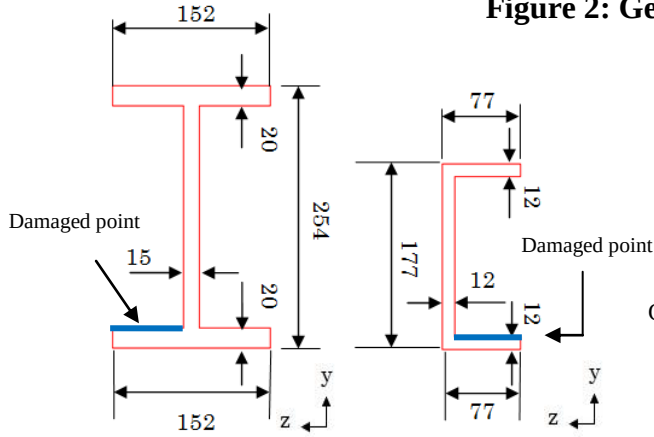
(a) Main girder

(b) Crossbeam

Figure 3: Dimension of member (mm)

Scenario C: the thickness of lower flange of both I-beam and channel member are reduced at the connection (element #(3) and #(25)) for considering probable damage scenario in real structure. The damaged points in each section are pointed in Figure 3. Table 2 shows section area and moment inertia of each cross section with damage scenario. In each damage scenario, 4 damage levels are

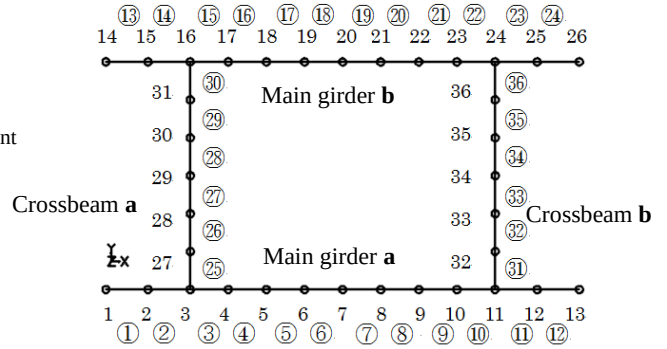
Figure 4: Node numbers and element numbers (Circled)

member of the bridge. FEM model of this bridge composed of these properties. For simplification, these members are modeled as beam elements. The bridge model is divided by 36 elements and the model has 36 nodes as shown in Figure 4. Node 1, 13, 14 and 26 are supported points. All displacements are restrained and rotation of Y-axis is only free on these nodes. For FEM analysis, TDAP3 which is a general structural analysis program is used in this study. Natural frequencies and mode shapes less than 1000Hz are shown in Figure 5 from eigenvalue analysis.

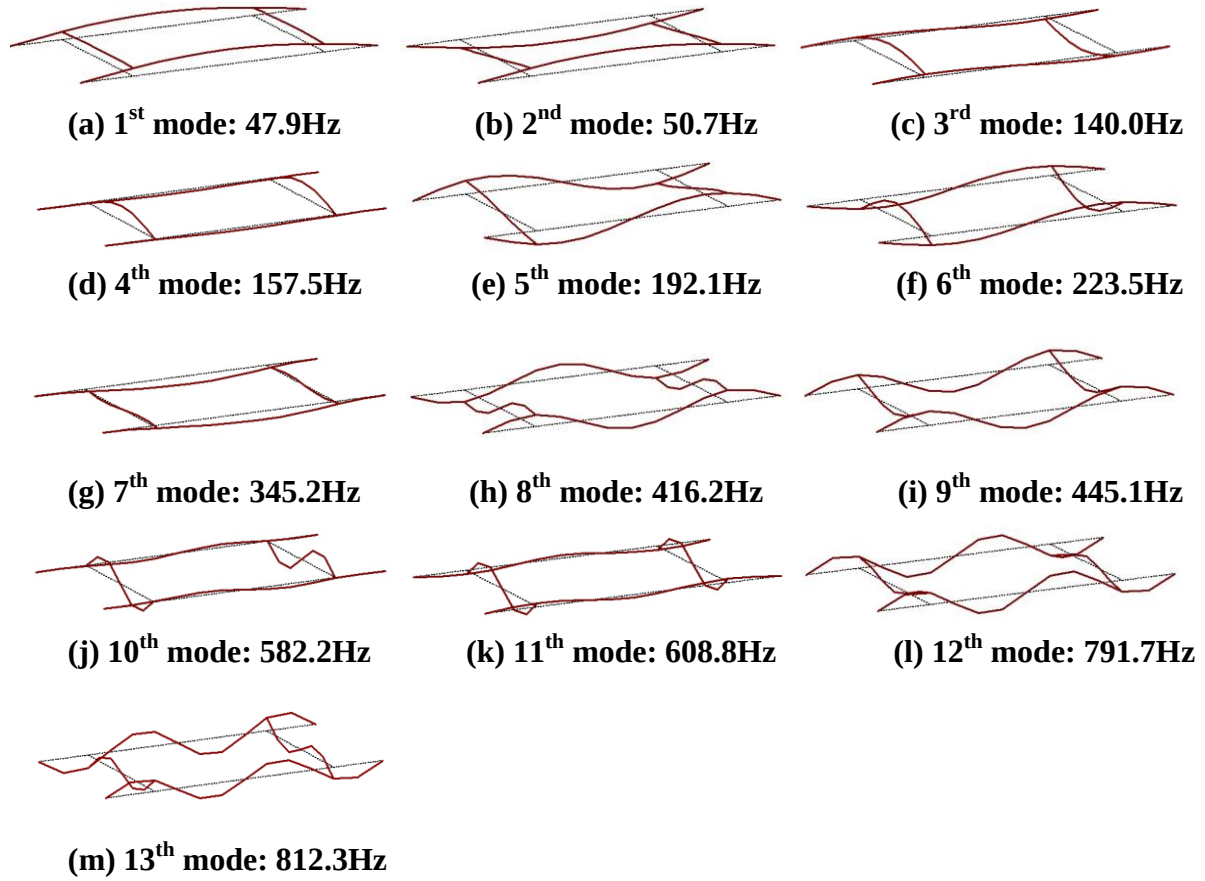
Figure 5: Natural frequencies and mode shapes

where  $\phi$  is modal amplitude of each node in undamaged state,  $\phi_d$  is modal amplitude of each node in damaged states and  $k$  is mode order. The maximum mode order is 13 because modes less than 1000Hz of natural frequencies are considered in this study as shown in Figure 5. The index is the accumulation of modal amplitude differences in each nodal point.  $d_n$  is calculated for each damage scenario and damage level based on eigenvalue analysis of FEM model.

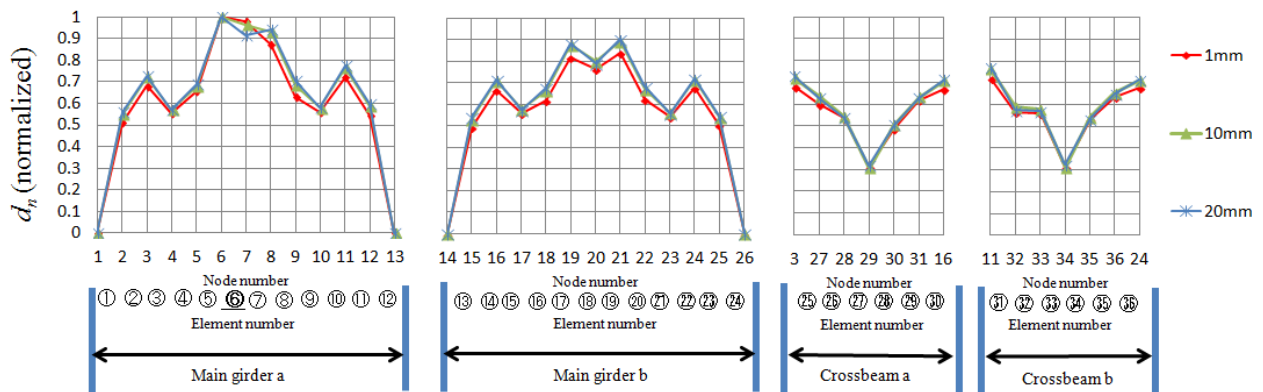
The damage index obtained by eigenvalue analysis for the damaged element #(6) is shown in Figure 6. Horizontal axis shows node and element number and vertical axis shows normalized  $d_n$  by the maximum value. The index is dimensionless number and it takes between 0 and 1.  $d_n$ s at the node #6 and #7 which are both ends of the damaged element #(6) show the largest values in all nodes for damage scenario A1 and A10. It is considered that element #(6) is easily affected by reduction of the moment of inertia and its deflection increases. However in the severe damage scenario A20, the second maximum value of  $d_n$  is not obtained in the node #7 but it is obtained in the node #8.

Figure 6: Damage index  $d_n$  in damage scenario A

Moreover,  $d_n$  increased in nodes on the undamaged main girder **b**. This result indicates that larger structural damage affect mode shape in whole of structure not only around damaged point.

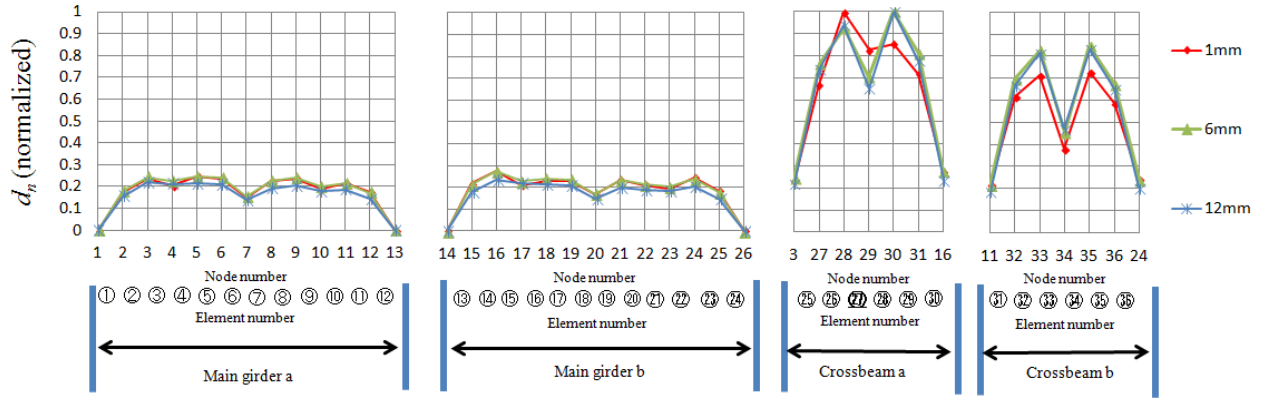
**Figure 7: Damage index  $d_n$  in damage scenario B**

The damage index obtained by eigenvalue analysis for the damaged element #(27) is shown in Figure 7. The indices of nodes on crossbeams are comparatively larger than indices on main girders. The largest value of  $d_n$  in the damage scenario of B6 and B12 appears at the node #30 although B1 has the maximum value at the node #28. This result is same in the damage scenario A as shown in Figure 6. Therefore, small thickness reduction gives more accurate result than large thickness reduction if the damage index considers modal amplitude changes in each node.

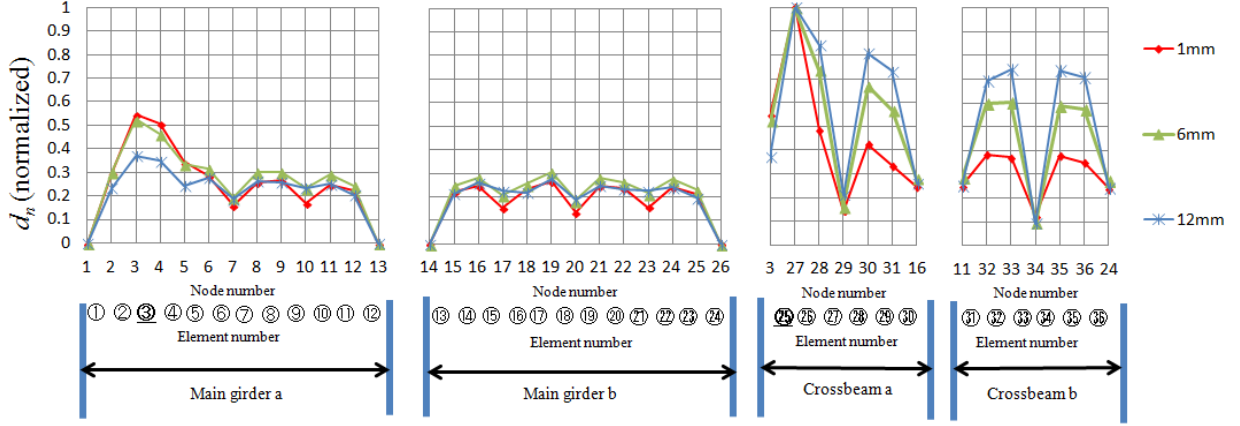
The damage index obtained by eigenvalue analysis for the damaged element #(3) and #(25) is shown in Figure 8. Nodes #3, #4 and #27 adjoin both ends of the elements #(3) and #(25).  $d_n$  in the node #27 on the crossbeam **a** shows the maximum value in all damage levels C1, C6 and C12. Nodes #3 and #4 have the largest  $d_n$  in main girders. As for C1,  $d_n$  is large at the nodes #27, #3 and #4 in that order. Therefore,  $d_n$ s at both ends of damaged elements show large amplitude in case of small damage. On the other hand,  $d_n$ s in undamaged nodes become larger than  $d_n$ s at nodes #3 and #4 for C6 and C12. In these cases,  $d_n$  cannot locate damage accurately. This reason is considered that mode shapes of multi degree of freedom system appear complicatedly. A part of cross-sectional reduction causes change in mode shapes. However, modal amplitudes also change at undamaged members. For example,  $d_n$ s at the node #33 and #35 increase although the crossbeam **b** is undamaged member. Therefore, the influence of each mode in  $d_n$  should be discussed.

Figure 8: Damage index  $d_n$  in damage scenario C

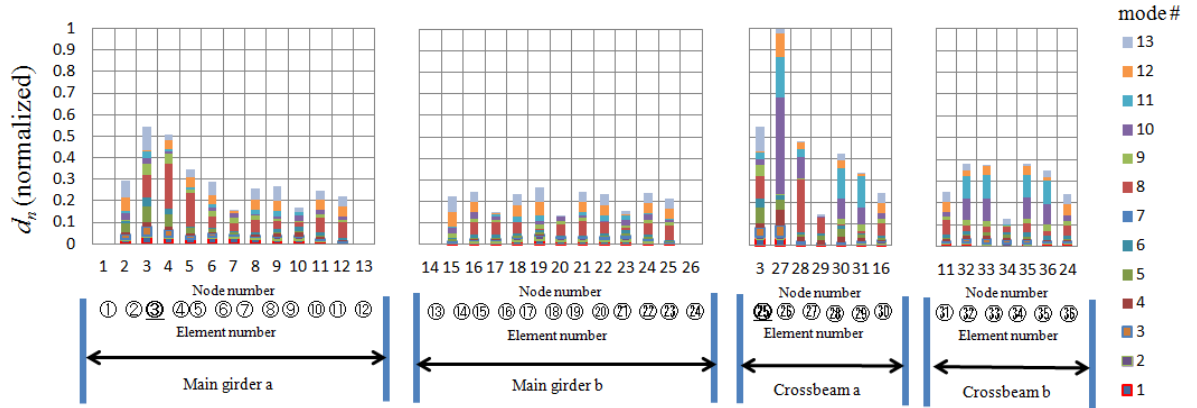
Contribution of each mode for  $d_n$  in C1 is shown in Figure 9. On the whole, influence of plural modes is shown in each node. Large  $d_n$  of the node #27 is influenced from the 10<sup>th</sup> mode. In other damage scenarios, other vibration modes give influence to the damage index. For example, the  $d_n$  of the node #6 becomes the largest in the damage scenario A1 as shown in Figure 10. In this case,

Figure 9: Damage index  $d_n$  and contribution ratio of each mode in C1

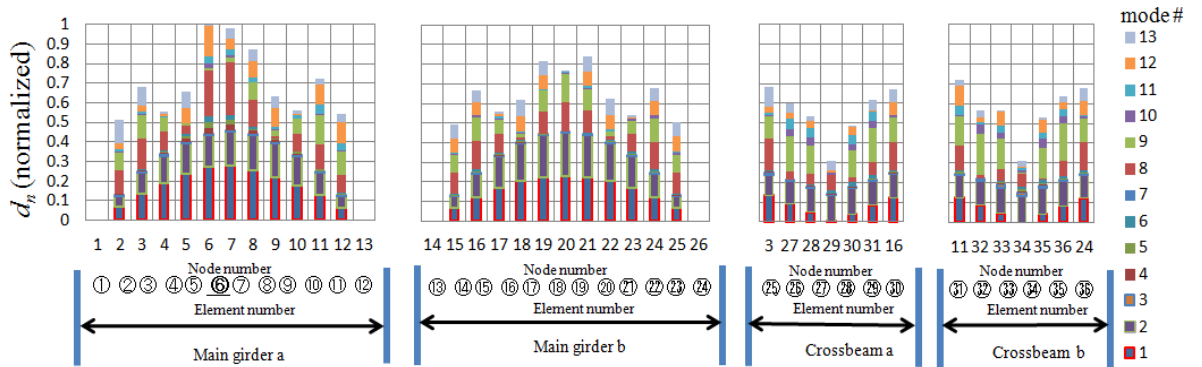
contributions of the 1<sup>st</sup> and 8<sup>th</sup> modes are large. Moreover,  $d_n$  of the node #28 becomes the largest in the damage scenario B1 as shown in Figure 11 by contribution of the 3<sup>rd</sup> and 10<sup>th</sup> modes. These mode shapes have bulge which node adjoins element with thickness reduction. In small thickness reduction, only modal amplitude having bulge in damaged location changes large. Therefore,  $d_n$  which accumulates modal amplitude differences of nodes in the model can detect damage location.

Figure 10: Damage index  $d_n$  and contribution ratio of each mode in A1

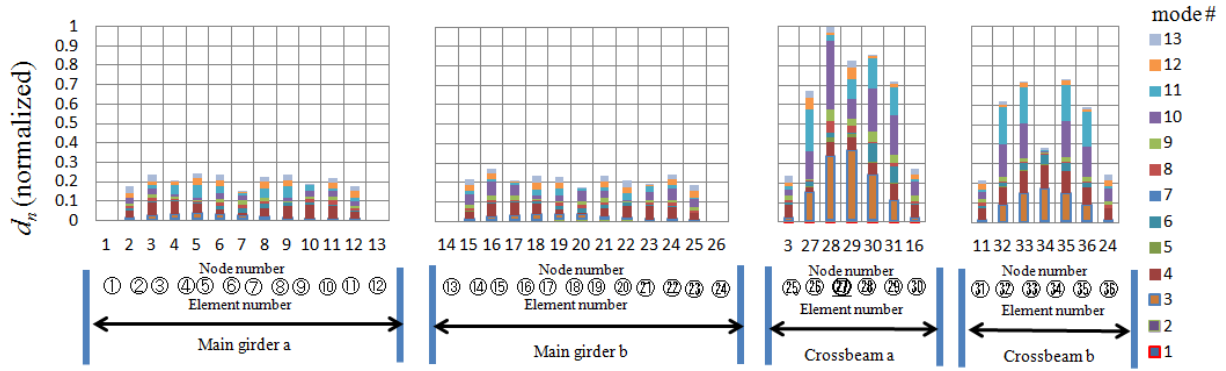
**Figure 11: Damage index  $d_n$  and contribution ratio of each mode in B1**
