| Title | New stent exchange technique following endoscopic ultrasound-guided nasobiliary drainage (with video) |
| Author(s) | Kawakami, Hiroshi; Kuwatani, Masaki; Sakamoto, Naoya |
| Citation | Digestive Endoscopy, 25(3), 343-344<br><a href="https://doi.org/10.1111/den.12051">https://doi.org/10.1111/den.12051</a> |

**Internal biliary stent placement following endoscopic ultrasound-guided  
nasobiliary drainage**

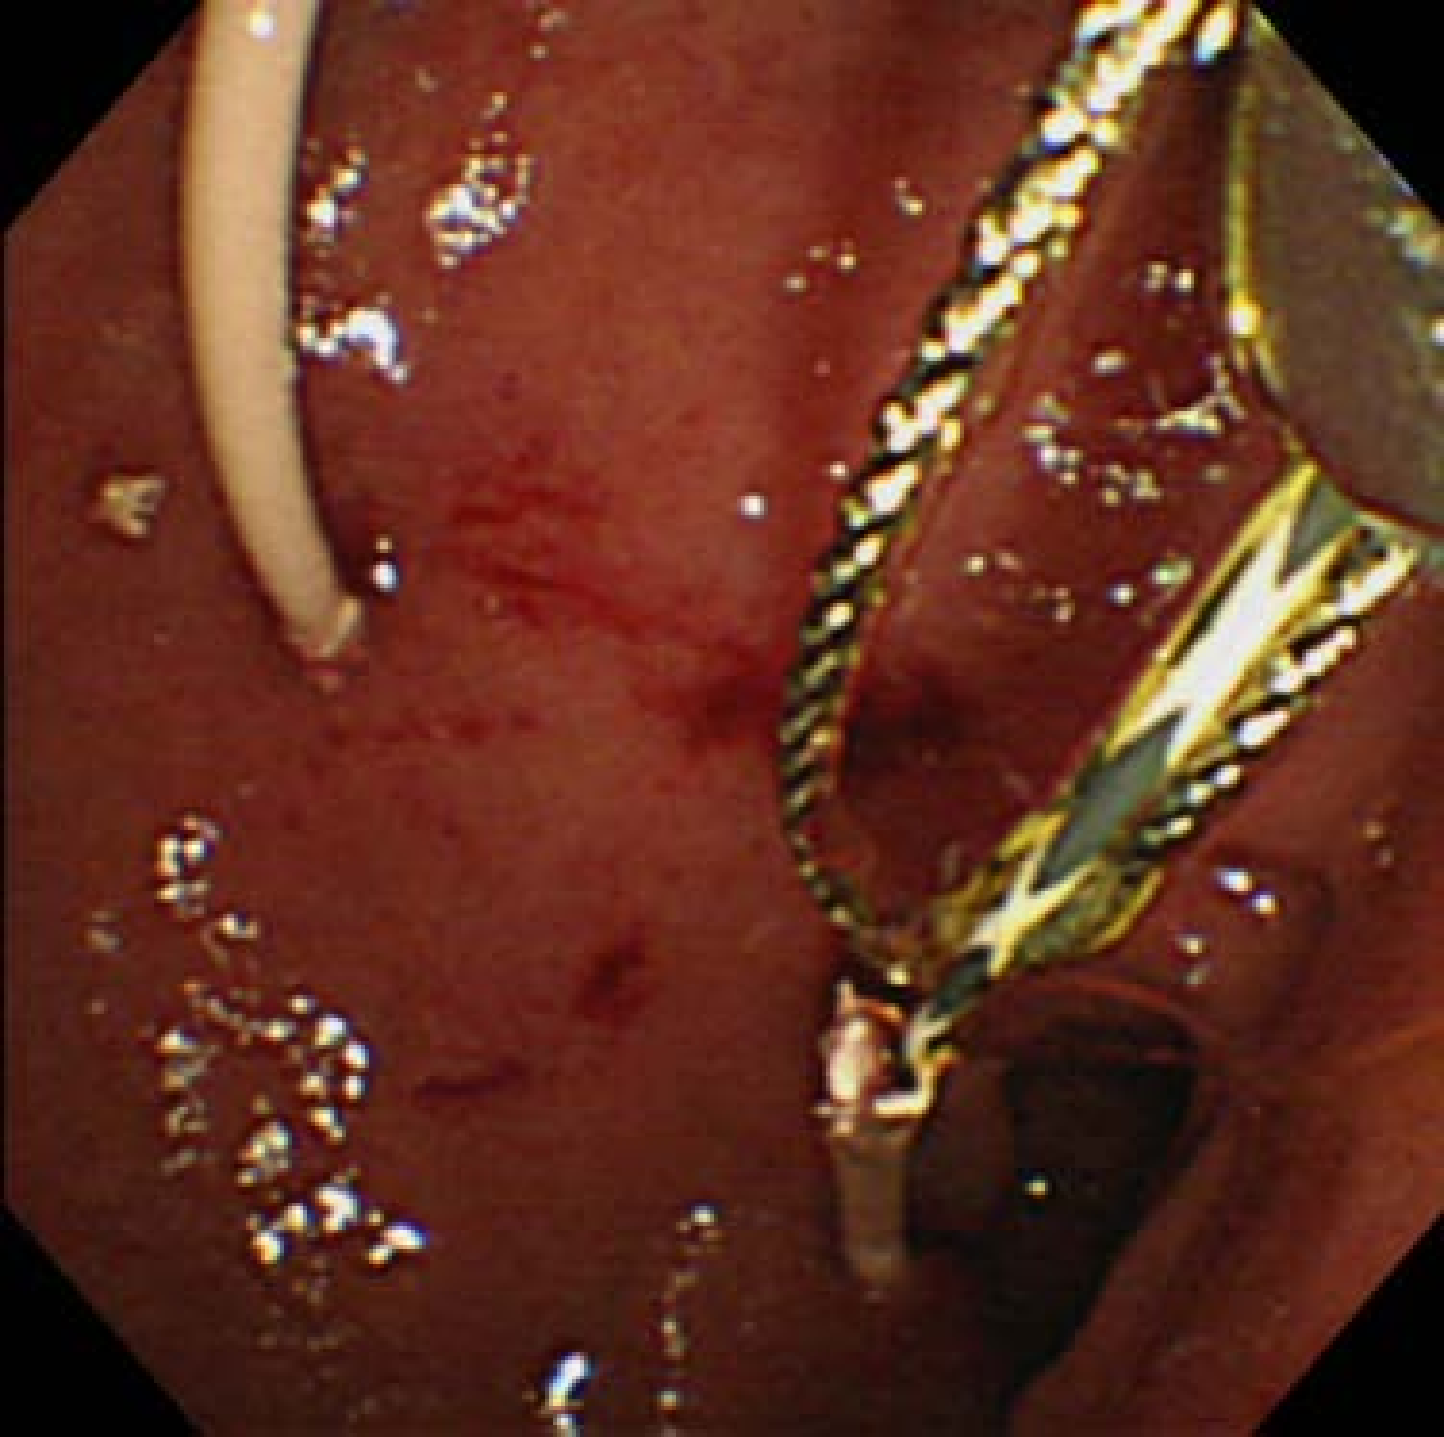
**Fig. 1:** Endoscopic image showing the snare-over-the-wire technique via the remnant nasobiliary tube following endoscopic ultrasound-guided nasobiliary drainage.

An 83-year-old man with obstructive jaundice was admitted to our department. He had undergone chemotherapy for malignant lymphoma. Seventeen months later, computed tomography revealed a distal bile duct mass. Endoscopic ultrasound (EUS)-guided fine-needle aspiration of the mass revealed malignant lymphoma. Endoscopic retrograde cholangiopancreatography (ERCP) was unsuccessful due to difficult cannulation, so EUS-guided choledochoduodenostomy (EUS-CDS) was performed. Although a 0.025-inch guidewire was advanced into the intrahepatic bile duct, a tapered ERCP/balloon/Soehendra biliary dilation catheter (SBDC-6, Cook-Japan, Tokyo, Japan) could not be passed across the tract. We attempted to dilate the tract using a guidewire-induced needle knife, but the knife was displaced from the axis of the bile duct between the duodenal bulb and bile duct. Then, a 5-Fr nasobiliary tube was put in place. Fourteen days after EUS-CDS, we tried to exchange the nasobiliary stent with a duodenoscope. First, the nasobiliary tube was cut using scissors (FS-3L-1, Olympus Medical Systems, Tokyo, Japan) and loop cutter forceps (FS-5L-1, Olympus). Next, the remnant tube was cannulated using a wire-guided technique via the ERCP catheter. The tube was trapped in the snare with the snare-over-the-wire technique [1] (**Fig. 1**). After removing the remnant tube via the working channel with the snare-over-the-wire technique, a 7-Fr plastic stent was put in place without complications (**Fig. 2**).

The nasobiliary tube was cut using scissors (FS-3L-1, Olympus Medical Systems, Tokyo, Japan) and loop cutter forceps (FS-5L-1, Olympus). The remnant tube was cannulated using a wire-guided technique via the ERCP catheter. The tube was trapped in the snare with the snare-over-the-wire technique. After removing the remnant tube via the working channel with the snare-over-the-wire technique, a 7-Fr plastic stent was put in place without complications.

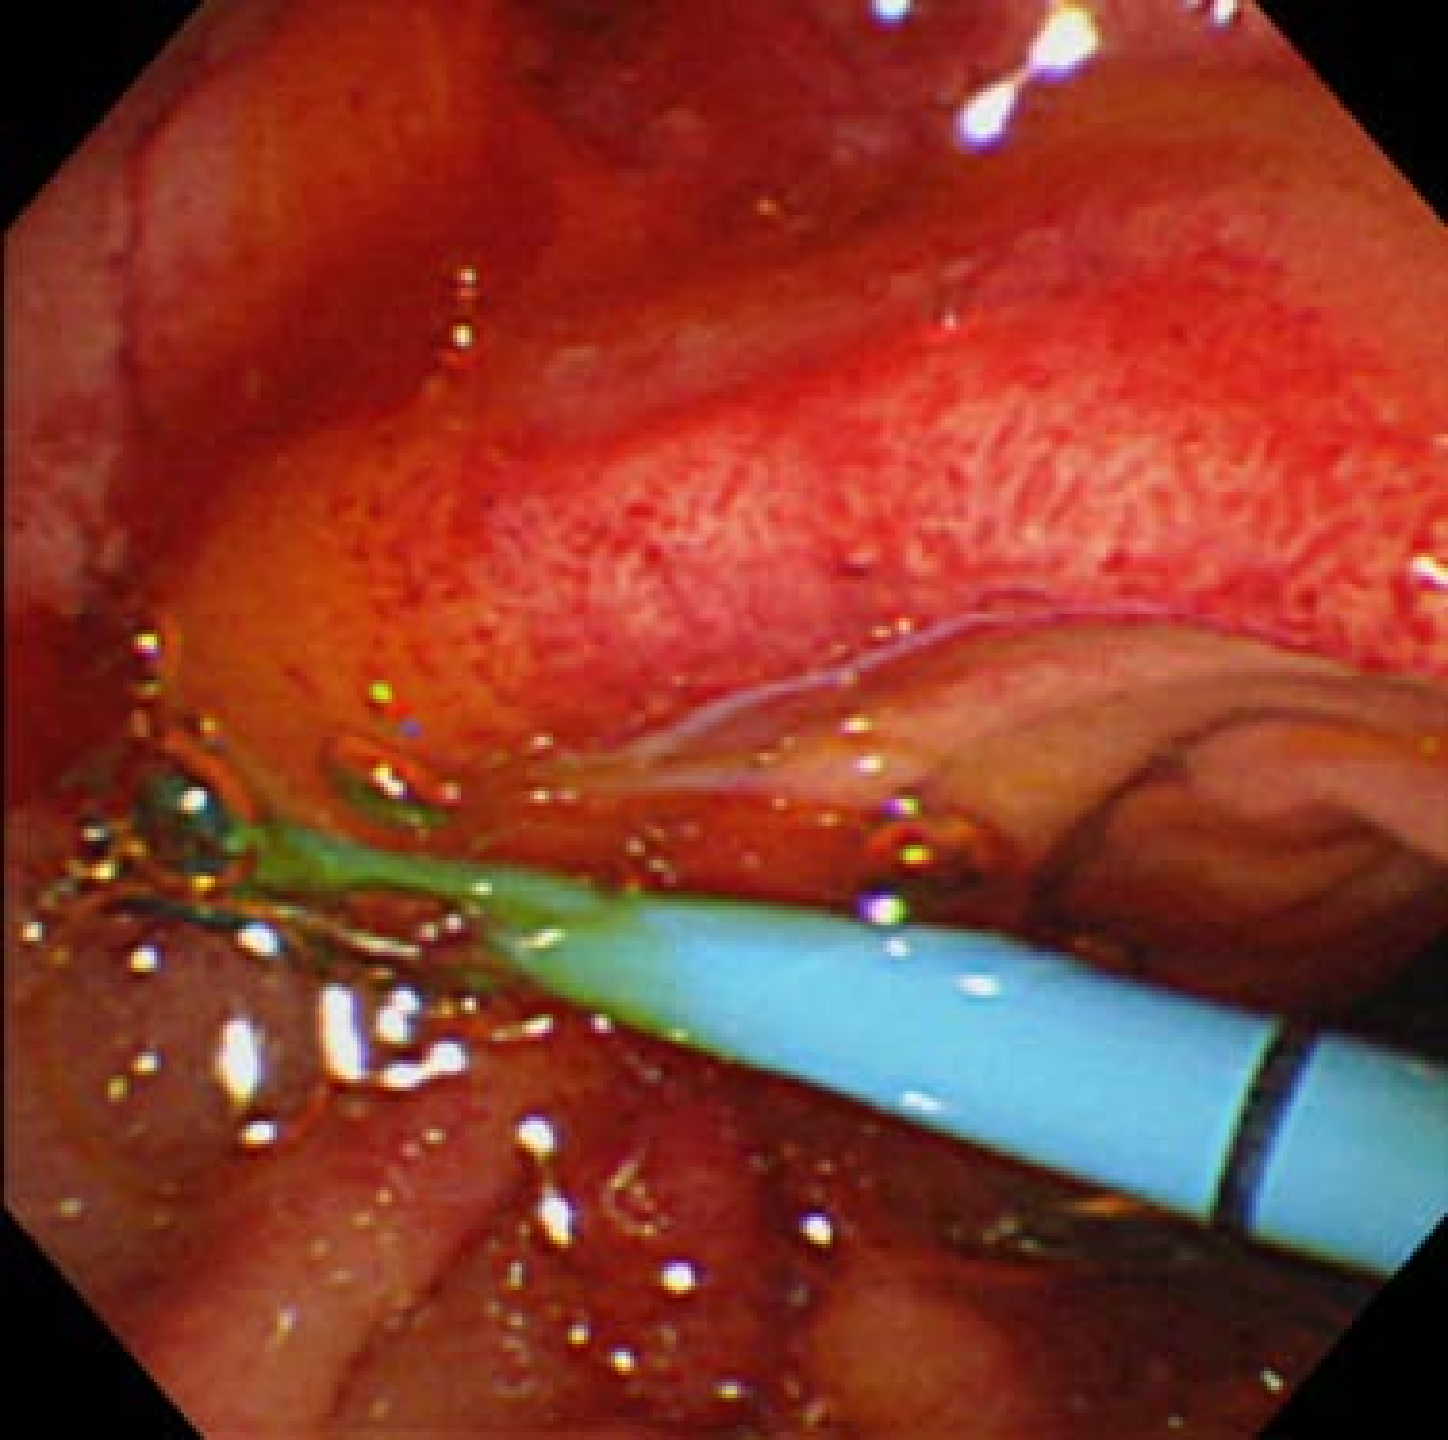
**Fig. 2:** A 7-Fr plastic stent was placed via the fistula without complications after endoscopic ultrasound-guided nasobiliary drainage.
