| Author(s) | Ishigaki, Takahiro; Wakasa, Satoru; Sato, Koji et al. |

*How to Do It*

## **Reconstruction of right ventricular outflow tract with severe calcification: Lantern procedure**

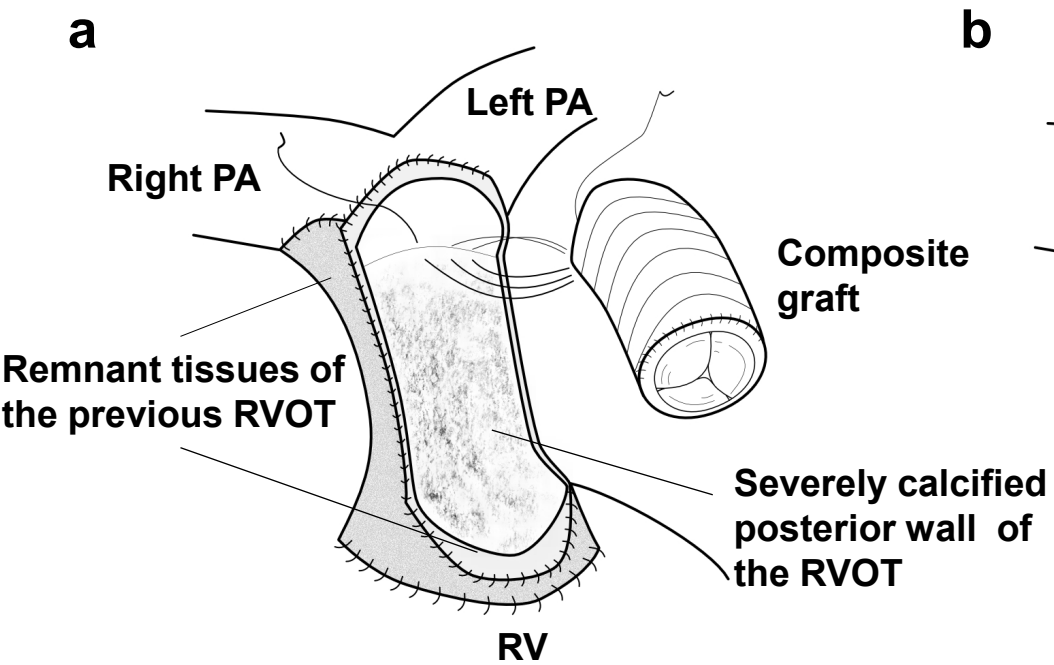
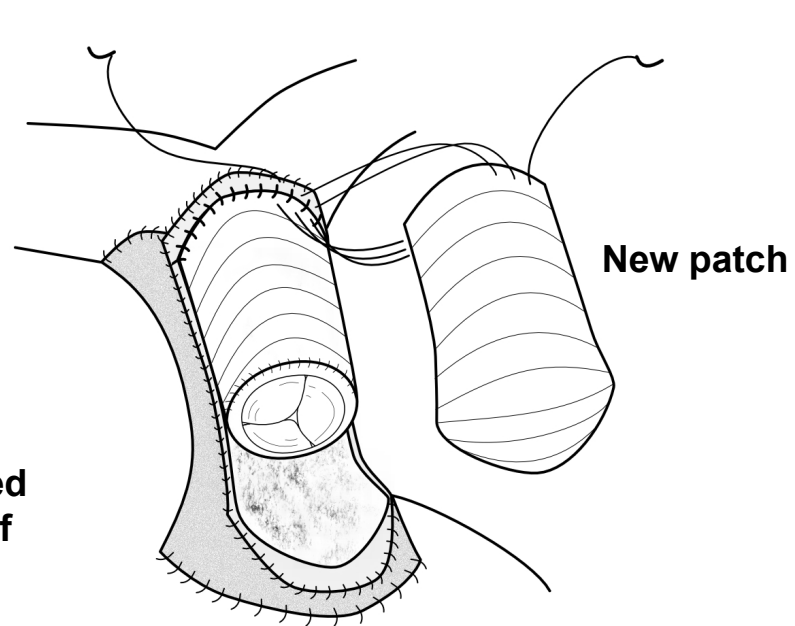
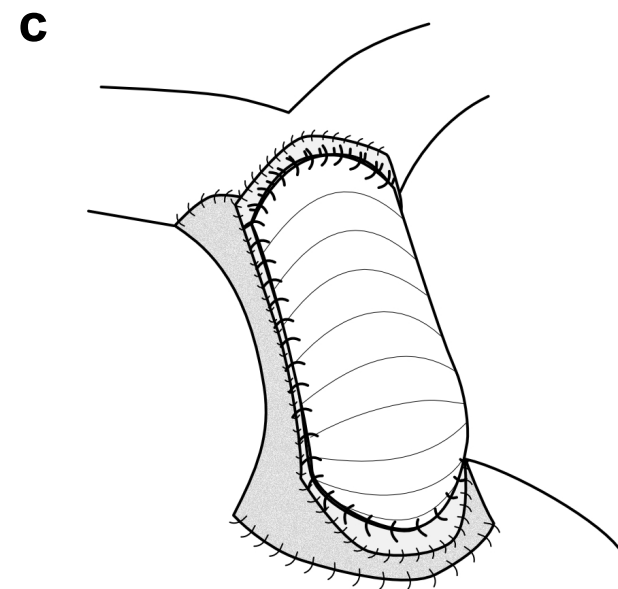
**Fig. 1** RVOT was reconstructed using the lantern procedure (a-c). Severe calcification was observed in the right ventricular outflow tract (RVOT) posterior wall made of the previous conduit (d). A composite graft fitted tightly in the new RVOT without blood flow or thrombus around the composite graft (e)

1 The surgery was performed under general anesthesia. After a successful resternotomy,  
2 standard cardiopulmonary bypass with ascending aortic perfusion and bicaval venous  
3 drainage was established. After cardiac arrest was achieved, a longitudinal incision was made  
4 on the anterior wall of the RVOT and the calcified anterior wall was resected. A short valved  
5 composite graft was anastomosed to the distal end of the pulmonary trunk using a 4-0  
6 polypropylene suture (Fig. 1a). The composite graft was then covered using a prosthetic graft  
7 patch, which was anastomosed to the remnant tissues of the previous RVOT conduit or patch  
8 using a 4-0 polypropylene suture for the reconstruction of the anterior wall of a new RVOT  
9 (Fig. 1b). A small patch size was selected to tightly fix the proximal side of the composite  
10 graft in the new RVOT (Fig. 1c).

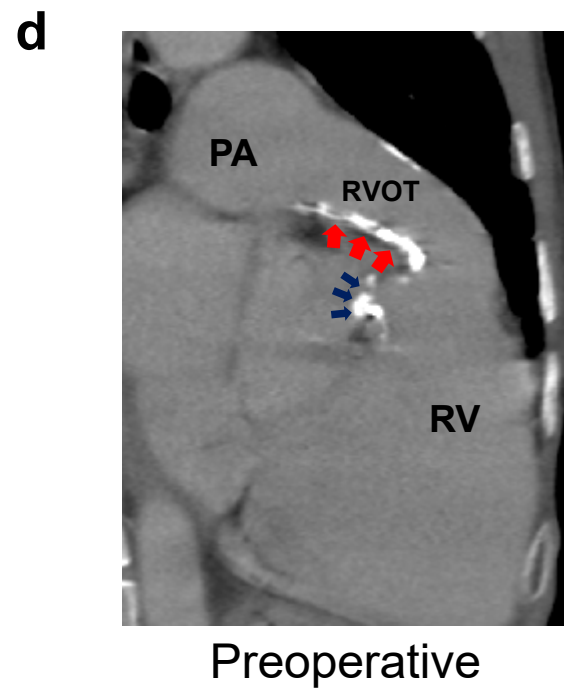
Red arrows indicate the calcification of the posterior wall. Blue arrows indicate the previous intraventricular re-routing patch.

11 The lantern procedure was initially developed to reduce complexity and risk of RVOT  
12 reconstruction in the patient who underwent RVOT reconstruction, simultaneously with mitral  
13 valve repair, tricuspid repair, and ascending aortic replacement using hypothermic circulatory  
14 arrest. The patient featured was born with transposition of the great arteries with a ventricular  
15 septal defect and pulmonary valve stenosis. He had undergone RVOT reconstruction twice at  
16 the age of 7 and 16 years (using an equine pericardial conduit and autologous pericardial patch,  
17 respectively) and required the third RVOT reconstruction, due to heart failure. Preoperative  
18 computed tomography revealed severe calcification on the posterior RVOT wall and the left

coronary artery behind the proximal RVOT (Fig. 1d). Intraoperatively, severe calcification was also observed on the posterior wall of the RVOT and direct anastomosis was abandoned. We decided to adopt the lantern procedure, which required a single suture on the distal RVOT wall to implant the bioprosthesis. To date, this procedure has been successfully performed in two patients in their 30s with severe calcification on the posterior RVOT wall. In both patients, there were no difficulties in the distal anastomosis because no calcification was found on the distal end of the pulmonary trunk. The composite graft was created using a 25-mm and 27-mm bioprosthetic valves (Epic Supra, Abbott Vascular, Chicago, IL, USA) and a 28-mm (Triplex, Terumo Corporation, Tokyo, Japan) and 30-mm prosthetic grafts (J-graft, Japan Lifeline, Tokyo, Japan), respectively. Both patients recovered uneventfully. The composite graft fit well in the new RVOT without blood flow or thrombus around the graft on postoperative computed tomography (Fig. 1e).
